# Environmental Monitoring Report

Semestral Report  
January – June 2016  
July 2016

## Azerbaijan: Water Supply and Sanitation Investment Program – Nakhchivan City Water Supply and Sewerage Subproject (Tranches 2 and 3)

Prepared by State Amelioration and Water Management Committee for the Government of Azerbaijan and the Asian Development Bank.

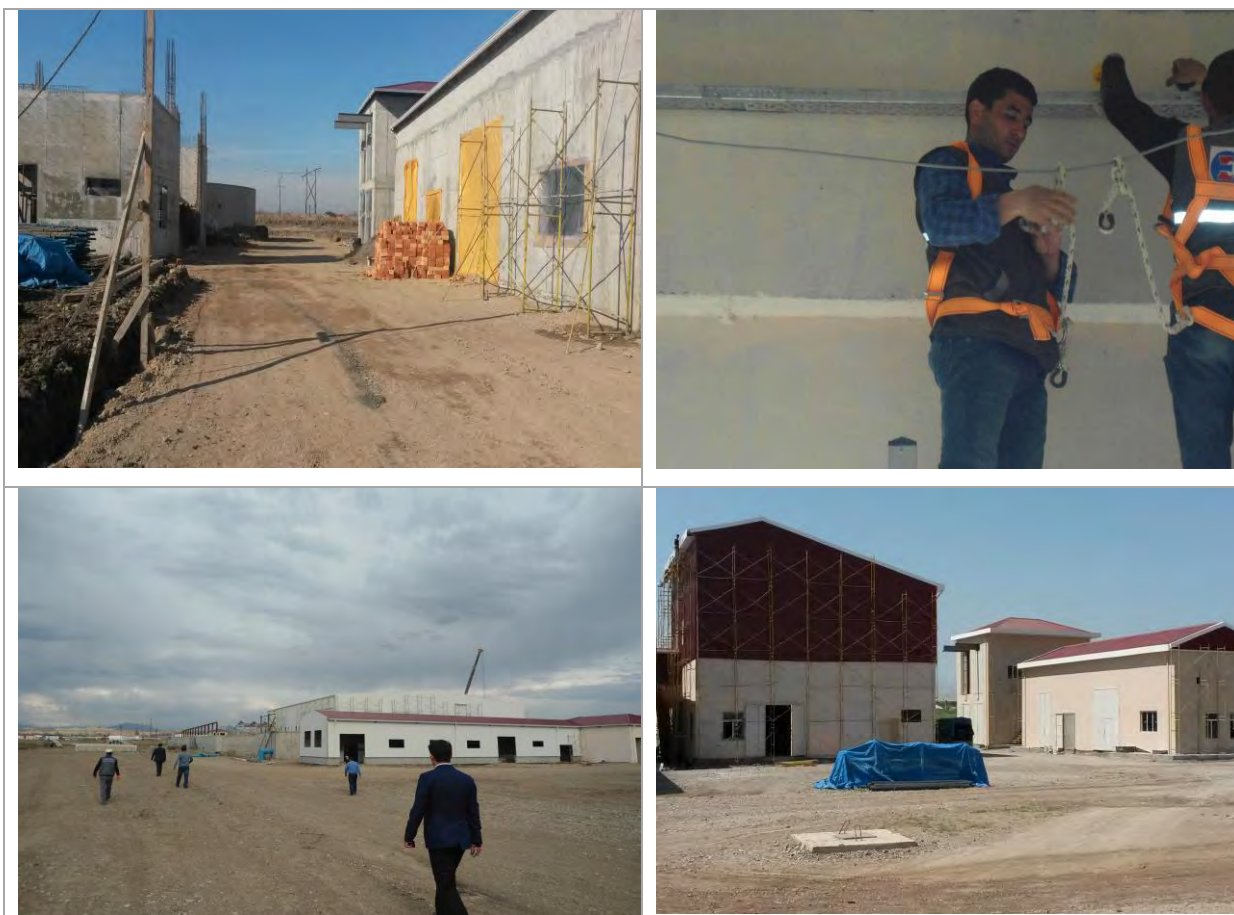
**Figure 1: General Views of the site**

46. The Contractor has continued the construction works on site over the past six months within the bounds of the SEMP; all works were compliant, and the site was clean, tidy, and well maintained. General view of the project site is shown in Figure 1 below.

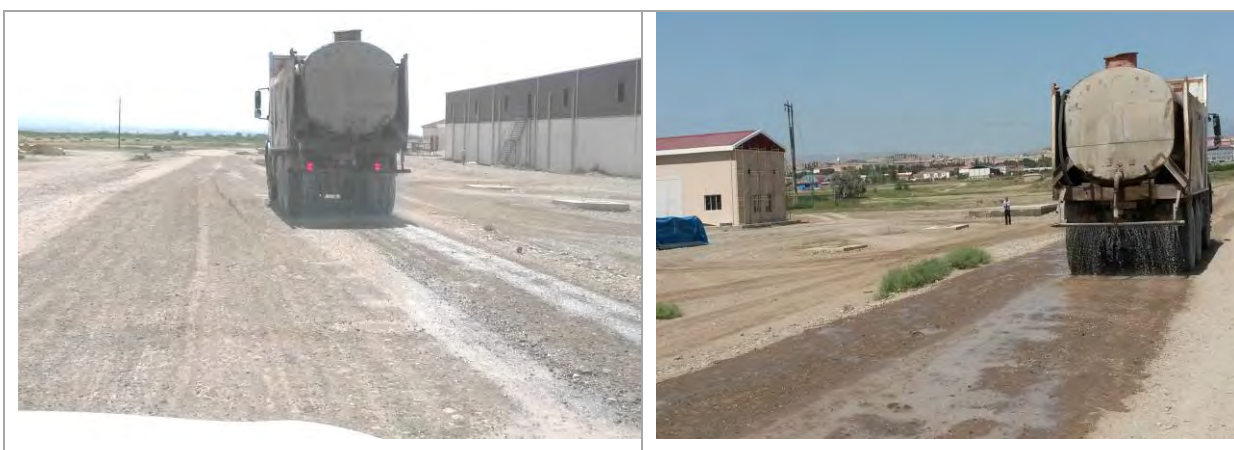
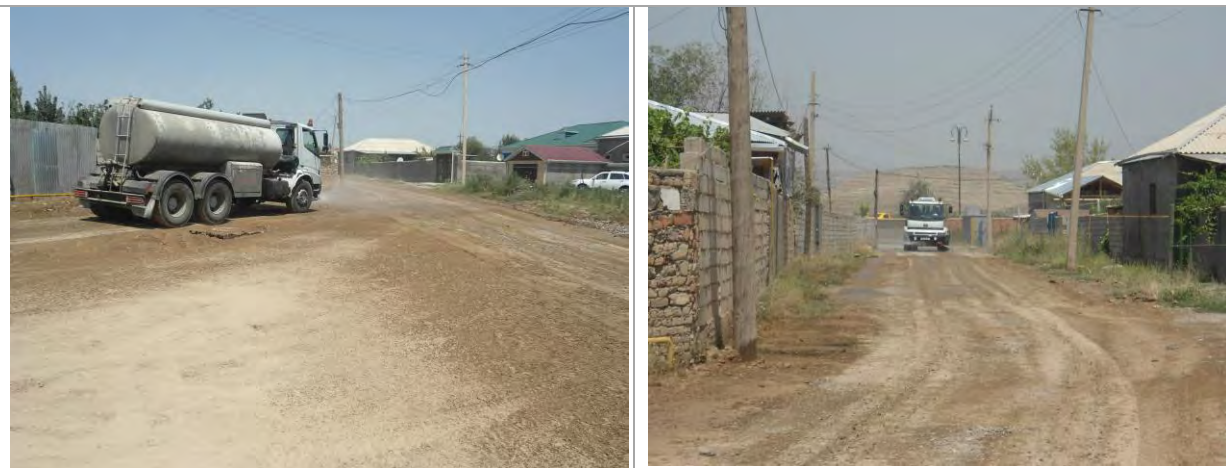
**Figure 2: Dust Control at Project site**

47. Dust control in general was observed to be appropriate, with trucks frequently observed at the project site; examples are shown in Figure 2 below.

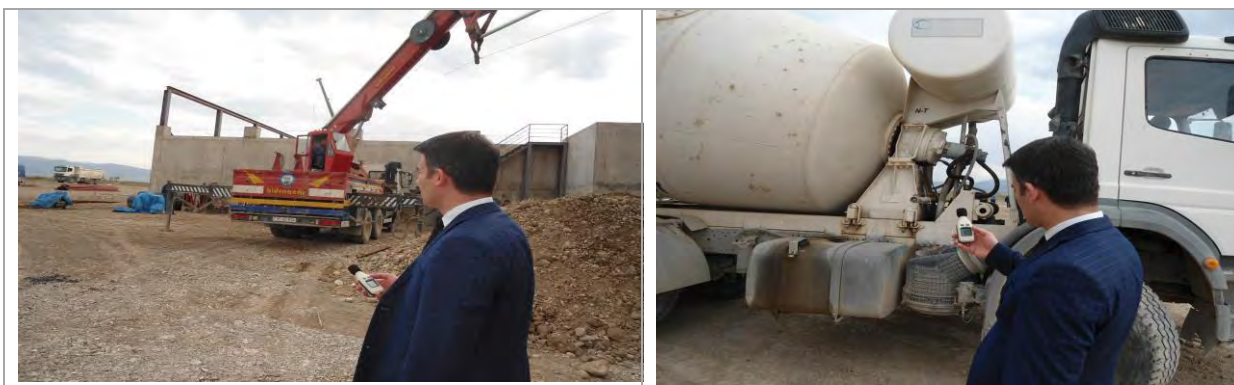
**Figure 3: Noise and Dust Measurement Equipment at Project site**

48. Air quality and noise monitorings were done frequently on the project site. Below are few examples of monitoring works.
