## Environmental and Social Assessment for the Paramaribo Urban Revitalization Program

*Advanced Draft*

October 2016

Environmental Resources Management  
1776 I (Eye) St. NW, Suite 200  
Washington, DC 20006

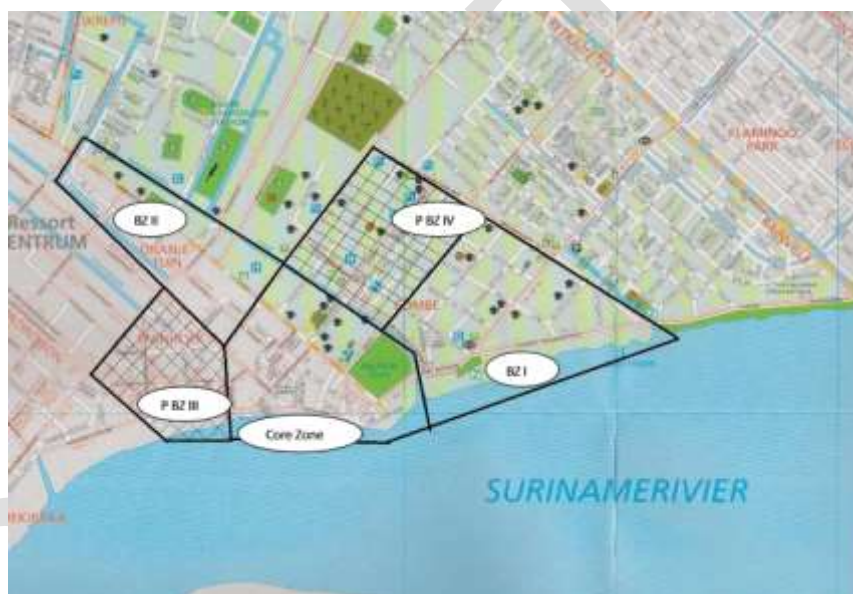
**Figure 1-1 Program Area (Core Zone of Paramaribo World Heritage Site)**

The Program will be centered on the historic urban center of Paramaribo in the Core Zone (Figure 1-1):

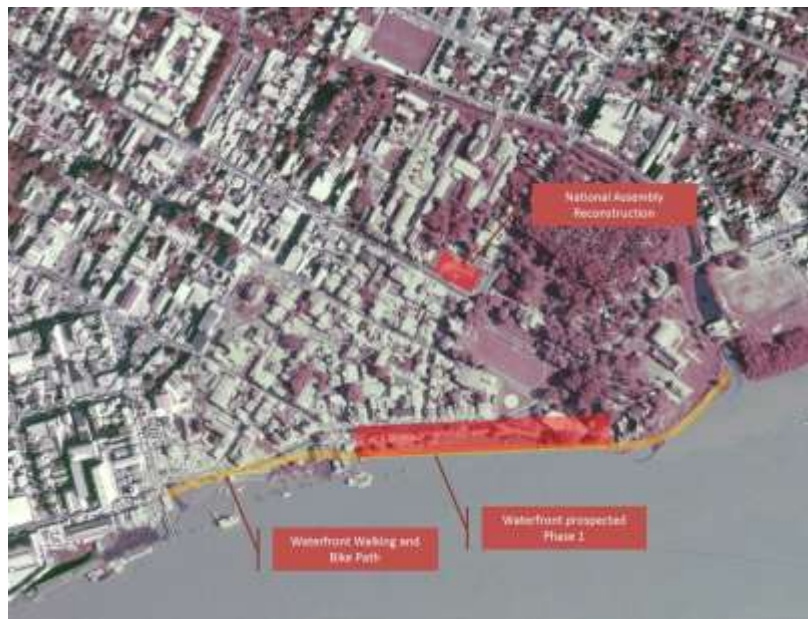
**Figure 1-2 Urban Interventions**

- A waterfront development project;
- The (re)construction of the Suriname National Assembly Building, as well and the restoration of 5-6 historic buildings historic center (yet to be identified); and
- A series of smaller urban mobility works.

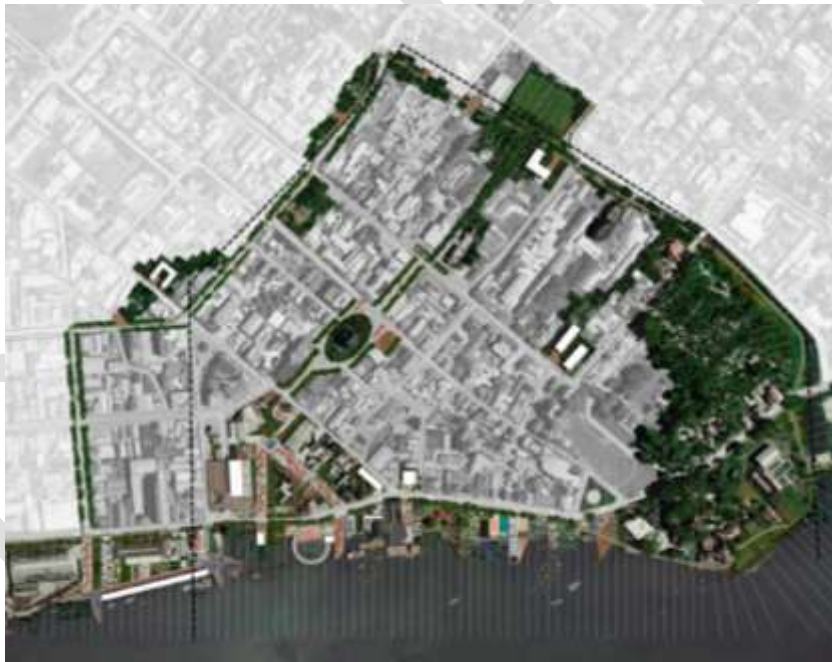
**Figure 1-4: Proposed Area of Intervention at the Waterfront**

**Error! Reference source not found.** and Figure 1-4 show the location of the Waterfront Project and its proposed area of intervention, respectively. Based on information provided by IDB, Geografia Urbana and El Equipo Mazzanti (2016), the objectives of this intervention include:

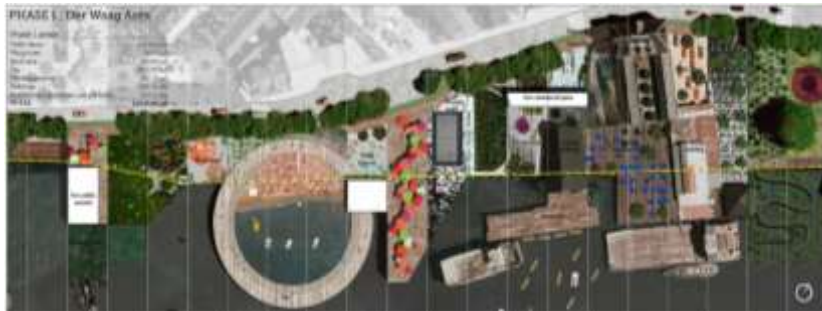
**Figure 1-5: Phase I of the Waterfront Project (preliminary conceptual design)**

The Waterfront Project is divided in two phases and it is still at conceptual level. At this time, final designs and components have not been defined. Phase I of the Program is the revitalization of Der Waag Area and **Error! Reference source not found.** shows the preliminary conceptual design of Phase I and its main components.

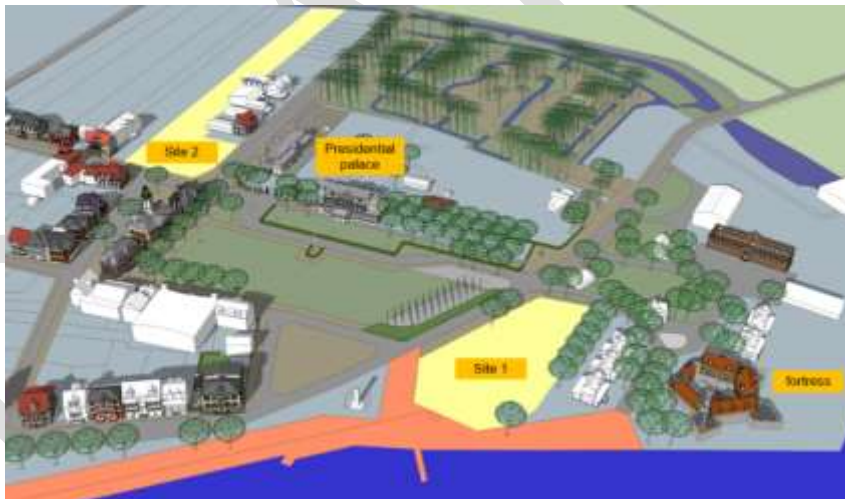
**Figure 1-6 Proposed site of Reconstruction of National Assembly (site 2)**

Comprised within the urban interventions, the reconstruction of the Suriname National Assembly Building (Figure 1-6), as well the restoration of 5-6 historic buildings historic center (yet to be identified) are considered. The aim is to rehabilitate heritage buildings currently in state of decay and risk of collapse, putting them back into residential and/or commercial use. (Figure 1-7)

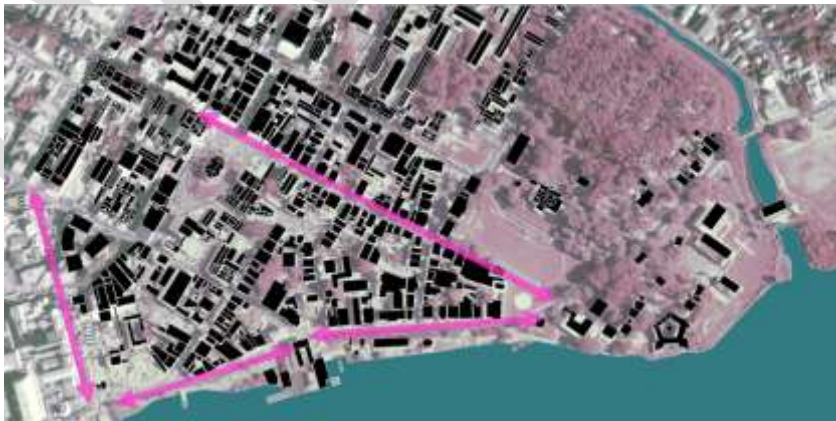
**Figure 1-8: Urban Mobility**

Will focus at implementing traffic management and infrastructure solutions to improve mobility within the historic center and its connection with the rest of the city (Figure 1-8), solutions will include:

- Upgrading transit corridors to divert traffic from the historical center;
- Introducing traffic lights and signage;
- Creation of bicycle lanes and improving pedestrian paths;
- Developing parking strategies; and
- Reorganizing the bus terminal area.

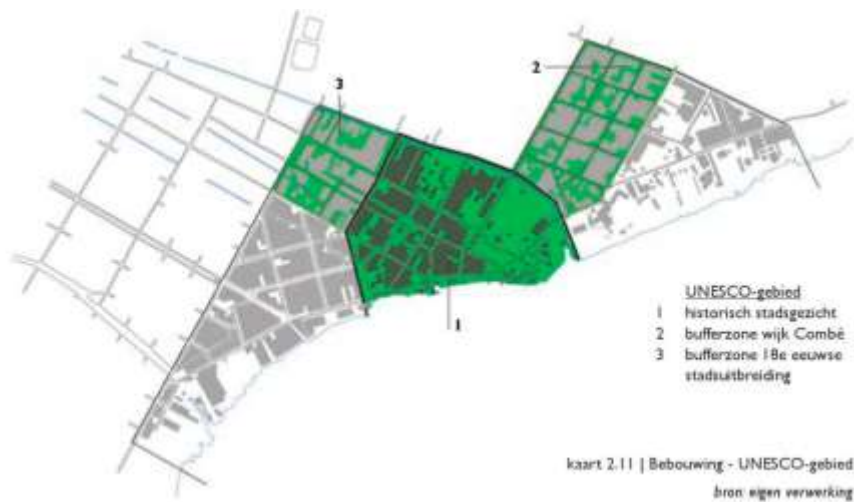
**Figure 2-1: UNESCO World Heritage Site delimitation of Paramaribo, Suriname**

*Note: Area 1 corresponds to the site proper, while areas 2 and 3 correspond to buffer zones, also protected.*

The area of intervention is the waterfront of Paramaribo's UNESCO world heritage site (UWHS). The UWHS is comprised of approximately 20 - 25 city blocks in downtown Paramaribo that configured the early XVII Century Dutch settlement (see **Error! Reference source not found.**). This area houses the main sites and buildings of Paramaribo's civic life, including Fort Zelandia, the civic park/plaza known as The Plain, the former Governor House and now Presidential Palace, the Palm park (formerly the Governor's garden), the Paramaribo Parliament, the Court House, the Orange Park, important churches and synagogues of the time and the homes and businesses of prominent families.

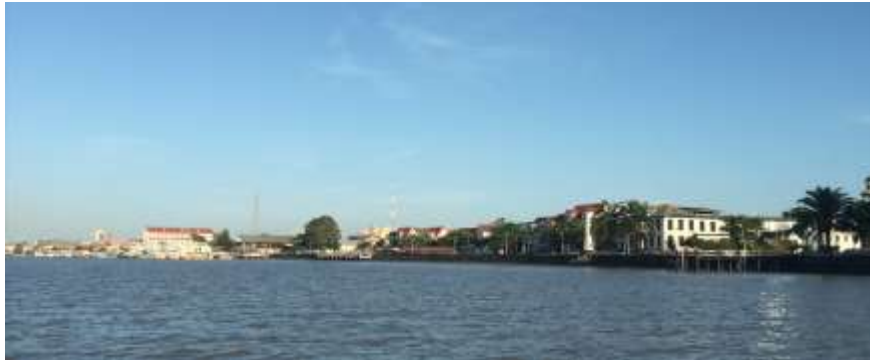
**Figure 2-3: Paramaribo UWHs waterfront on September 2016**

These landing areas are, notably, a pier and set of stairs in front of the Parliamentary building, (see [Figure 2-3](#)) and the commuter boat landing area near the market warehouses and terrestrial transport hub, which can be viewed in [Figure 2-4](#). Along this stretch of Suriname riverbank, there are also a number of private or controlled access points to the water, servicing mostly tourists and voyagers navigating to and from long-distance towns and tourist attractions.

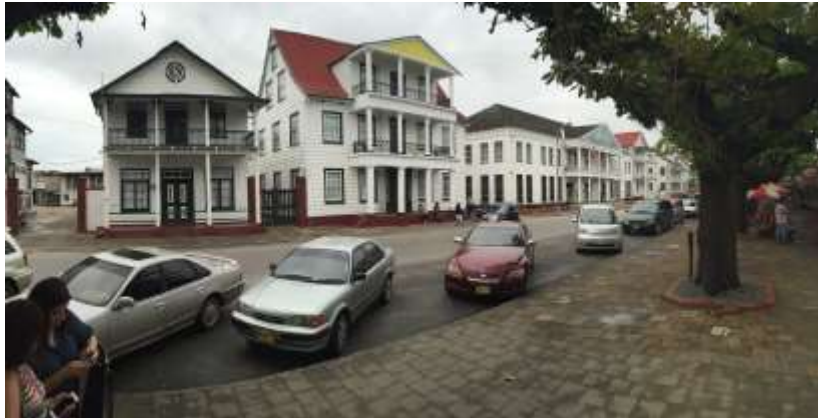
**Figure 2-5: Parking and Pedestrian Sidewalks at the Waterfront**

Because of these factors, the waterfront's 'life' is limited to the pedestrians walking between the transport hub and their workplace two times a day, the few tourists and visitors, and the local merchants of the artisans' market (see [Figure 2-5](#)). While the built setting is comprised of exemplary Dutch and North American plantation-style buildings, the fact that the majority are offices with no relationship to the street other than that of access contributes to that sense of limited life.

In the downtown area and the waterfront, automobile parking is allowed on all streets; this affects the pedestrian experience significantly. But perhaps the most challenging element is the high tide retaining wall, whose specifications meant building it to approximately 1.5 m above the level of the sidewalk. The wall is made of steel panels crowned by a concrete curb, providing the pedestrian with a sense of almost entire isolation from the water.

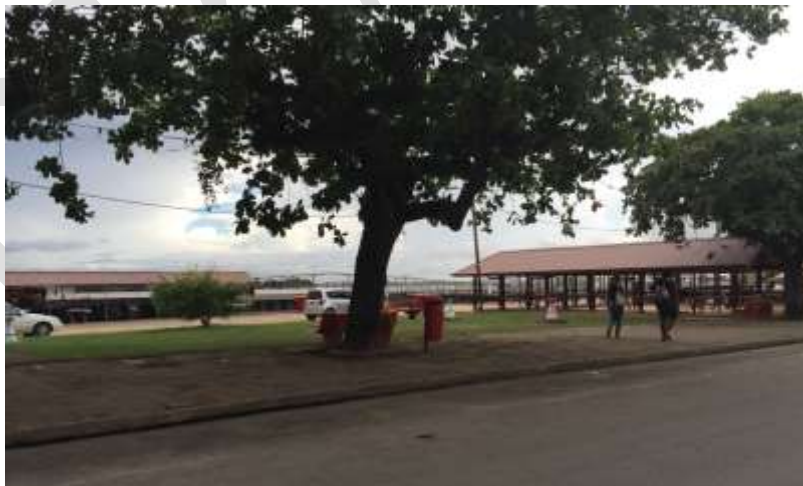
**Figure 2-6: Paramaribo waterfront today.**

*Note: The landscape is marked by the height of the high tide retaining wall, visible on the background, which blocks the continuous flow of space that was traditional in the early periods of Paramaribo.*

These and other factors all converge to create the sense that the area is more a water-back than water-front, to the point that, as illustrated in [Figure 2-6](#), parking takes place along the sidewalk.

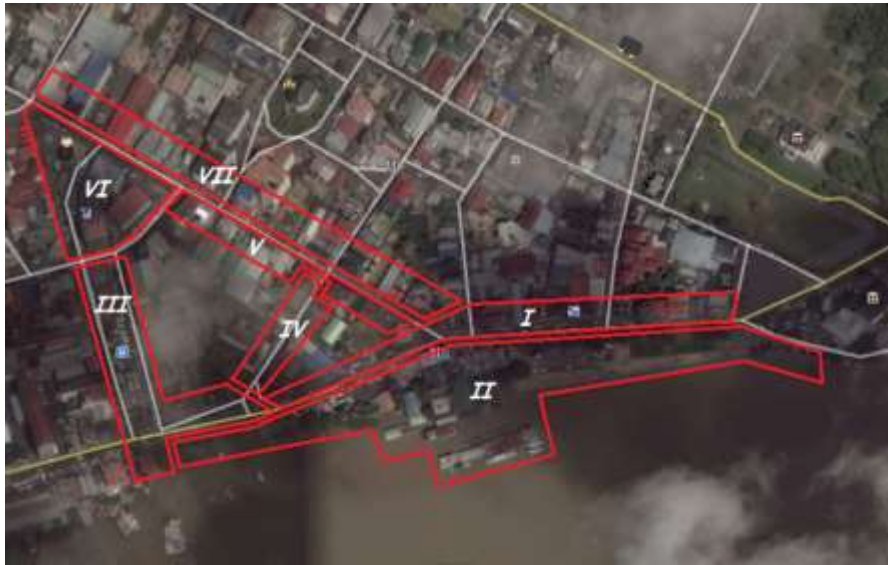
**Figure 4-1: Map of study area.**

To facilitate the study, the study area has been split into seven zones (see Figure 4-1) in order to capture the very different social and physical characteristics of these spaces and the associated structures.

These areas have been subdivided into separate blocks.

ERM, and its local partner, Culturecom, are undertaking a livelihoods assessment in order to acquire relevant data to establish an accurate baseline. Given the evolving nature of the Program, ERM and the IDB have selected a study area (see Figure 4-1) that reflects current understanding as to where the main businesses and traders are located. If as the Program specifics evolve and it is found that additional areas of businesses and traders could be affected by the Program (beyond those assessed here), then additional livelihood surveys will to be undertaken.

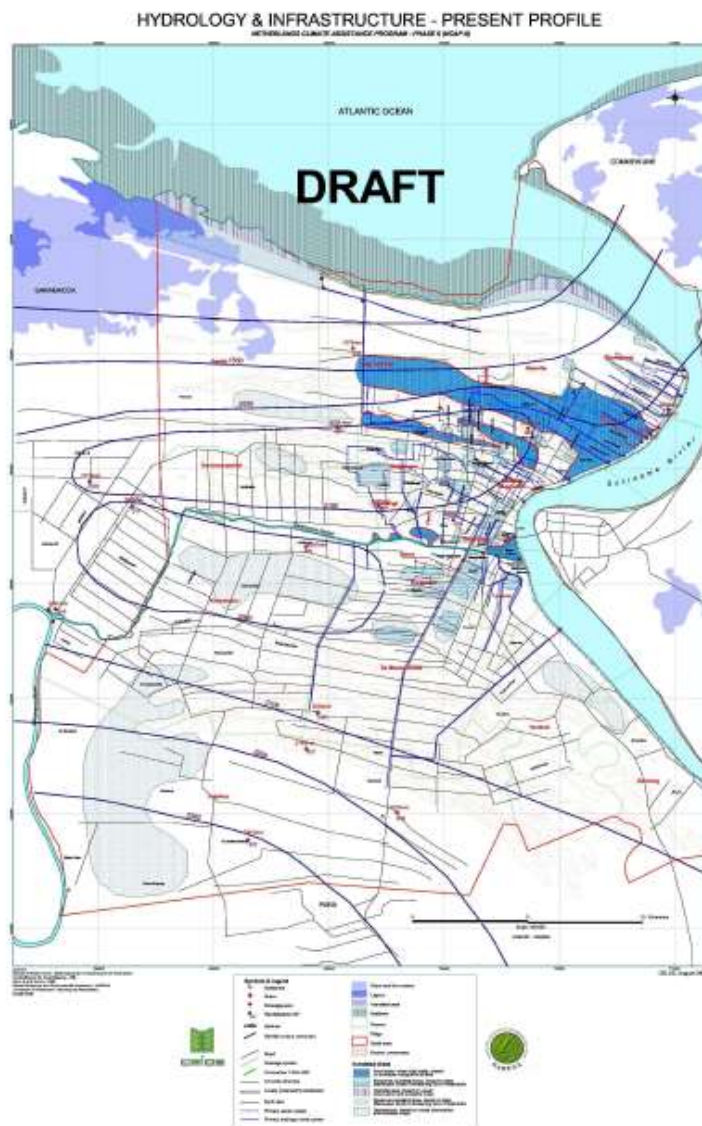
**Figure 4-5: Frequent and Seasonal Inundated Areas in Paramaribo based on Data from Masterplan Study Ontwatering Groot Paramaribo**

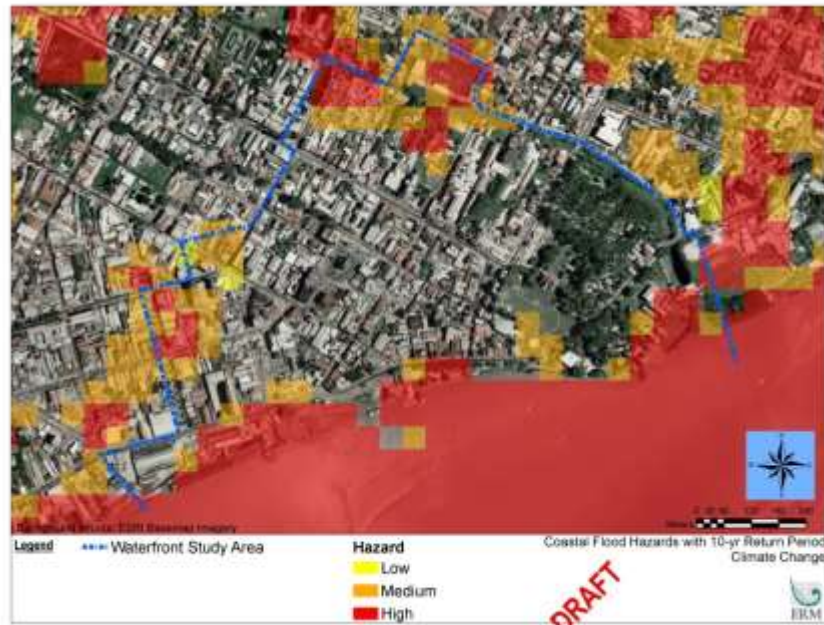
**Figure 4-9: Preliminary coastal flooding hazard maps under existing land use and climate change (SLR +1 m) for 10-year return period**

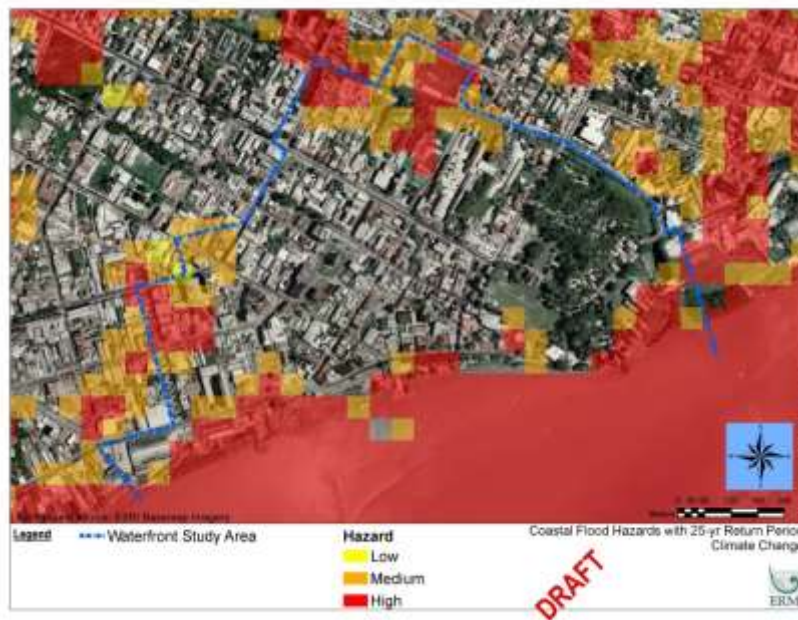
**Figure 4-10: Preliminary coastal flooding hazard maps under existing land use and climate change (SLR +1 m) for 25-year return period**

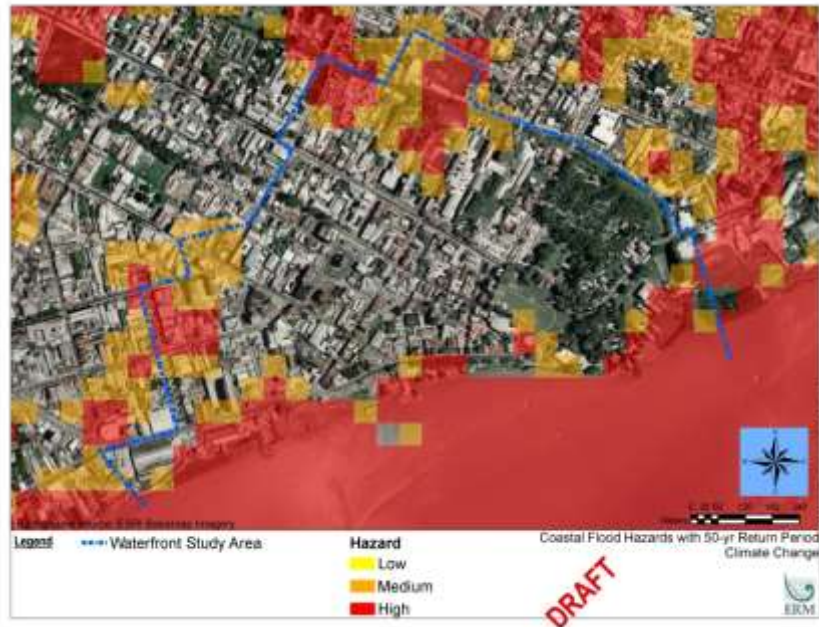
**Figure 4-11: Preliminary coastal flooding hazard maps under existing land use and climate change (SLR +1 m) for 50-year return period**

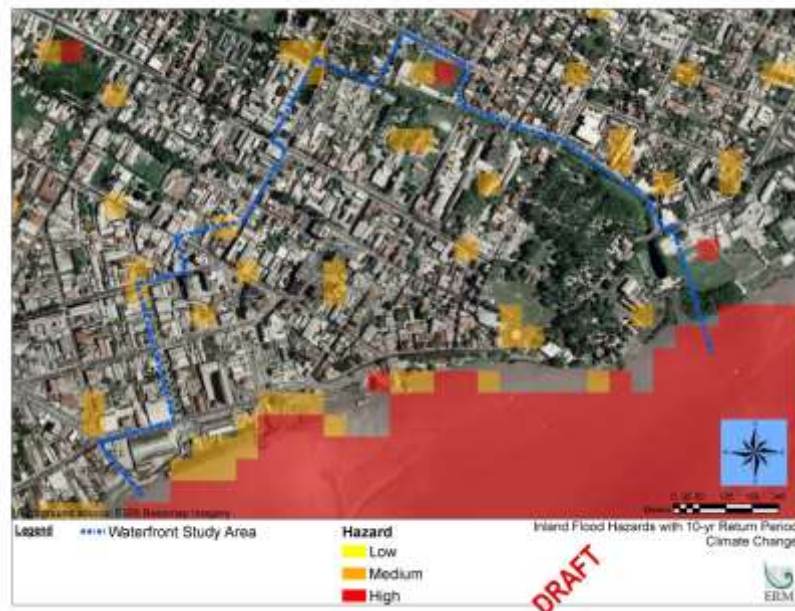
**Figure 4-13: Preliminary inland flooding hazard maps under existing land use and climate change (+13% intensity) for 10-year return period**

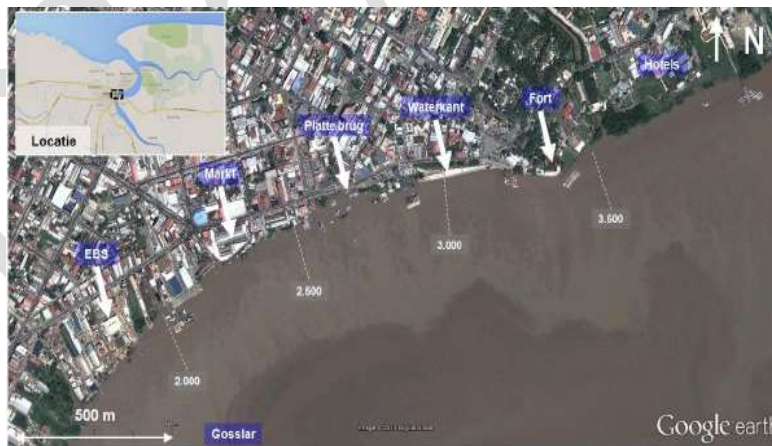
**Figure 4-17: Suriname River Bank Protection Project**

According to the River bank protection waterside Paramaribo, SMS pier project prepared by the Ministry of Public Works (ND), the Suriname River's left bank between Waterkant and Knuffelsgracht indicates signs of erosion (see **Error! Reference source not found.**). The area represents bad conditions and protection measures are required to prevent further bank erosion, which causes instability and flood risk during high tide. General recommendations aimed to mitigate riverine erosion are described further in this document.

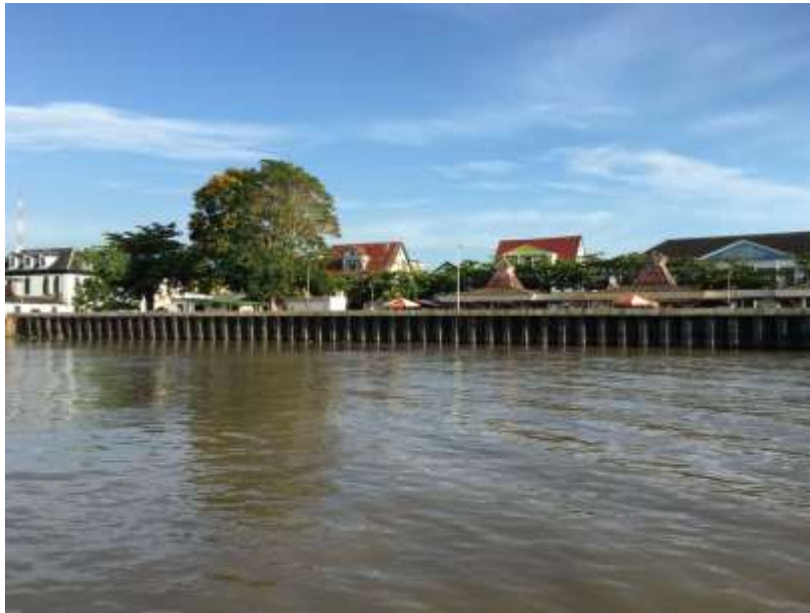
**Figure 4-18: Existing Barriers along the Left Bank of Suriname River**

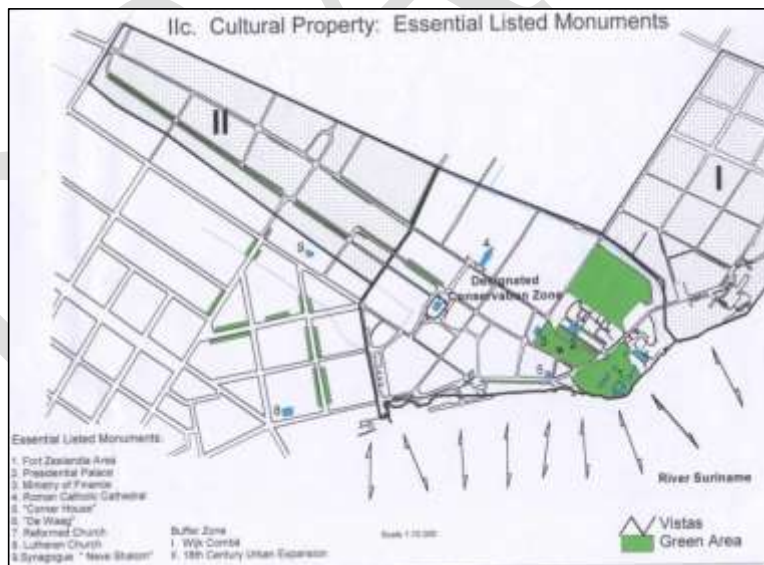
**Figure 4-6: Essential Listed Monuments.**

At the time of nomination, the World Heritage Site consisted of 244 formally protected monuments. Approximately 50% of these monuments are located within the Designated Conservation Zone, and approximately 15% are located in the two Buffer Zones. The Designated Conservation Zone and Buffer Zones comprise an area of approximately 90 hectares. Based on a map in the nomination form,
