**Assessment of the Environmental and Social
Compliance of the
Vorotan Hydropower Cascade, Armenia**

Hazardous Substances Assessment Report

Final Version

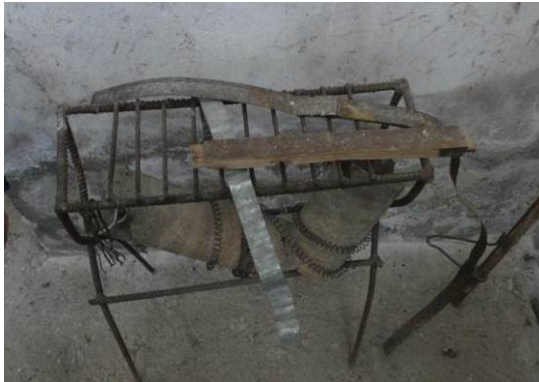
Photo 1: Old heating device with asbestos tube

If asbestos has to be disposed of (e.g. heating devices used at dam sites and HPPs, insulation material, asbestos plates in electrical devices, eternit plates, etc.), it shall be stored in concreted, roofed and secured facilities. If asbestos containing material is found but has not to be touched in the course of the working activities (e.g. 6 kV cable pipe at Spandaryan HPP), it is good practice to leave this material as it is.

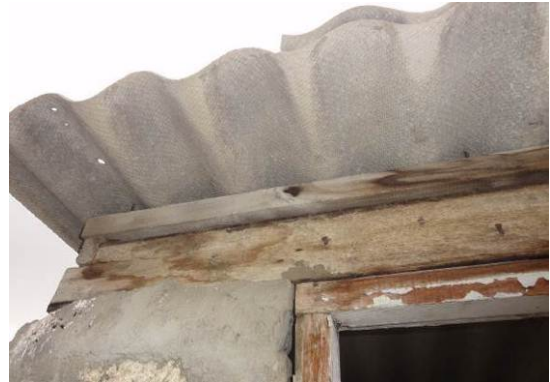
Photo 2: Eternit roof of pit latrine probably containing asbestos

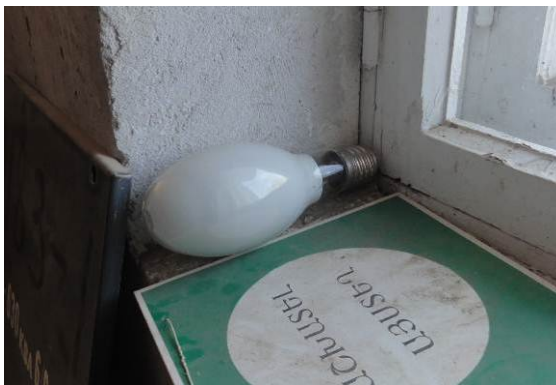
Photo 3: Lamb bulb containing mercury

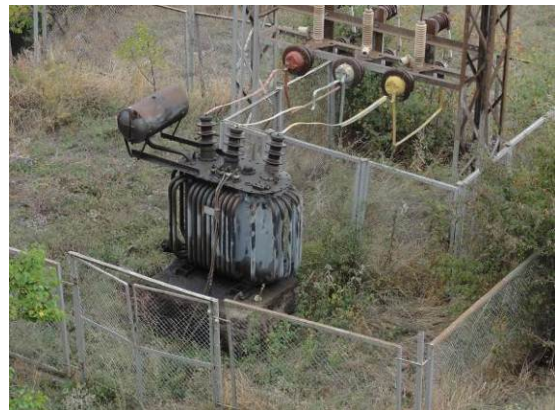
Photo 4: Old leaking transformer without drainage system at Daily Regulation Reservoir

- Clean area and buildings by collecting disposed waste
- Segregate all hazardous wastes and transport to storage areas at HPPs
- Remove old oil from transformers (e.g. Tolors Reservoir, Tatev Daily Reservoir)

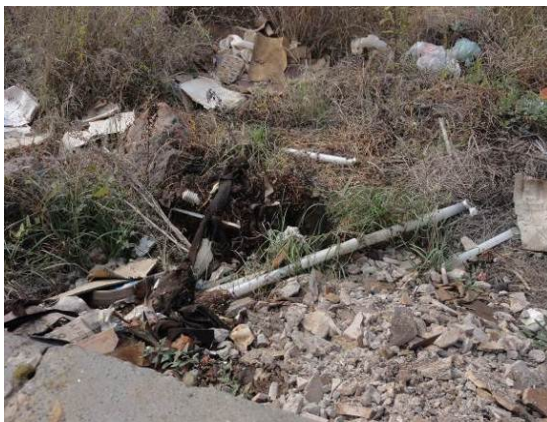
Photo 5: Dumped waste including hazardous waste

Observed Gaps	Proposed Measure	Estimated price
All kind of waste dumped near to river or HPP (Photo 5)	Clean area and buildings by collecting disposed waste. Segregate hazardous waste.	Done by trained staff
	Store hazardous wastes securely packed in sealed drums or other suitable containers at lockable, roofed and ventilated storage areas which have a concreted and bunded floor. One storage area at each HPP.	60,000 USD (20,000 USD for each storage area at HPPs)
	Label hazardous substances accordingly and install warning signs.	
	Prepare Material Safety Data Sheets (MSDS).	
	Provide adequate spill absorbent material.	
Asbestos plates have been found in electrical equipment at Shamb and Tatev HPPs (Photo 6)	Store asbestos in facilities as described above.

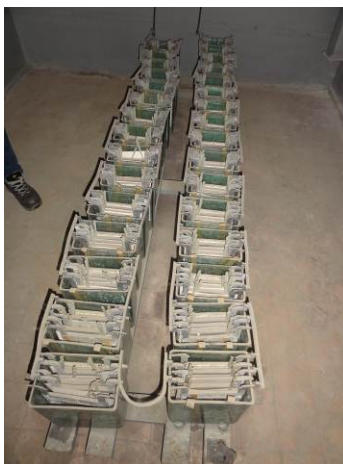
Photo 7: Old batteries to be removed

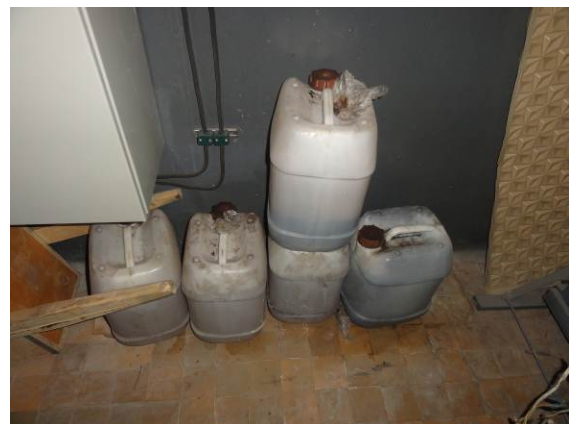
Photo 8: Old sulfuric acid (approx. 20 l) not properly stored at Tatev HPP

Observed Gaps	Proposed Measure	Estimated price
Cable ducts at Shamb and Tatev HPP probably contain asbestos		(see above)
Old lamp bulbs containing mercury	Store waste containing mercury in facilities as described above.	
Old batteries to be removed e.g. from Spandaryan HPP (Photo 7)	Store old batteries in facilities as described above.	
Old sulfuric acid at Spandaryan and Tatev HPPs (Photo 8)	Store old sulfuric acid in facilities as described above.

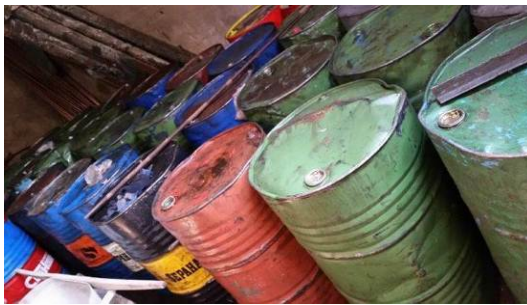
**Photo 9:** Different substances stored without labelling in rooms without any ventilation

- Store hazardous wastes securely packed in sealed drums or other suitable containers at lockable, roofed and ventilated storage areas which have a concreted and bunded floor.
- Label hazardous substances accordingly and install warning signs.
- Prepare Material Safety Data Sheets (MSDS).

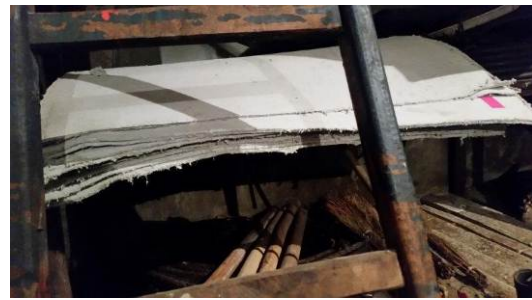
**Photo 10:** Incorrect storage of asbestos sheets

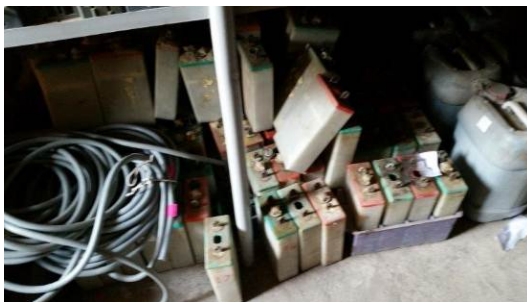
**Photo 11:** Incorrect storage of old batteries and sulfuric acid

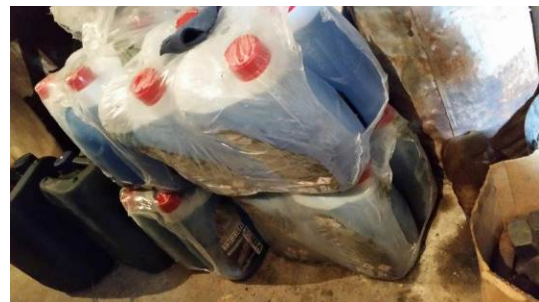
**Photo 12:** Incorrect storage of antifreeze

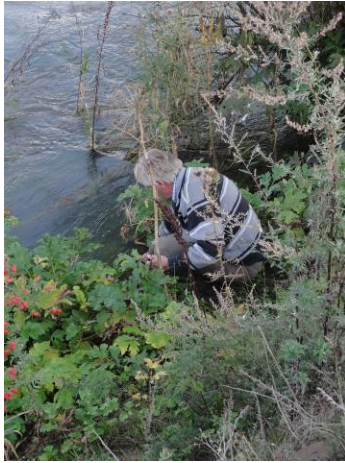
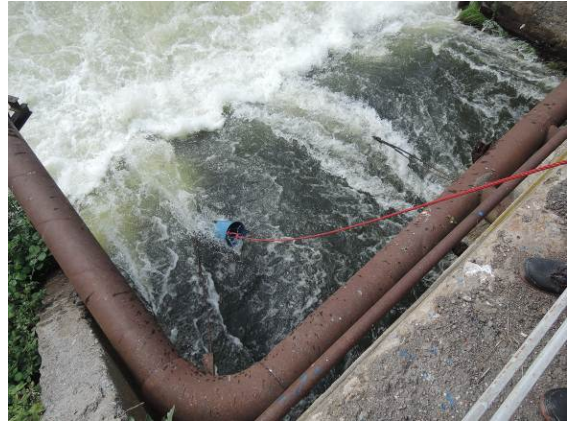
Water samples were taken during the site visit at the outlet channels of Spandaryan HPP and Tatev HPP (Photo 13 and Photo 14). These samples have been analyzed by a certified laboratory in Germany (see Section 9.3 - Appendix III) for contents of oil (hydrocarbon oil index) and PCBs. No oil

or any PCBs have been found in the water samples (for results see Section 9.4 - Appendix IV).

Photo 13: Water sampling at Spandaryan HPP

Photo 14: Water sampling at Tatev HPP

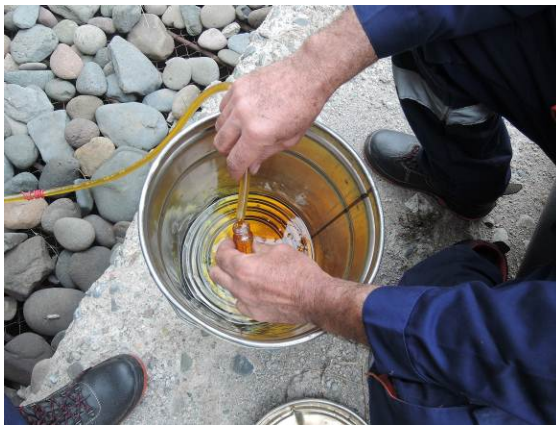
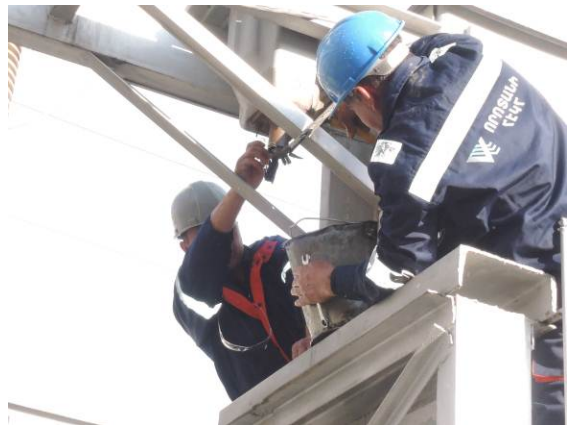
Oil samples were taken from transformers and circuit breakers at dam sites and HPPs (Photo 15 and Photo 16). These samples have been analyzed for PCB contents by the laboratory mentioned above. Results from these analyses are summed up in Table 5. For detailed results see Section 9.5 (Appendix V).

Photo 15: Taking oil sample from a transformer at Shamb HPP

Photo 16: Taking oil sample from a circuit breaker at Spandaryan HPP
