ENVIRONMENTAL AND SOCIAL MANAGEMENT PLAN

For the "Rehabilitation of the Cobblestone road to castle "Mihal Komneno" and the Panoramic View Point "Tabja""

Town of Berat Draft June 2016

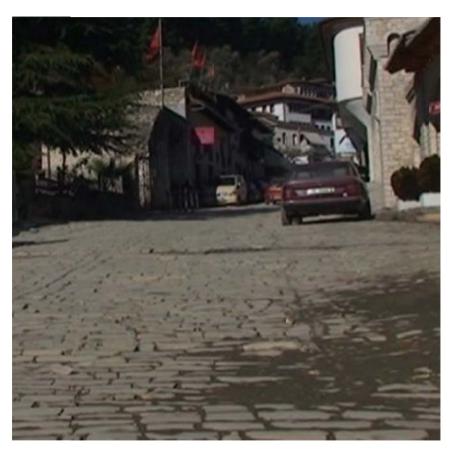
Figure 1: View of Berat cobblestone road connecting to castle

The aim of the sub-project is the rehabilitation of the pedestrian road to the castle of Berat (Figure 1), at a length of 1,060 m, including the panoramic view point located at the Southern Side of the Castle.

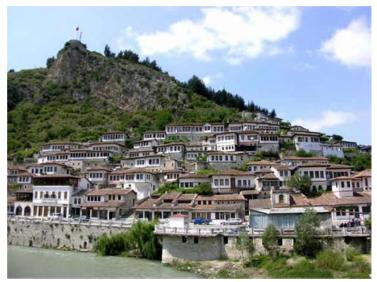
Figure 2.2: View of Tabja (top) from Berat town

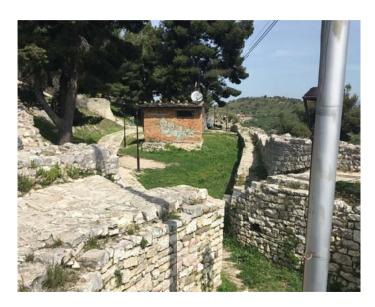
Figure 3: View of the antenna building to be removed (building in red bricks)

In more detail, works for the Tabja view point include: The demolition of 1 store antenna's object, removal of the concrete foundation and the television antenna, pavement of the new path as the existing model cobbled pavement, improvement of the green area, stone pavement of the damaged area from the removal of television antenna, new metallic railings, wooden benches with metallic structure, trash cans, telescope.

During the implementation of the works, since the stones of the pavement will be replaced, a certain amount of waste will be generated. The waste will be generated during works for site clearance, removal of inert materials, dirt, including the old unused antenna and the unused building.

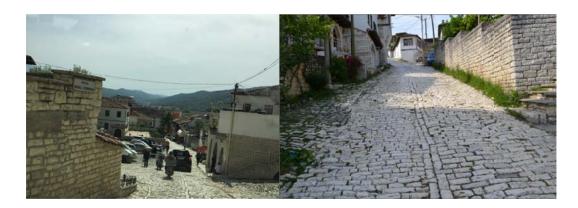
A plan design of the project layout is given in Figure 6, where the "Mihal Komneno" road is highlighted in green.

The pedestrian road (green line in Figure 6) is steep going all the way up from Berat downtown to the castle. The Tabja panoramic view point is situated on the southern side of the castle (Figure 6.2).

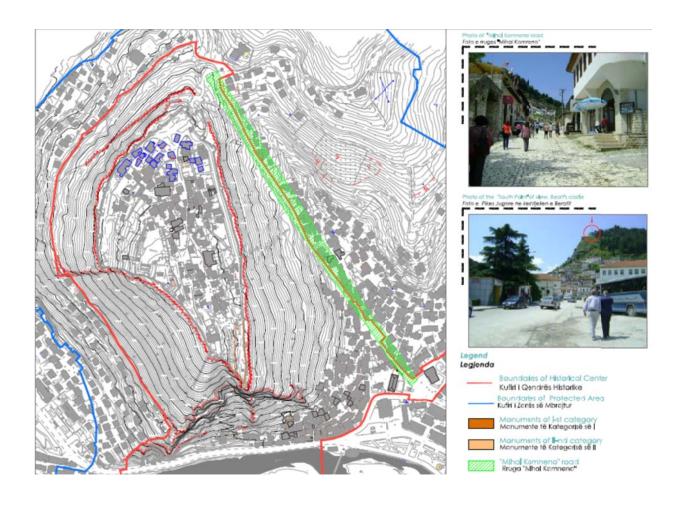
Figure 6.1: Map of the roads connecting to Berat castle (Mihal Komneno road in green)

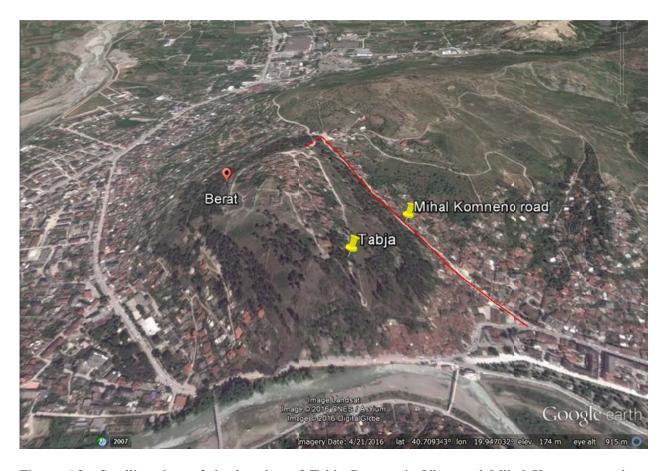
Figure 6.2.: Satellite view of the location of Tabja Panoramic View and Mihal Komneno road (Source: Google Earth)

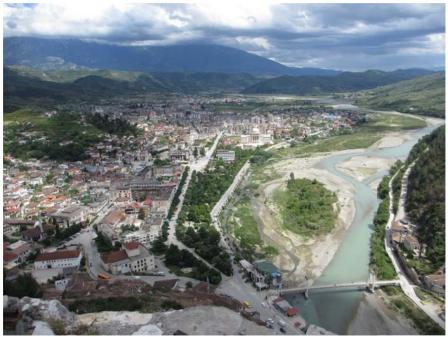
Figure 7: Osumi river and the town of Berat

The town of Berat is situated on both sides of Osumi river (Figure 7). Osumi is one of the main rivers of Albania, important for agriculture, hydroenergy, ecology, tourism and landscape.

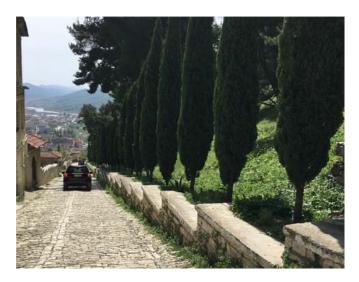
Figure 8: Existing cypress trees on the road sides, planted for landscaping purposes

Near the Tabja, there are a certain number of trees that are planted for urban beautification purposes (Figure 8). Since the project does not foresee any widening of the road, these trees and surrounding vegetation will remain untouched. There are no known protected areas, parks or habitats of special national value at the subproject area.
