Gaza Wastewater Management Sustainability Project

Environmental and Social Audit of the Operation and
Maintenance Activities of the Northern Gaza Wastewater
Treatment Plant and Associated Facilities

Dr. Fahid Rabah (Consultant)

March, 2020

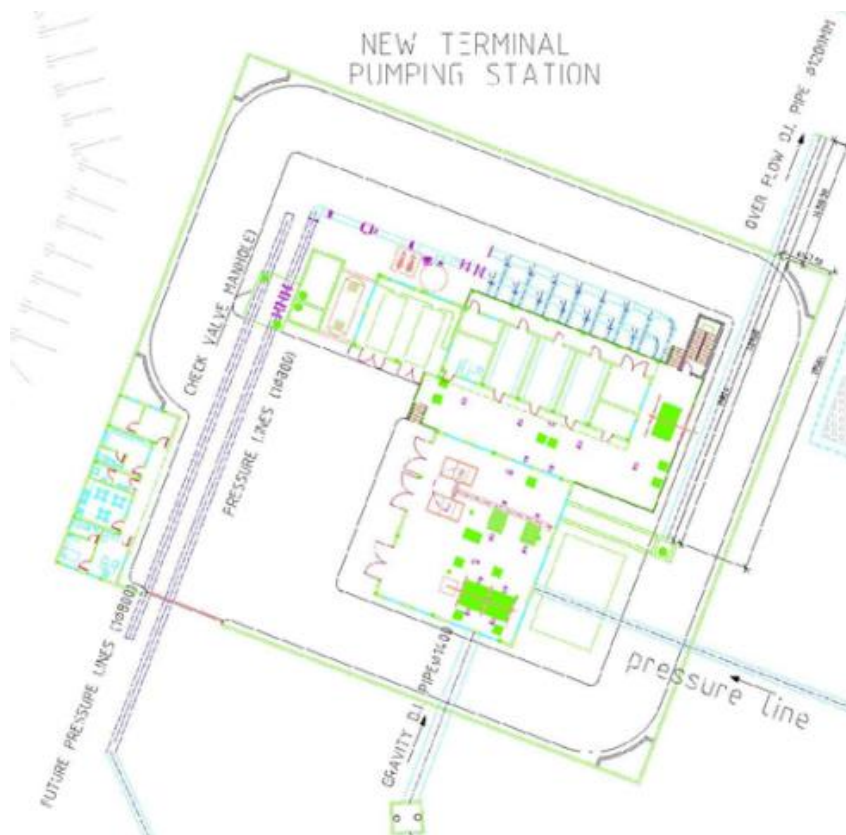
Figure 3.1 General Layout of the terminal pumping station (TPS).

The terminal pumping station is the main station where North Gaza sewage is collected and pumped to the NGWWTP. Figure 3.1 presents the site general layout of the TPS.

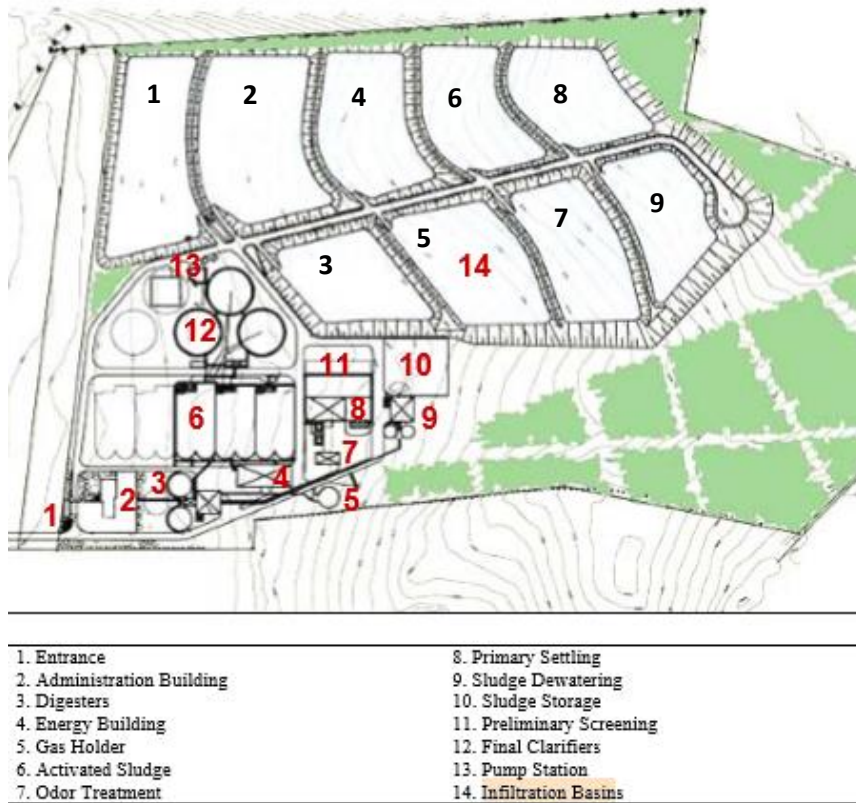
Figure 3.2 General Layout of the NGWWTP

The infiltration area is divided into nine basins with a total effective area of approximately 80,000 m² (see Figure 3.2). The infiltration basins are divided into three groups; Basins 1-2-3, Basins 4-5-7; and Basins 6-8-9. The effluent of the NGWWTP is distributed only to one of the three basin groups at a certain time. After flooding for a certain period, 0.5-2 days, the flooded basins are allowed to dry and the water is directed to the next basin group. The upper 5 cm layer of the basins is periodically scraped to remove the accumulated solids to overcome clogging.

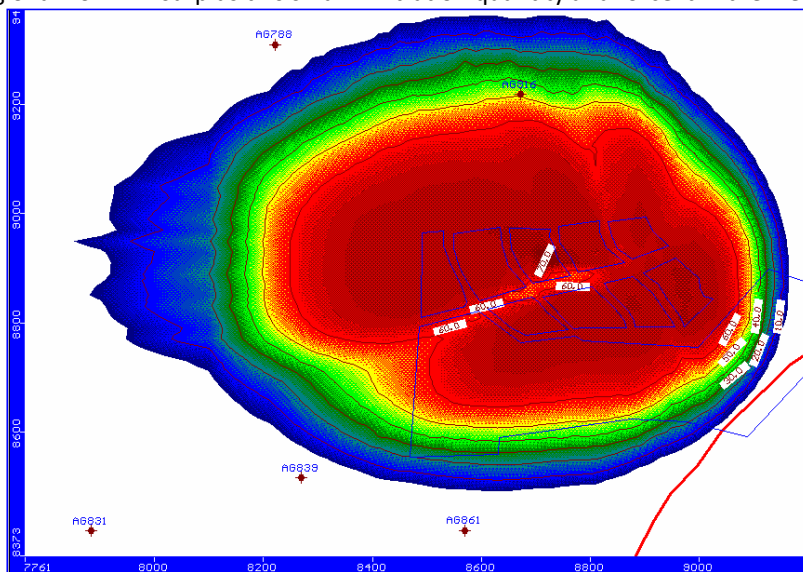
Figure 4.2: NO₃-N Plume at the End of Part A using 12,000 m³/day and not using Infiltration Basins 7 and 9

4.30 Figure 4.2 and Figure 4.3 show the short and long term impacts of these measures. Comparing the results with Figure 3.16 shows that the nitrogen plume at the end of the emergency phase will extend about 200 m to the west and about 100 to the east of the infiltration site. Comparing the results shown in Figure 3.13 and Figure 4.3, it can be seen that the transport path will be confined to a smaller area at the long run. The reason is that the regional flow will surplus this small infiltration quantity and force it in the western direction.

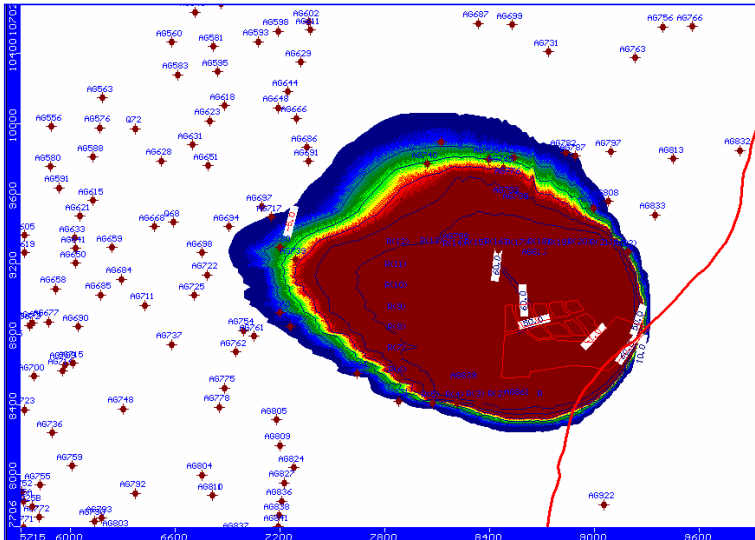
Figure 4.5: Long Term Extent of the NO3-N Plume with the Implementation of Recovery System.

4.35 Figure 4.5 also demonstrate the effectiveness of the proposed recovery system in reducing the expected extent of the contaminant plume compared with the model results shown in Figure 3.20. The proposed new wells will be able to pump 19,200 m³/day (800 m³/day for each well and screened between -10 to -30 from the mean sea level).
