ENVIRONMENTAL DUE DILIGENCE

Hanjin Shipyard – Philippines Version 19 December 2019

- Instructions were received from Acquiror on 11 October 2019 to carry out a Technical & Environmental Due Diligence Survey on Hanjin Shipyard located at Clarke. (herein "Project Agila"). This report summarizes our findings following our site inspection and documentation review.

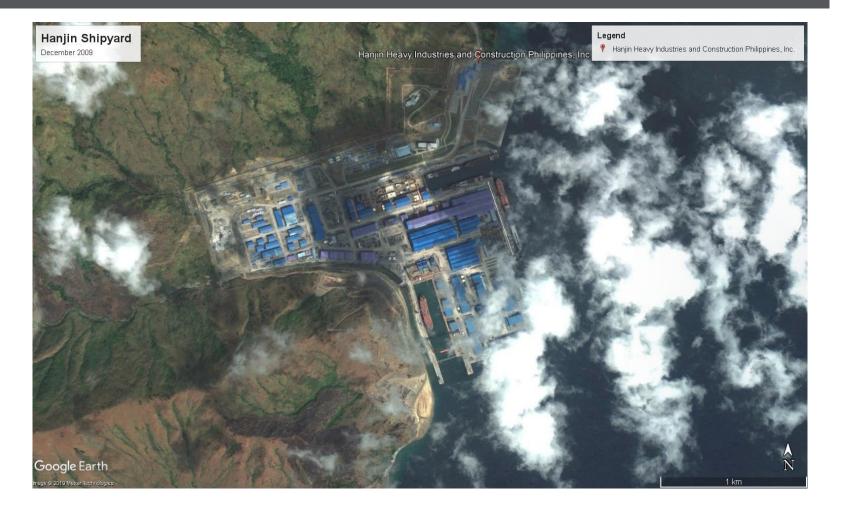
Map of December 2009, the year of construction completion

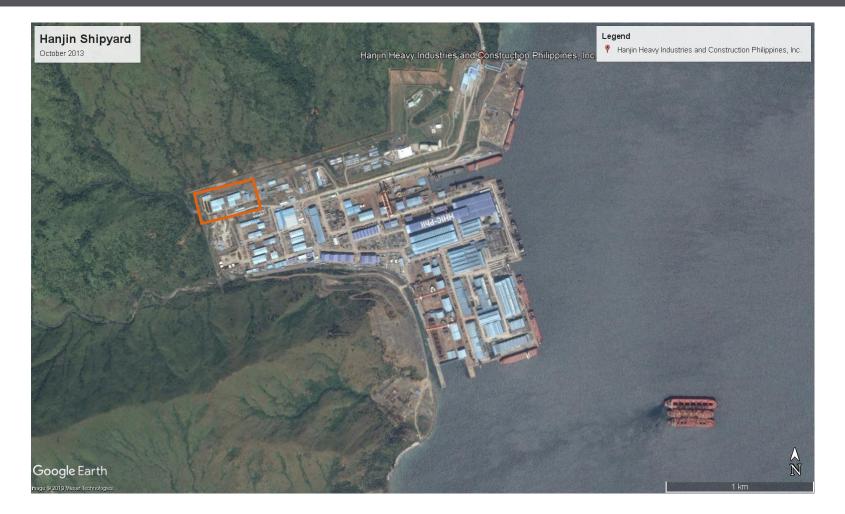
Map of October 2013, some additional buildings (piping manufacturing) in Northwestern part of site

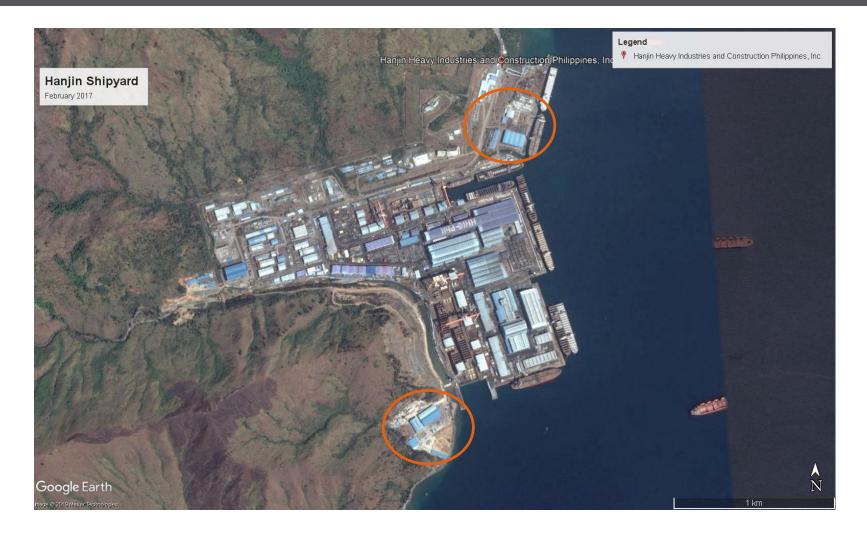
Map of February 2017, waste storage area developed (south) and building at northern quay (assembly shop, blasting & painting shop)

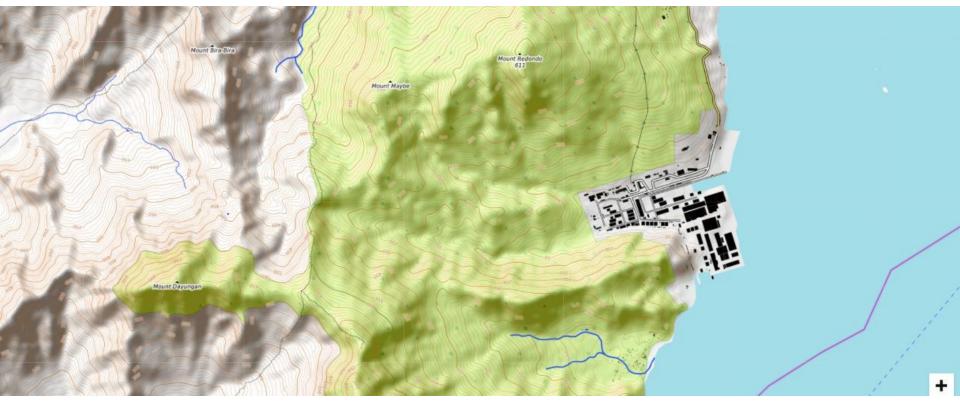
5.1.2 Topography

The site lies on a slightly inclined hill towards the west. The dockyards are predominantly situated around 3.5m above mean sea level (AMSL), where the western most edges of the site are lying around 36m AMSL. On the North of the site Mount Redondo is situated at 611m and at the south a hill at around 220m. The site is cupped in between mountains, directing any pluvial water towards the shipyard.

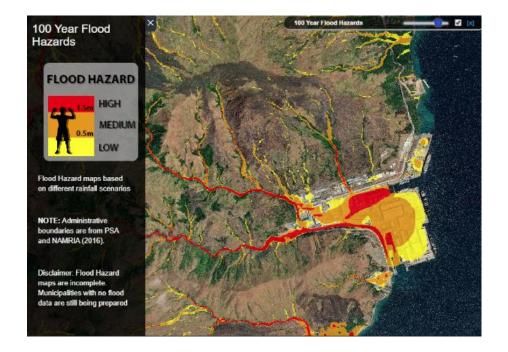
5.3.2 Flood Risk: Extreme Precipitation

Flood <u>hazard</u> due to extreme precipitation is in the medium to high ranges for some parts of the site, considering a 100year flood event (pluvial) which is a 1% chance a year. For 50-year and 25-year flood events, the site does not show any vulnerability, based on the available information.

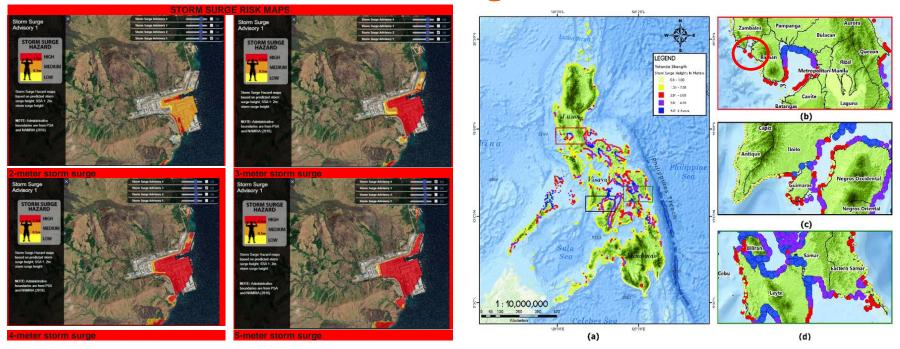
5.3.3 Flood risk: Storm surges

Available storm surge level sin the Subic Bay, during Typhoon Yolanda (Haiyan, the most destructive typhoon) show storm surges between 2 – 3m, which would relate to a medium-high impact.

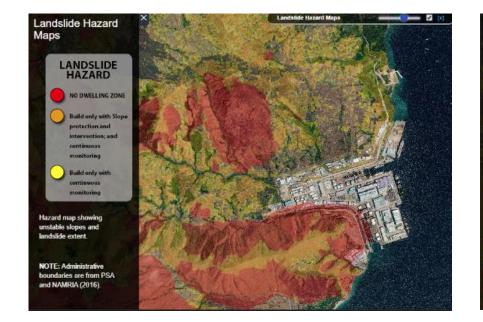
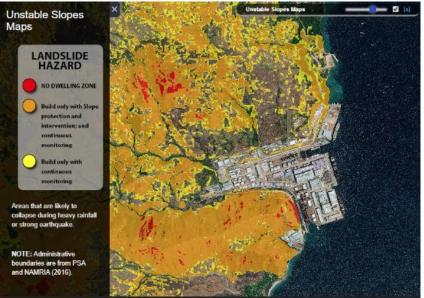
5.3.8 Landslides and Unstable Slopes

The South/Southwestern border of the site is surrounded by unstable slopes. Thereby, a small fringe of the south/southwestern border of the site is located in the landslide "no dwelling zone" which means it is prohibited to build residential buildings, but building for commercial purposes is allowed, although not recommended.

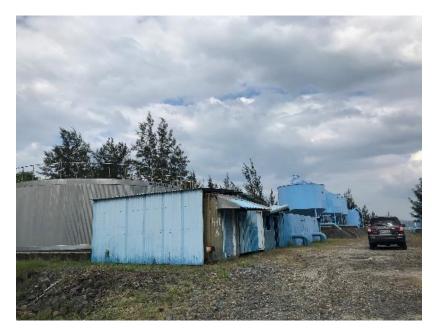
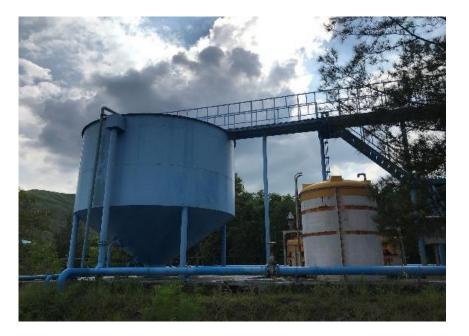
5.4.1 Water supply

The project sites receives it's general water supply of the municipal water system (Subic Water District) and extracts groundwater at the water treatment plant, which is used (after treatment/settling) as process water for pre-treatment and galvanizing. No extraction permit was reviewed, but staff informed it was available. At full operation, the site reported to pump 7,500 m3 of groundwater per day.

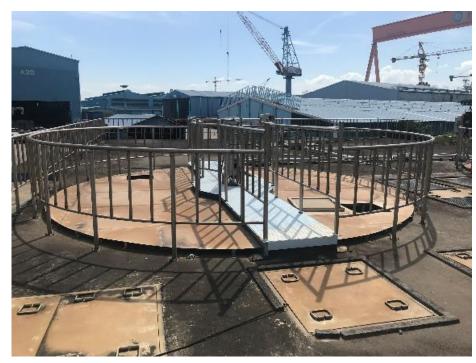
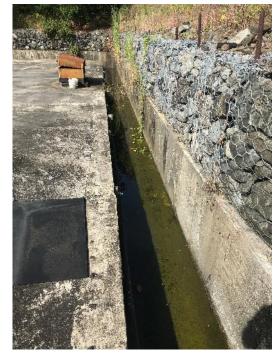
5.4.2 Wastewater: STP and Drainage

Sanitary and Kitchen waste water are treated in the STP (left) and at full operational capacity it treated 3,500 m3 water per day. Grease traps are present in the kitchen, but no API oil/water separators were observed. Stormwater is discharged through a drainage system (right) towards the sea. No spills leading towards the drainage were found and water drained towards sea is tested on quarterly basis on water quality parameters as specified in Annex D. No exceedance of Philippine water quality limits was found and marine ecological monitoring results show no significant changes in the past year (2019). Monitoring records for marine and aquatic have been included in **Annex F**.

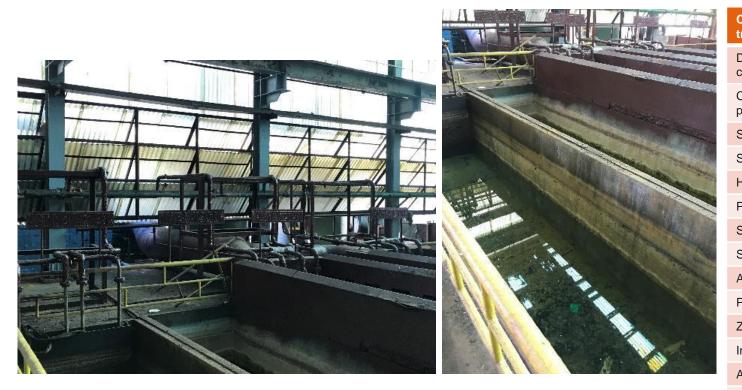
5.4.3 Wastewater: Process wastewater

Site personnel informed that contaminated process water from pre-treatment (left and right) and galvanizing is treated in the attached wastewater treatment facility (WT-50, Shinzo) and afterwards is stored in containers and transferred as hazardous waste towards the waste storage area. At the waste storage, the hazardous wastewater is picked-up, transported and disposed of by a contractor. Chemicals used in the pre-treatment and galvanizing process are given in the table to the right.

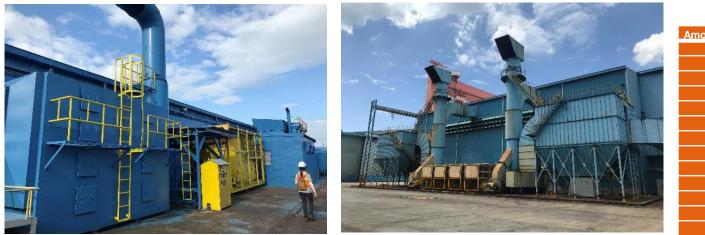
Air Emission Management

Dust collectors (right) and scrubbers (left) are collecting particles and filtering gases from production processes. Dust collectors are mainly used for blasting and painting processes, whilst the wet scrubbers are used for more intense processes as galvanizing, pre-treatment and alternative paint processes. Waste from the dust collectors are collected in large containers (including filter bag) and transported to the waste storage facility as hazardous waste.

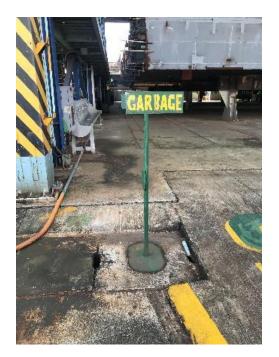
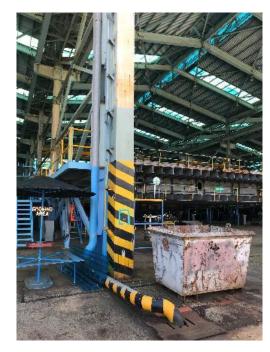
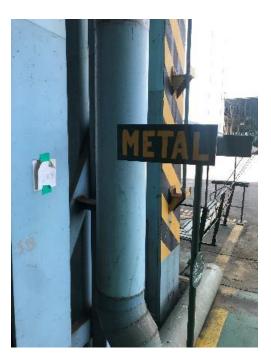
5.6.1 Waste transportation on site

Site infrastructure was observed to be set for collection and separation. On site waste is therefore believed to have been segregated and transported to the waste storage for hauling and disposal.

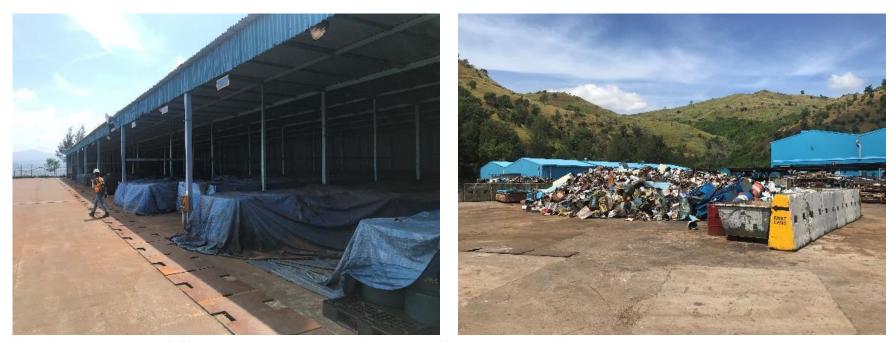
5.6.2 Waste storage

Hazardous waste storage (left) is covered and sorted according to type of hazardous waste. Non-hazardous waste is segregated and picked up twice a week in operational period. Some signs of leachate were observed at the general waste dump (garbage pile), although this waste is not anticipated to be hazardous, considering discharge monitoring results of 2019 of drainage channels and the river do not show exceedance of local Philippine limits for effluent of industrial sites. Thereby these results are shared with regulatory bodies for compliance check and the continuation of the discharge permit (**Annex D** shows monitoring results of the drainage water). No secondary containment was provided for the hazardous waste management storage.

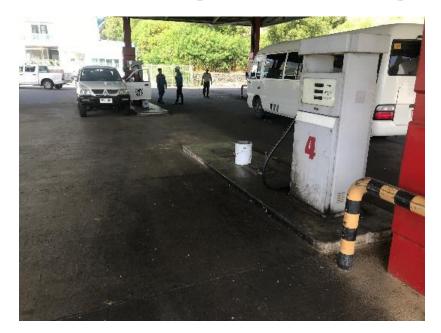
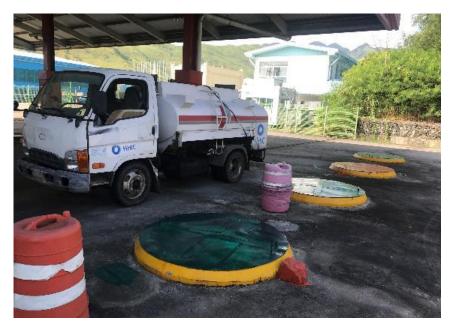
5.7.1 Underground Storage Tanks

There are reportedly 4 USTs that can be reached via the entry hatches at the gasoline station (right). No spills were detected near the UST. Only calibration records of the tank were received, but no actual maintenance records or a permit for operation. Calibration records of 2009 show that the tank sizes are respectively 16,882, 27,913, 27,768 and 28,042 liters.

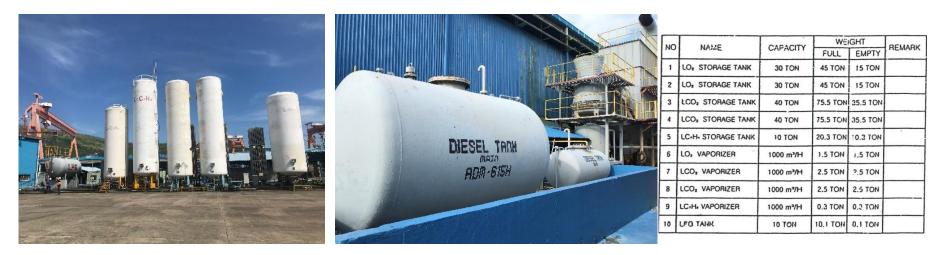
5.7.2 Aboveground Storage Tanks

Aboveground storage tanks are spread across the site. Production gas station has oxygen, ethylene, LPG and carbon dioxide storage (left) and capacity has been given in the table (right). The storage tanks for the production gas station and the air receivers at this location have all completed and approved inspection records available. Pre-treatment and paint shop have diesel tanks (mid) which are bunded (good condition) and a carbon dioxide AST.

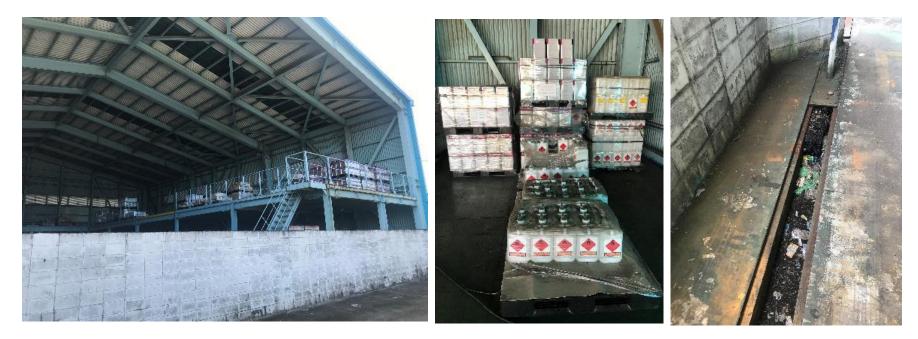
5.8.1 Chemical/Paint Storage

Open chemical storage (left) is locked for unauthorized personnel, but still prone to outside events (weather). Chemicals/Paints are not stored on drip trays (mid). Drainage of the storage leads out to sea (right). Naked lights are present in the open storage, close to flammables. As no secondary containment is provided in the open chemical storage, and drainage leads out to sea, the risk of contaminating seawater and potential marine wildlife is present. Secondary containment in the form of drip trays and spill kits (dry) should be provided.

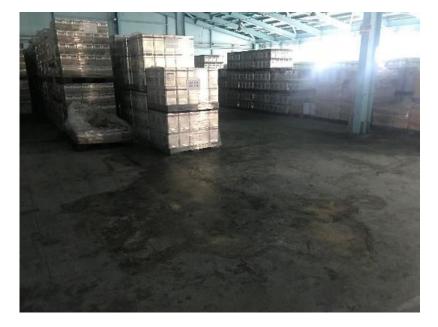
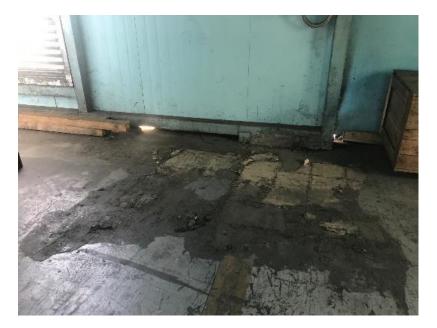
5.8.2 Closed chemical/paint storage

Closed chemical/paint storage has explosion proof lighting, but is insufficiently ventilated (left). Spill was present on the floor (right), which did not spread outside, but the potential is there, due to holes in the walls near the surface level.

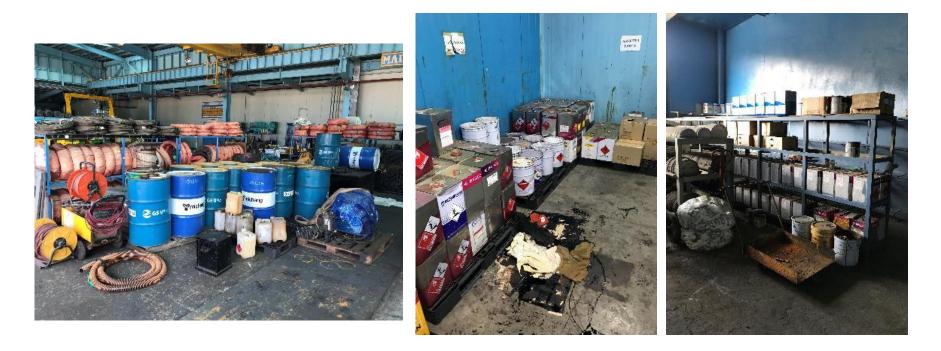
5.8.3 Other storage areas

In other areas, batch storage is present, none secondary contained. Left is the maintenance shop, middle is piping pre-treatment (including spill), right is piping paint shop. Risk of contamination is present due to the absence of secondary containment, although the flooring is fully concreted and no stains were observed to move to the outdoor areas. Anticipating the before-mentioned aspects, the risk is classified as **medium**.

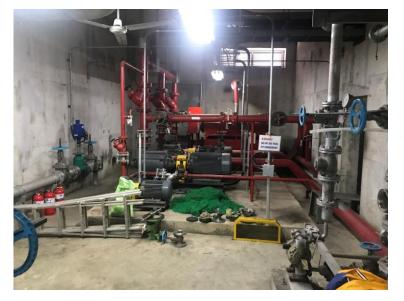
The fire hydrant pumps are located at the water treatment plant and in the building of the STP (as shown in the picture below). They involve 1 main supply pump, a spare support pump and a assistance supply pump as specified in the figure on the right.
