VIE: Ha Noi and Ho Chi Minh City Power Grid
Development Sector Project

SEMI-ANNUAL ENVIRONMENTAL MONITORING REPORT

Period July – December 2016

Loans 3161/8286-VIE: HA NOI AND HO CHI MINH CITY POWER GRID DEVELOPMENT SECTOR PROJECT

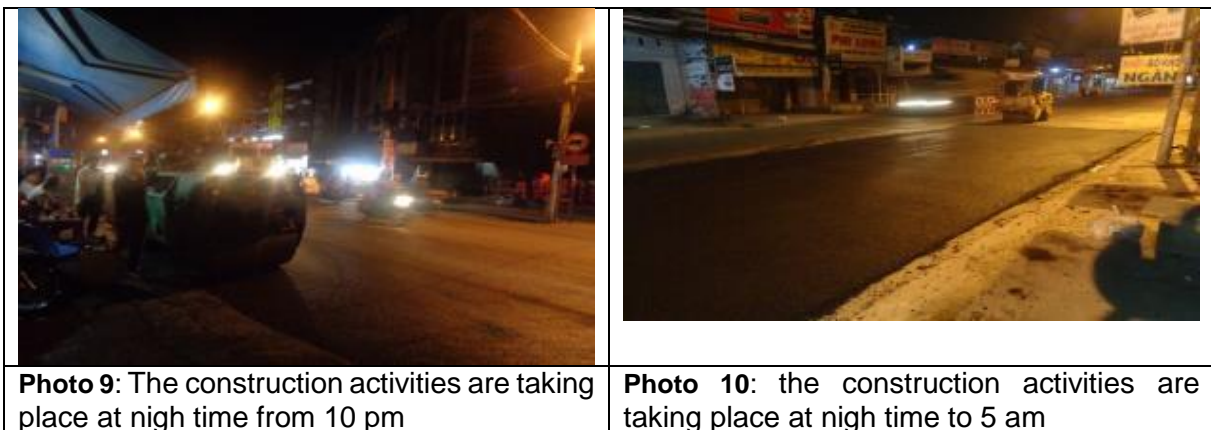
The subproject has placed board with subproject information and contacted telephone number. The workers were using proper protective equipment and were provided with satisfactory facilities. Since the cable trench is excavated along much clouded street, contractor is permitted to work at night time from 10 pm to 5 am to avoid traffic obstruct (Photo 9, Photo 10). Soil was generated from excavating the underground cable trench activities. However, almost all soil was used to refill the trench, the remained soil is transferred into licenced Da Phuoc land field every night by HCMC Urban Environmental Company. To reduce the noise generated by project vehicles/trucks transporting the soil during the night, contractors have requested drivers made no horn and during the loading of materials or waste turn off the engine. All drivers follow strictly the regulation. As a result no claim from households living along the construction has been occurred.
