Project Number: 47085  
September 2015

## Lao People's Democratic Republic: Road Sector Governance and Maintenance Project (Financed by the Asian Development Bank)

**ADB TA-8492 LAO:  
ROAD SECTOR GOVERNANCE  
AND MAINTENANCE PROJECT  
(47085-001)**

**Final Report  
Volume 2: Annexes B – Q  
[Chapters 2, 3 & 4]**

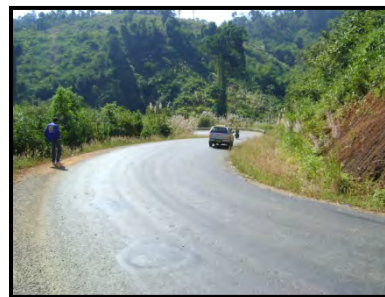
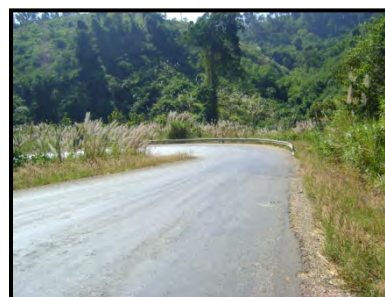
Run-off-the road accidents are reported to occur at a rate of 2-3 / year and usually involve trucks and private vehicles who travel too fast for the conditions and/or suffer from brake fade.

Downhill view – Bend 1

Downhill view – Bend 2

- advance warning signage;
- improved skid resistance;
- additional roadside containment barriers;
- installation of arrestor beds.

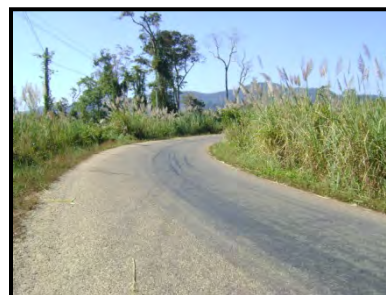
### Site No. 2 at km 41.0 approx.

This site is located at the bottom of a steep gradient [e/b direction] with a series of sharp 'S' bends. The road surface is presently 'slick' which reduces grip significantly. Run-off-the road accidents are reported to occur at a rate of 4-5/ year and involve trucks and some smaller private vehicles. The DPWT considers a horizontal realignment to be the best solution and has a preliminary design layout in mind that would occupy only state-owned land.

Downhill view

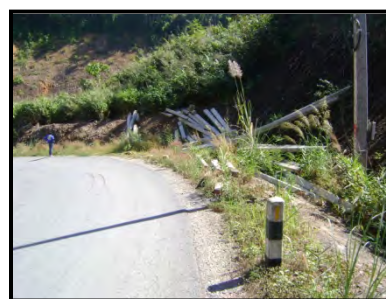
This is another site in steep terrain where eastbound traffic must negotiate another sharp bend in the middle of a long gradient of around 10%. The road surface is again quite 'slick' which reduces grip significantly.

Run-of-the road events are reported to occur sometimes - the last being in 2013. The cargo being carried at the time remains on the scene.

Downhill view

- provision of roadside containment barriers;
- provision of arrestor bed[s].

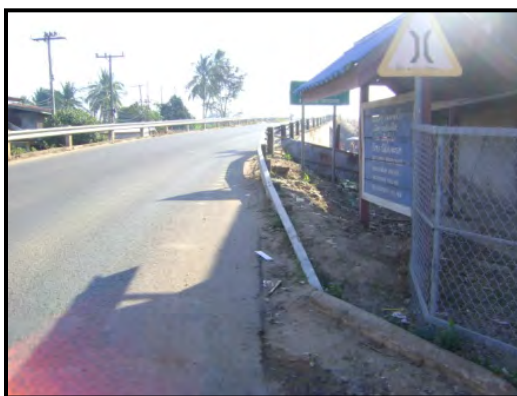
Photo NR-18B/01

Sub-section A – E/B view of main river bridge on east bound exit from Attapeu.

Deck has no provision for pedestrians. SBGR on approach is not anchored to parapet and has poor mounting height.

Rail approach end is buried and has little 'flare'.

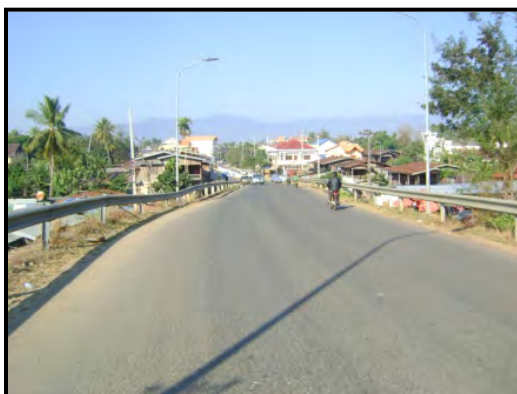
Photo NR-18B/02

Sub-section A - View of bridge deck on exit from Attapeu.

Deck has no provision pedestrians. SBGR is at varying mounting height and wide support spacing.

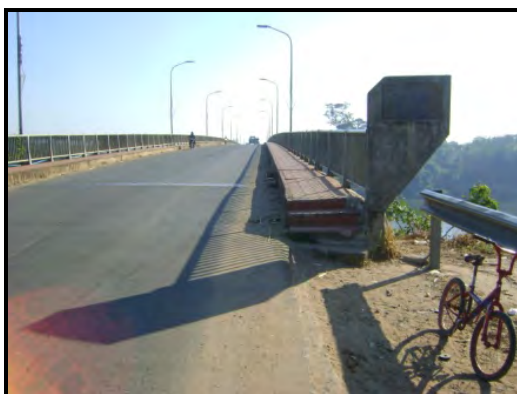
Photo NR-18B/03

Sub-section A – W/B view of main river bridge east of Attapeu.

Deck has no provision for pedestrians. Steps present ‘square’ end to oncoming traffic.

SBGR not anchored to parapet and wide support spacing.

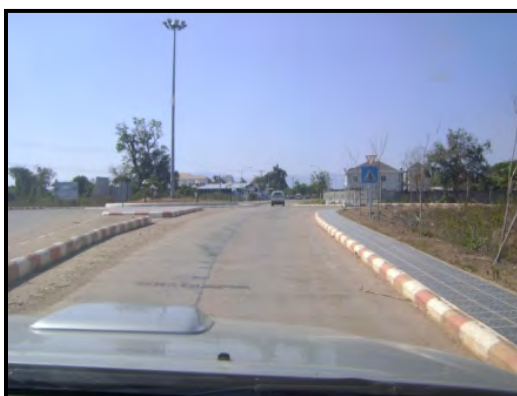
Photo NR-18B/04

Sub-section A - Approach to roundabout [2 km east of Attapeu]

Entry alignments are almost tangential and contravene the ‘slow-in’ / ‘fast-out’ principle.

Layout may be improved by increasing central island radius and entry/exit road throat configurations.

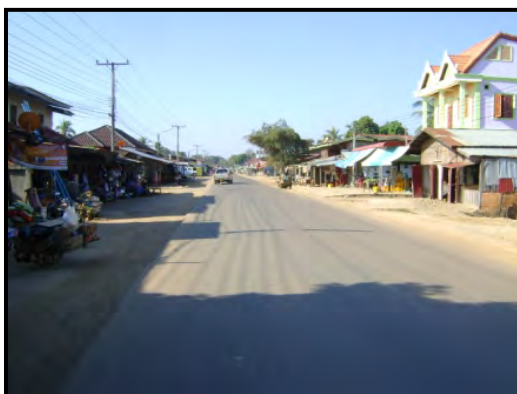
Photo NR-18B/05

Sub-section A – Typical urban conditions.

No significant or effective street lighting in evidence.

Pavement needs centreline markings and ideally, reflective edge lines and paved shoulders added.

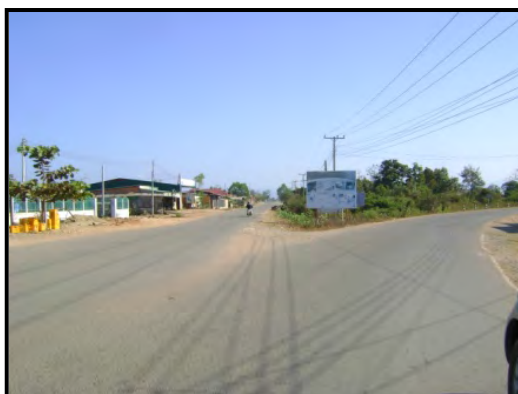
Photo NR-18B/06

Sub-section A – View or one of two major forks.

No lane markings or vertical signage in place nor any street lighting.

Directional signage for Attapeu and International Border is desirable.

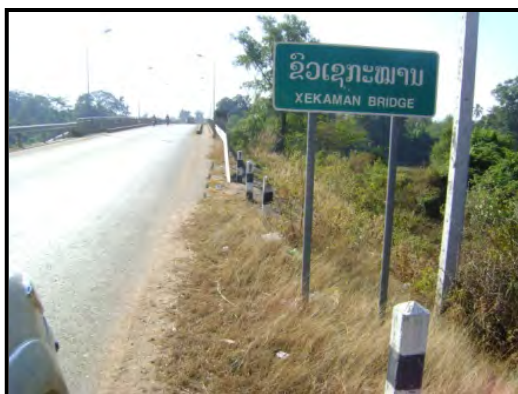
Photo NR-18B/07

Sub-section B – Typical bridge end treatment.

Deck has provision for pedestrians but curb presents a 'square' end to oncoming traffic.

SBGR not anchored to parapet but has 'reducing' support spacing dimensions. Rail end is buried but not 'flared'. Length of protection needs checking.

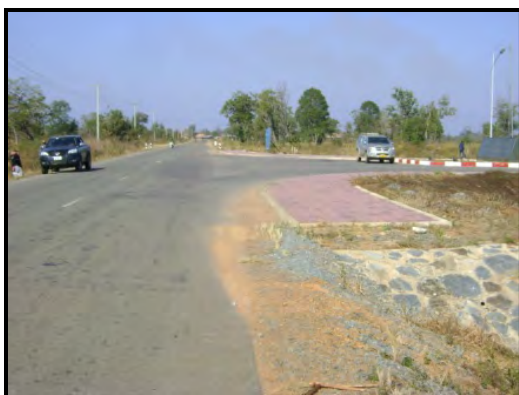
Photo NR-18B/08

Sub-section B – Junction with International Airport Access Road [km 12.4].

New road is 4-lane divided with lighting installed – and due to open in April, 2015.

National Road needs widening to 3-lanes [min] with island protected turning lanes. Also advance signage and transitional lighting.

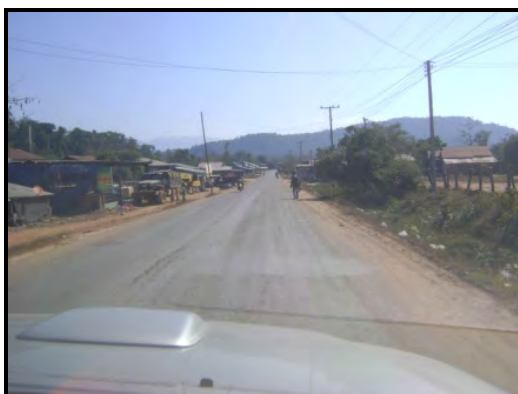
Photo NR-18B/09

Sub-section B – Typical village street conditions.

No significant or effective street lighting in evidence.

Pavement needs centreline markings and ideally, reflective edge lines and paved shoulders added.

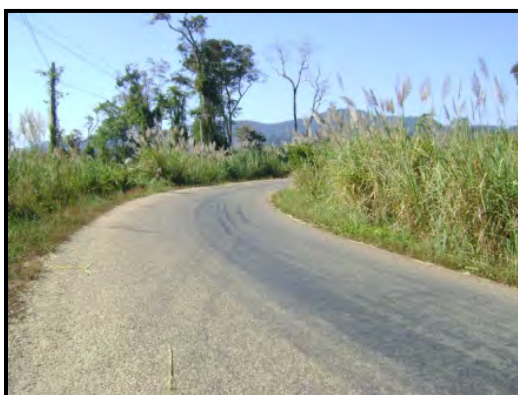
Photo NR-18B/10

Sub-section B – Rural area.

No pavement markings or road edge delineators present.

Bush to be cut to improve sight distances.

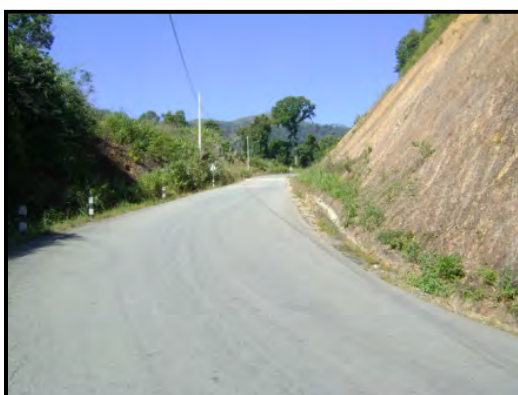
Photo NR-18B/11

Sub-section B – Rural area.

Concrete posts used as edge delineators with small offset from traffic lane and should be replaced.

No pavement markings or road edge lines present

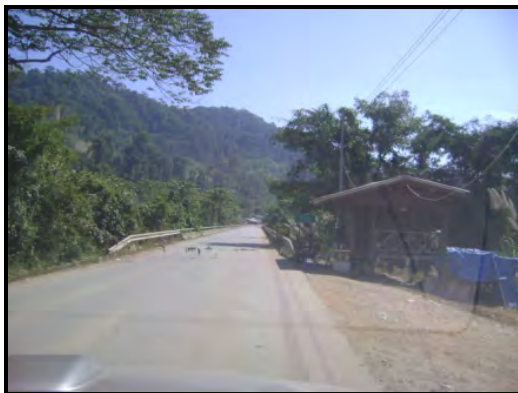
Photo NR-18B/12

Sub-section B - E/B approach to the Xesou River bridge at km 86.

Deck has no provision for pedestrians. SBGR on approach is not anchored to parapet and has poor mounting height. Rail approach end is buried but has no 'flare'.

Police check point [right] is 'informal' and needs advance signage etc.

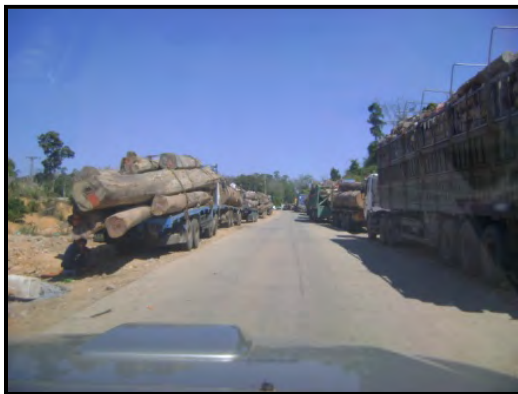
Photo NR-18B/13

Sub-section B - E/B approach to Border Crossing at 111.

Parked vehicles impede driver visibility and safe passage of other traffic.

If situation is expected to continue long term, parking must be formalized.

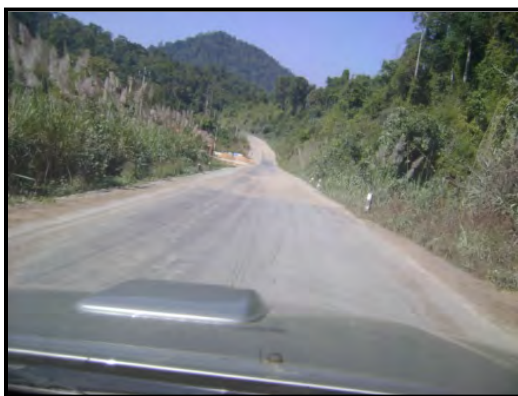
Photo NR-18B/14

Sub-section B – Road at near border crossing.

Intermittent repairs recently completed using DBST – presently unfinished. This has created a 'patchwork' effect with loose surfaces, no paint lines etc.

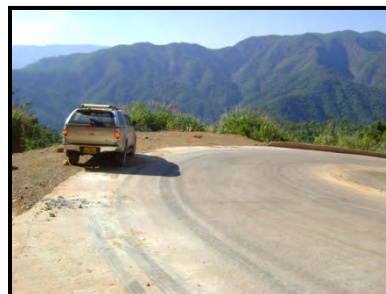
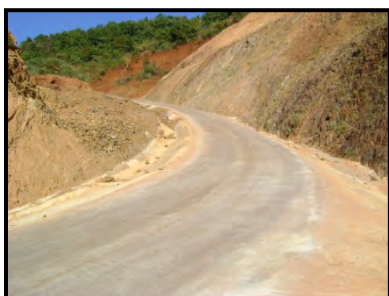
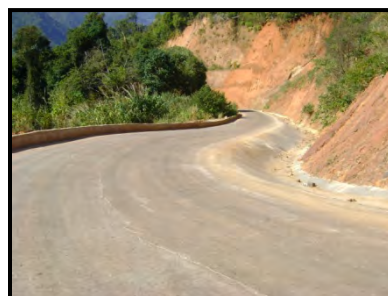
*Downhill view [1]*

*Uphill view of approach*

*Downhill view [2]*

**NOTE:** existing wall is for rainwater run-off control only and is 'non-structural'

Modification of road alignments and/or the addition of arrestor beds are likely to be impractical due to the local topography but additional solutions to be investigated should include:

- advance warning signage;
- improved skid resistance;
- roadside barriers [concrete or SBGR].

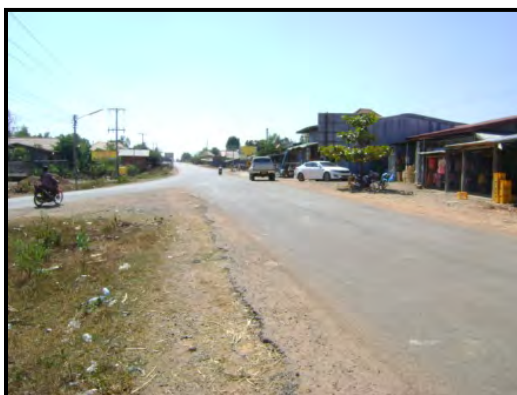
Photo LR-9001/01

Sub-section A – Junction with NR-18B at start of road in the community of Xaisettha.

No lane markings or vertical signage in place nor any street lighting.

Directional signage for Attapeu and the International Border is desirable.

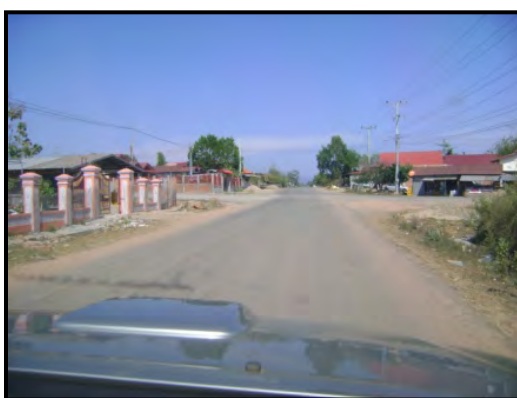
Photo LR-9001/02

Sub-section A - Typical semi-urban intersection.

No lane markings or vertical signage in place nor any street lighting.

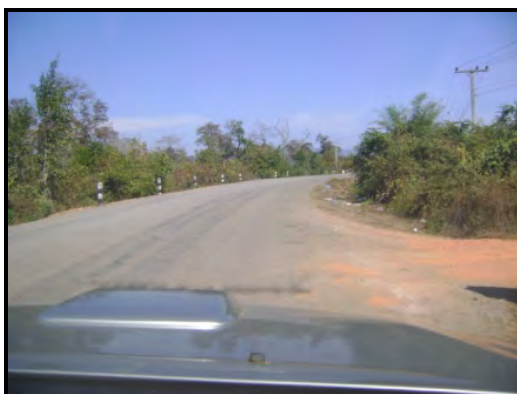
Photo LR-9001/03

Sub-section A - Typical rural intersection.

No lane markings or vertical signage in place.

Tracking of gravel onto main lanes could be reduced by localized surface application [10 m length] along minor road.

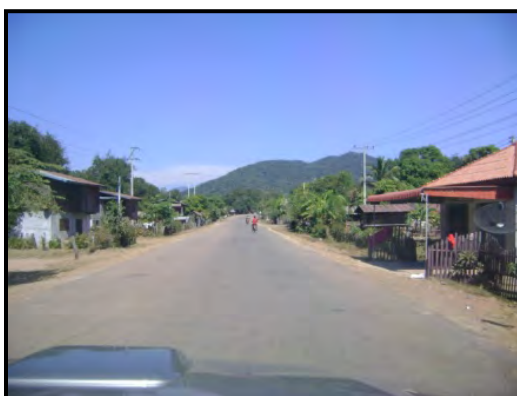
Photo LR-9001/04

Sub-section A - Typical village street conditions.

No lane markings in place and no segregated shoulders.

Steep, unpaved cross slopes from back of shoulders hard to use by pedestrians and for parking/access in some locations.

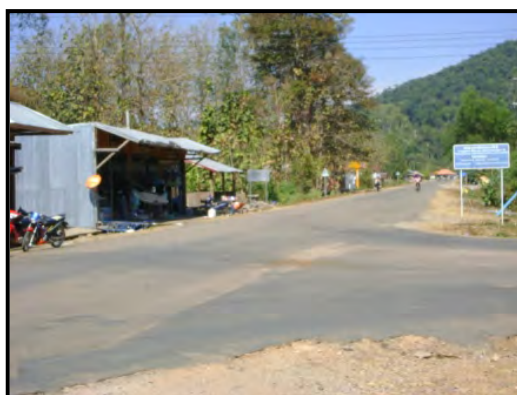
Photo LR-9001/05

Sub-section A - Village street junction within Ban Pa-am [km 15.6].

No lane markings or road definition in place - nor any directional / guide signing.

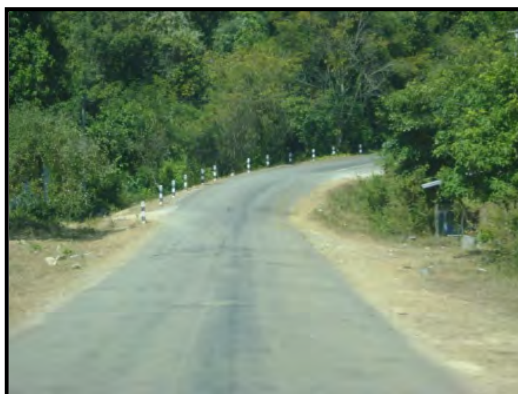
Photo LR-9001/06

Sub-section A – typical rural section.

Use of concrete posts for road edge delineation creates impact hazard. Should be replaced with edge lines and/or 'breakaway' post types.

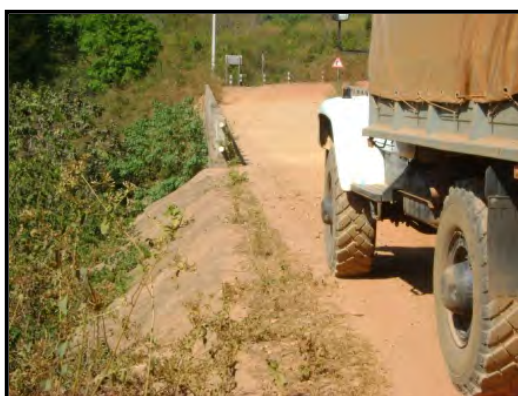
Photo LR-9001/07

Sub-section B – Bridge Approach [Nam Pa 1].

No protection [SBGR] on approach fills. End of parapets only facing traffic.

Rural location, so maybe no need to segregate pedestrians on deck.

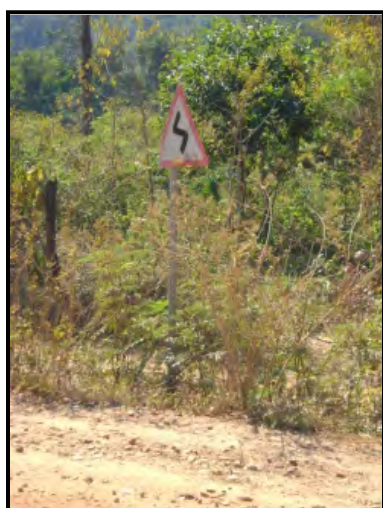
Photo LR-9001/08

Sub-section B - Typical sign installation.

Type of support appropriate but offset / location needs to be checked. Maintenance required.

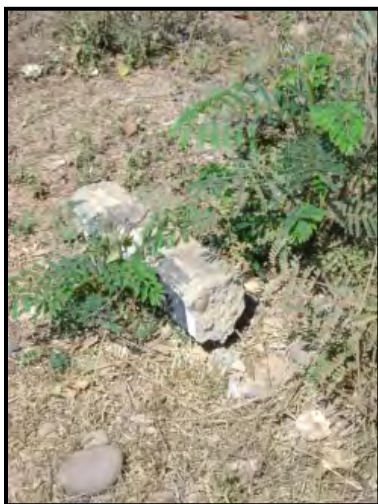
Photo LR-9001/09

Sub-section B – Concrete post delineator.

Likely to have caused severe damage if motorcycle or small vehicle and related injury.

Likely to have damaged but not restrained a heavy vehicle.

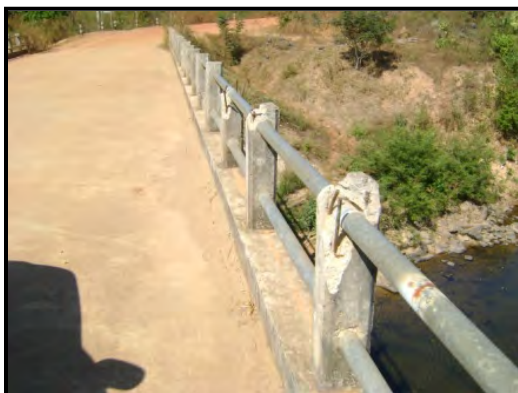
Photo LR-9001/10

Sub-section B – Bridge Approach [Nam Pa 2].

No protection [SBGR] on approach fills.

Rural location, so maybe no need to segregate pedestrians on deck.

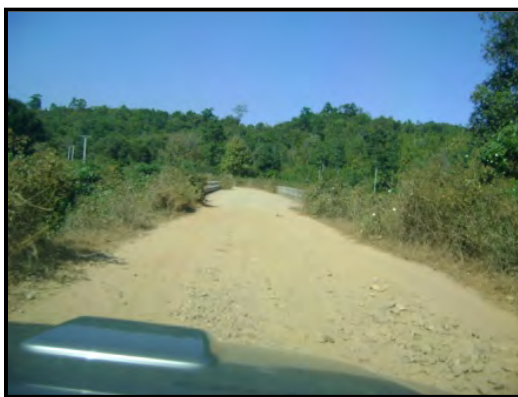
Photo LR-9001/11

Sub-section B – vegetation overgrowth.

Sight distances reduced on curved sections – to be cleared under maintenance program.

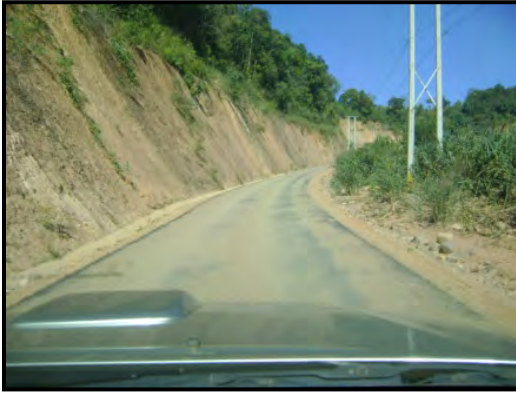
Sub-section B – loose surface.

Recently completed surfacing work resulting in loose surface. May need to be cleaned under program of maintenance works.

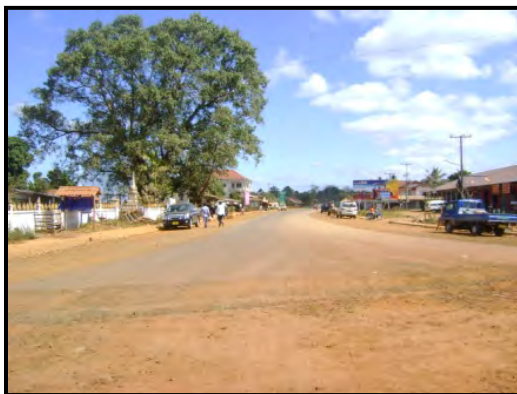
Photo NR-16/01

Typical view of 4-lane urban section in Thateng.

Loose surface needs attention to reduce skidding.

Curbing and raised sidewalks already in place.

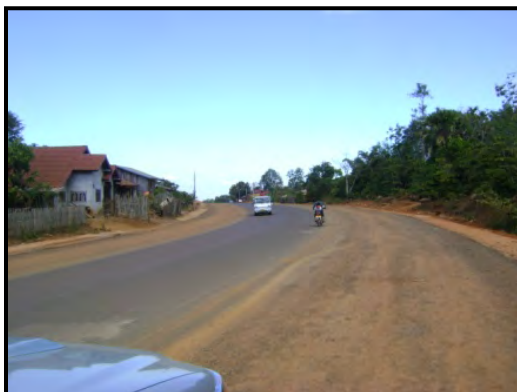
Photo NR-16/02

Typical view of 4-lane semi-urban section near Thateng.

Right lane not used - loose surface needs attention to encourage use and reduce skidding.

Some curb and raised sidewalks in place.

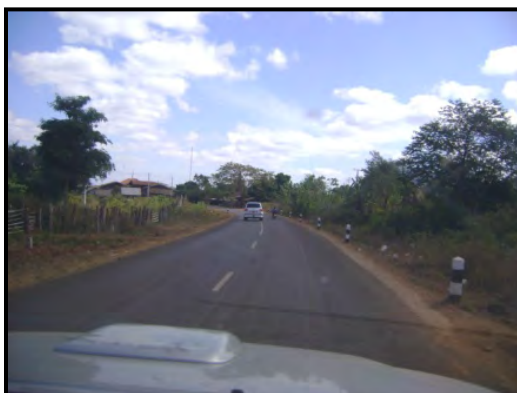
Photo NR-16/03

Typical view of rural section.

Concrete delineators used unnecessarily – might be replaced by an edge line

Shoulder effectively unusable causing 'crowding' of the single traffic lane.

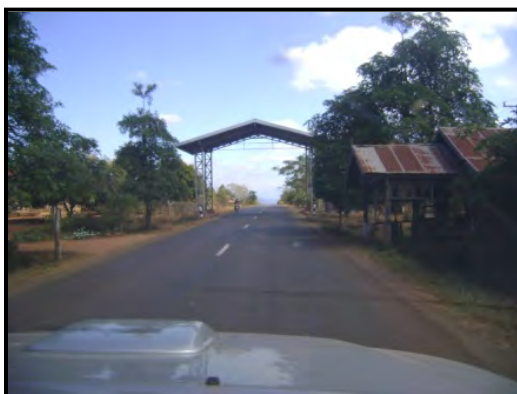
Photo NR-16/04

View of rural section.

Offset for road to arch supports needs checking.  
Similarly encroaching roof overhang at right.

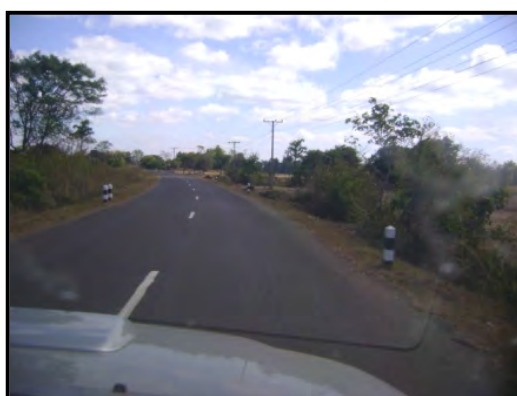
Photo NR-16/05

View of rural section.

Isolated concrete culvert marker posts [left] with limited offset from traffic lane should be replaced with 'breakaway' types and/or railing.

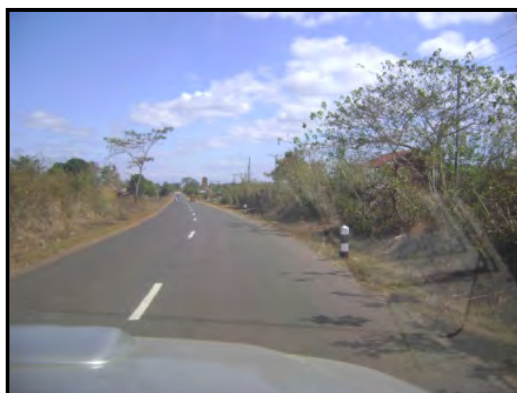
View of rural section.

Isolated concrete delineator post [right] with limited offset from traffic lane should be removed.

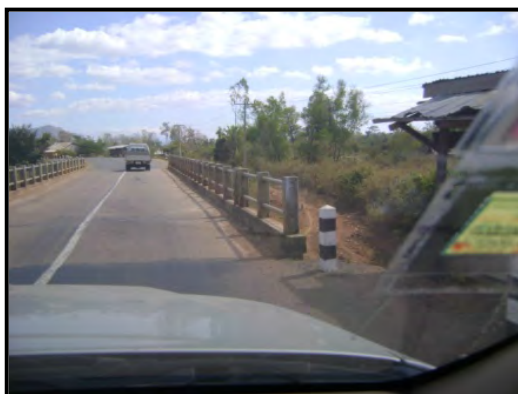
Photo NR-16/06

View of typical bridge parapet and approach.

Deck has no provision for segregating pedestrians from traffic.

Concrete delineator serving as guardrail on approach to 'square ended' parapet.

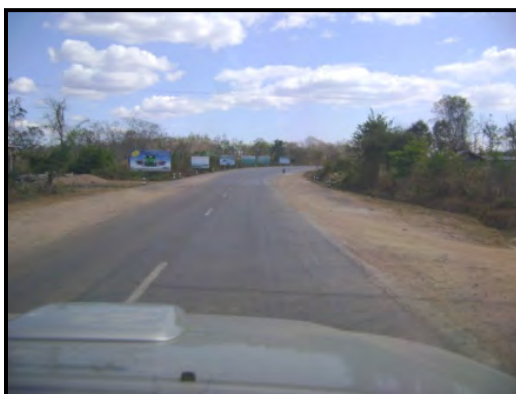
Photo NR-16/07

Typical view of 4-lane semi-urban section on approach to Xekong.

Outer lanes not used - loose surface needs attention to encourage outer lane use and to reduce risk of skidding.

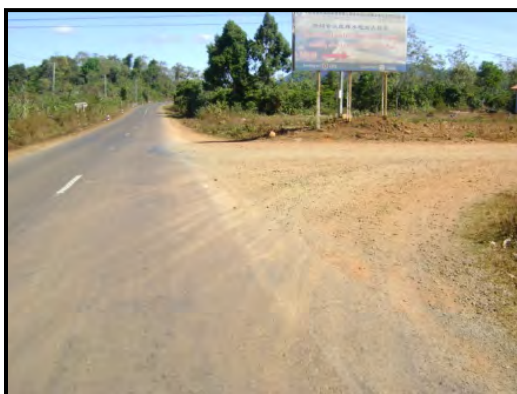
Photo LR-7615/01

Sub-section A - start of roadway.

Road edge delineation required and paved surface on entry [over distance of 5 to 10 m] to reduce tracking of gravel on to main road.

Additional vertical signage needed on all approaches.

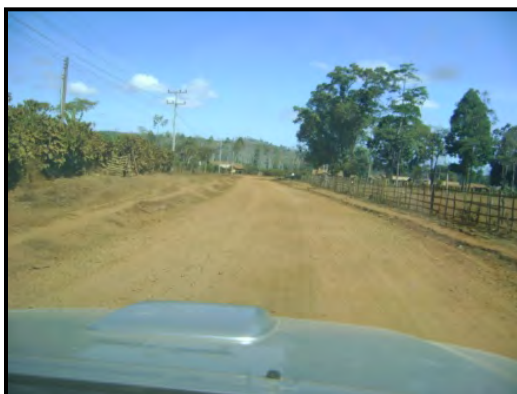
Photo LR-7615/02

Sub-section A - typical condition within first village.

DBST preferred for dust nuisance reduction.

Centrelines and preferably, reflective edge lines to segregate pedestrians from traffic needed - if DBST provided.

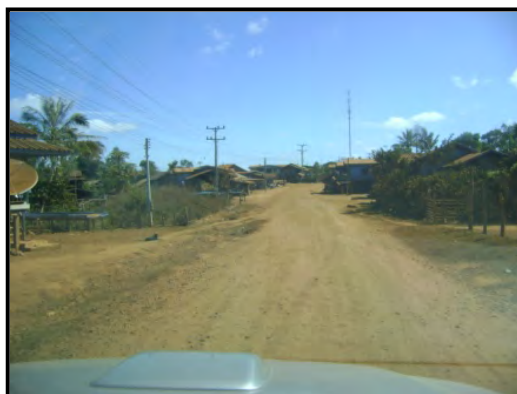
Photo LR 7615/03

Sub-section A - typical condition within second village.

DBST preferred for dust nuisance reduction.

Centrelines and preferably, reflective edge lines to segregate pedestrians from traffic needed - if DBST provided.

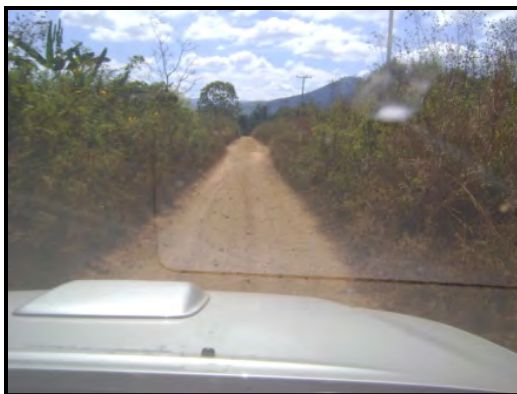
Photo LR 7615/04

Sub-section B - typical view of showing restricted road width.

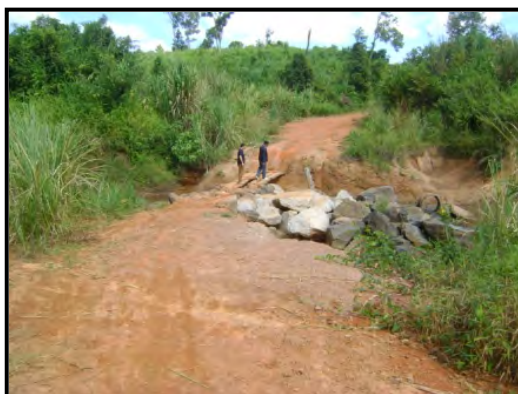
Photo LR 7615/05

Sub-section B - typical view of river crossings.

Will require box culvert or bridge crossing with related warning signage and approach fill delineation.

Bush clearing is needed to increase sight distances.

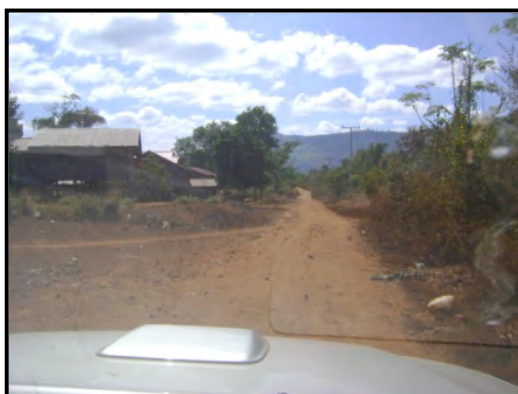
Photo LR 7615/06

Sub-section C - typical condition within main village.

DBST preferred for dust nuisance reduction.

Centrelines and preferably, reflective edge lines to segregate pedestrians from traffic needed - if DBST provided.

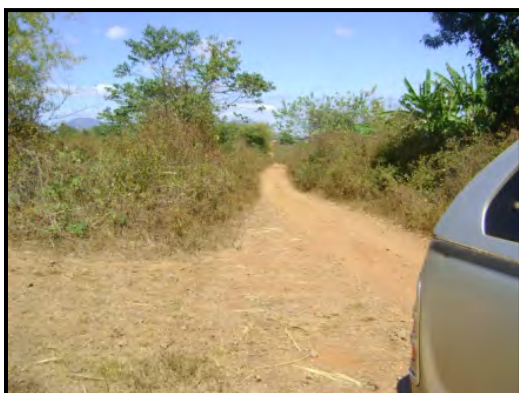
Photo LR 7615/07

Sub-section C – restricted road width.

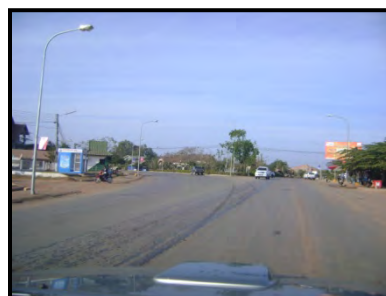
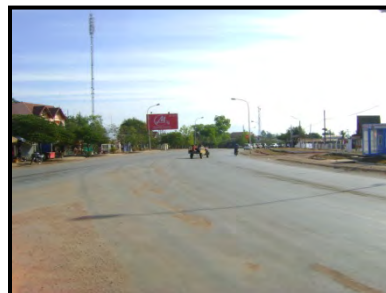
There presently no warning signs for the junction or the bus terminus and no lane or dividing island markings. Despite the presence of street lighting there are frequent collisions predominantly involving buses and motorcycles it is reported.

*View of fork from north*

*View to south of fork*

Alignment modifications seem neither necessary nor practical to introduce but lane markings and painted [or even raised] island channelization would be beneficial.

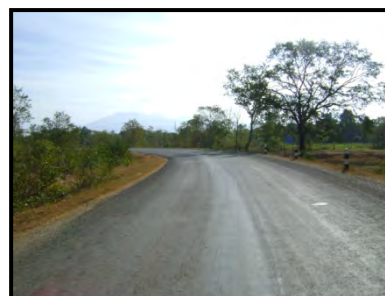
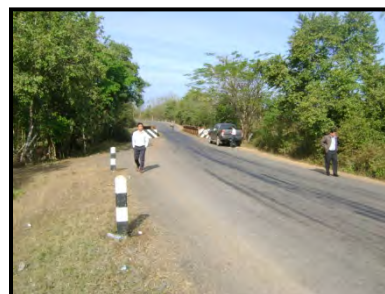
### Site No. 2 at km 17.4

*View of northbound approach*

*View of bridge on s/b approach*

The proposed replacement of the steel bridge with a new box culvert will improve the road width for 2-way operation.

This together with the addition of better signage would be beneficial at this point.

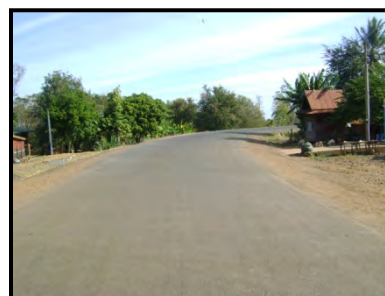
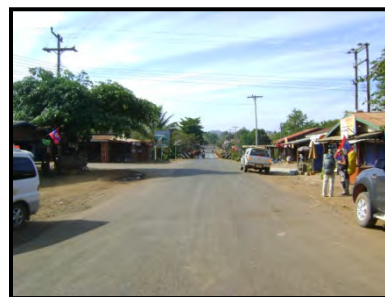
### Site No. 3 at km 17.4

There is no street lighting and the road surface is lacking some texture for skid resistance.

*View of southbound approach*

*View of northbound approach*

Horizontal alignment modifications appear to be impractical but warning reflective signs and lane markings would be very beneficial.

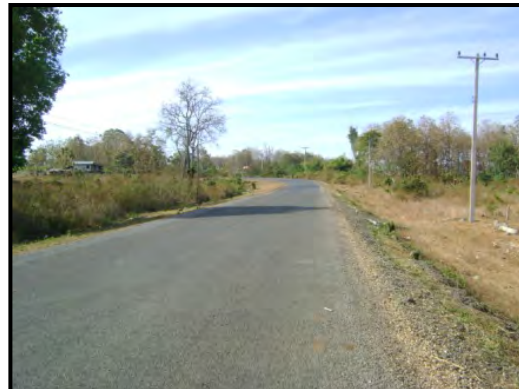
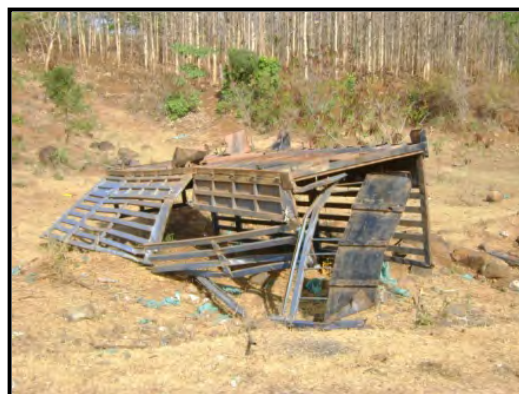
#### **Site No. 4 at km 32.3 approx.**

Accidents occur regularly and are due reportedly to excess approach speed on the down grade – the remains of a recent incident remain at the roadside.

*View southbound*

*Remains of a recent incident*

Additional warning reflective signs and lane markings would be highly beneficial.

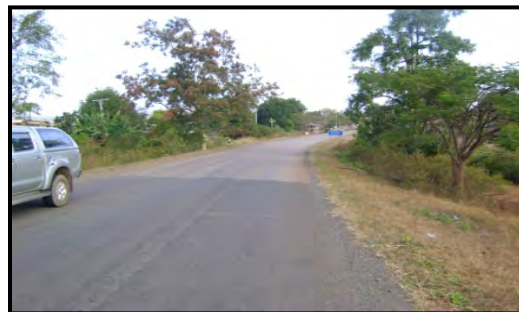
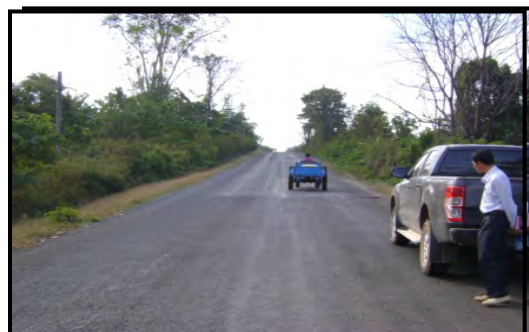
#### **Site No. 5 at km 34.9 approx.**

Accidents occur regularly and are again due reportedly to excess approach speed on the down grade. The results of a recent incident remain at the roadside.

*View northbound*

*View southbound*

Additional warning reflective signs and lane markings would be highly beneficial.

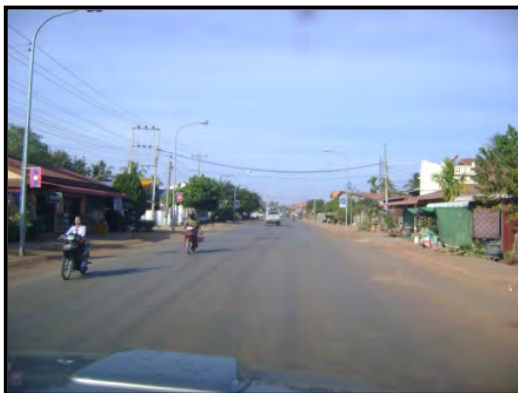
Photo NR-20/01

Sub-section A – Typical urban stretch inside the city of Saravan [at km 5 approx.].

Roadway has no centreline, edge line of lane markings giving users no guidance.

Curbing and raised sidewalks are in place but with no segregation of stopping, parking areas. There are no pedestrian crossings or refuges provided.

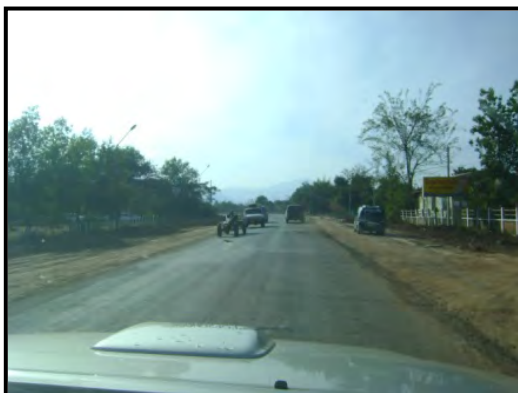
Photo NR-20/02

Sub-section A – Two lane semi-urban road presently being widened.

Roadway has remnants of a centreline but no edge markings or shoulder segregation - though this may be rectified by Contractor.

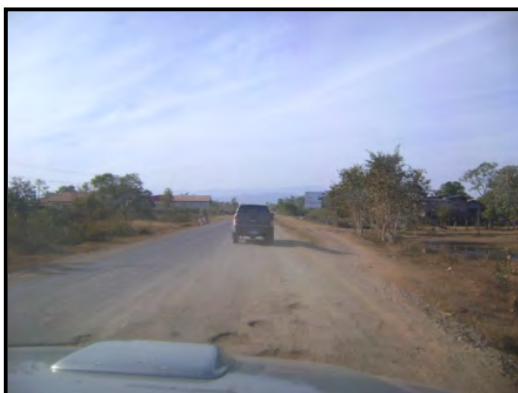
Photo NR-20/03

Sub-section A – Restart of 2-lane section [km 6 approx.].

No indication of start / end of construction zone given.

Materials tracked onto road surface resulting in loss of skid resistance. Contractor should be made to clean.

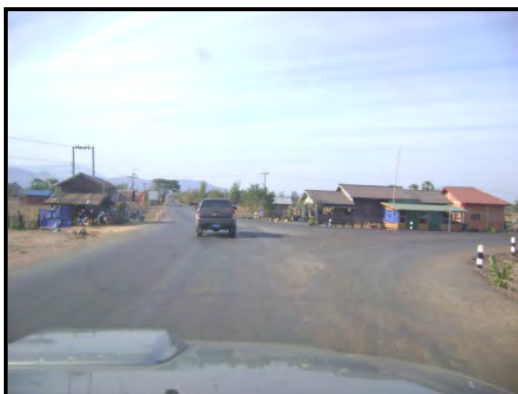
Photo NR-20/04

Sub-section A - S/B approach to major junction [Napong Rd].

No centreline, lane lines or edge delineation in place.

Minimal regulatory signage and no directional information given.

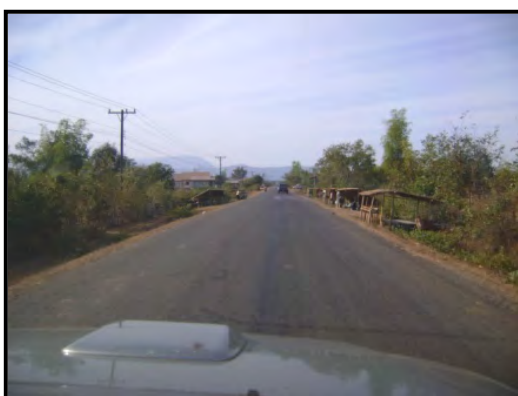
Photo NR-20/05

Sub-section A – Informal sales outlets [km 10-12].

Structures are mostly located clear of traffic lanes but the likelihood of drivers making sudden stops and starts creates hazardous situation.

Consideration might be given to creating paved shoulders with suitable entry/exit tapers and warning signage.

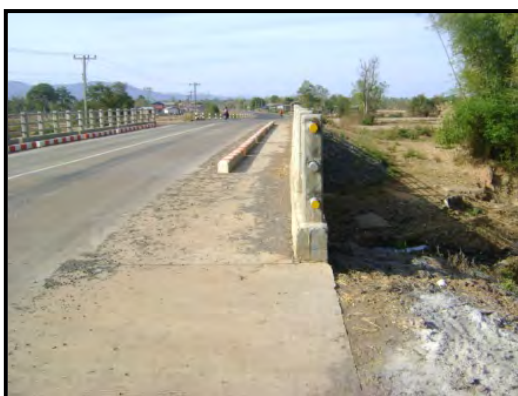
Photo NR-20/06

Sub-section A – S/b approach to newly reconstructed bridge [km 13.5].

Square end of curb and parapet presented to oncoming vehicles. No guardrail protection provided on any approach fills.

Contractor should be urged to install flared SBGR, add reflective edge lines and 'slope' concrete curb end. MPWT standard should be reviewed.

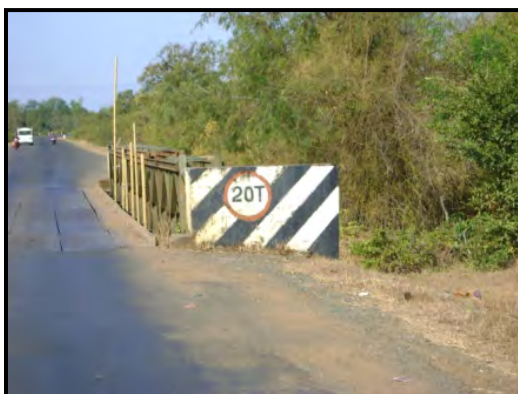
Photo NR-20/07

Sub-section A – Concrete wall ‘square’ to approaching traffic on all 4 bridge rail ends.

Minimal warning signage installed.

These bridges recommended for replacement under the ‘Project’.

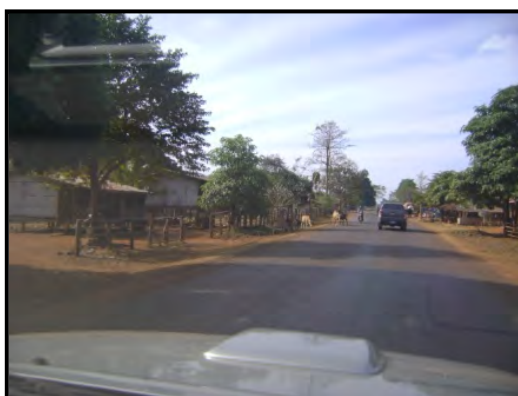
Photo NR-20/08

Sub-section A – Unattended animals in roadway.

Typical occurrence in several locations – avoidance should be emphasized in ‘community road safety awareness’ program.

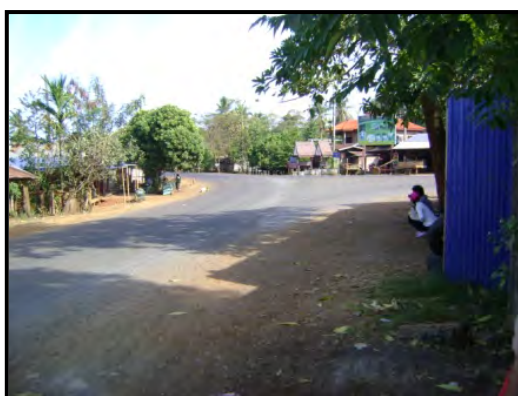
Photo NR-20/09

Sub-section A – View of n/b approach to main junction [Ban Beng – km 25 approx.].

No centreline, lane lines or edge delineation in place although remnants of edge lines remain on eastern leg of ‘T’.

No segregation of shoulders/ parking areas and minimal regulatory signage and no directional information given.

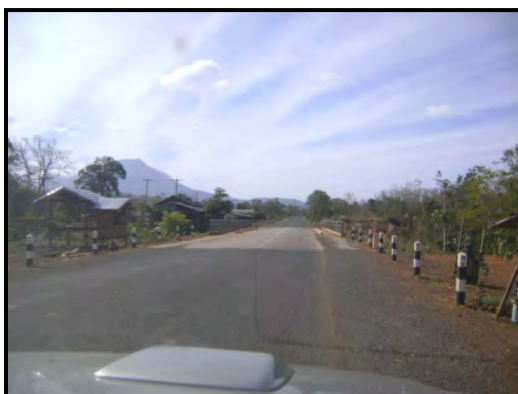
Photo NR-20/10

Sub-section B – S/B approach to bridge [km 27.0].

Concrete delineators might be replaced with reflective edge lines.

MPWT standards should be reviewed.

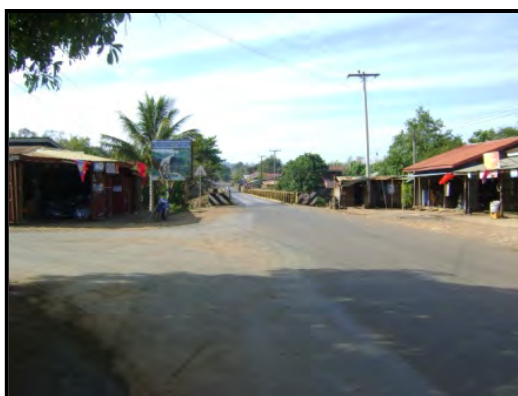
Photo NR-20/11

Sub-section B - S/B approach to major junction with Tad Lor Road.

No centreline, lane lines or edge delineation in place.

Minimal regulatory signage and no directional information given.

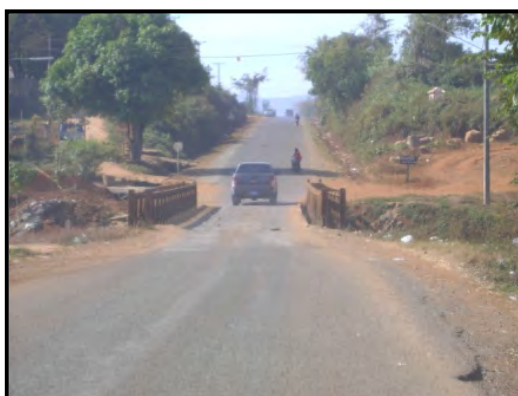
Photo NR-20/12

Sub-section B – Concrete wall 'square' to approaching traffic on all 4 bridge rail ends.

Despite these hazards, it was noted that minimal warning signage has been installed.

This situation is typical of all of the Bailey bridges that are located within Sub-section B at km 39.7, km 46.0, km 48.0 and km. These should be considered for replacement under the 'Project'.

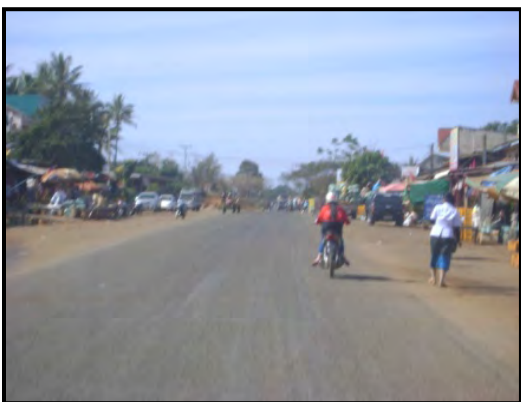
Photo NR-20/13

Sub-section B – View of village street section [km 46.5 to 47.5].

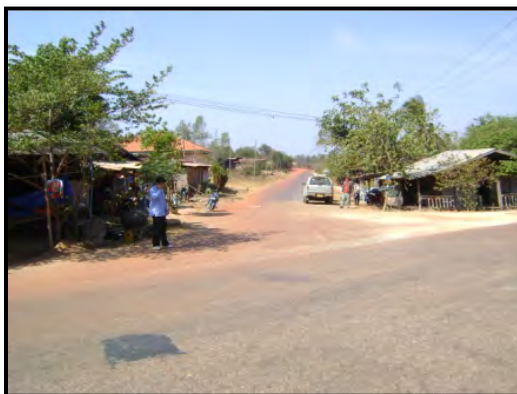
Photo LR-6901/01

Sub-section A – Start of road at NR-13S.

Even though both roads are surfaced, no lane markings or vertical signage [including stop or directional types] exist even though this is a route to an international border crossing.

The minor road surface is unclean and of low skid resistance.

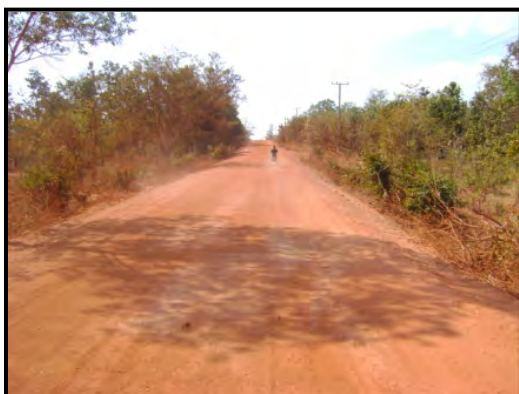
Photo LR-6901/02

Sub-section A – Location of annual flood impact area [km 3.6].

Inundated road surface causes both access and safety problems regularly.

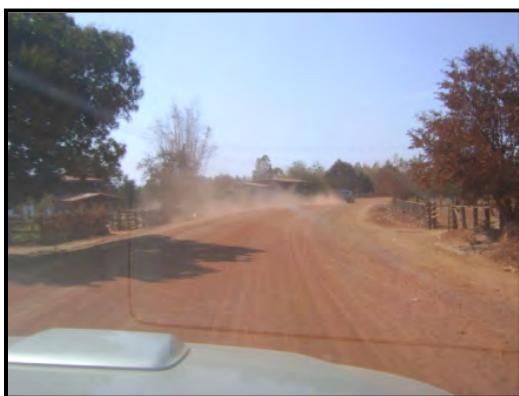
Photo LR-6901/03

Sub-section A - Typical view of village area.

Loose surface causes visibility and potential health problems. The application of markings [lane lines, stop lines etc.] is precluded by surface condition.

No vertical signage present at school zones.

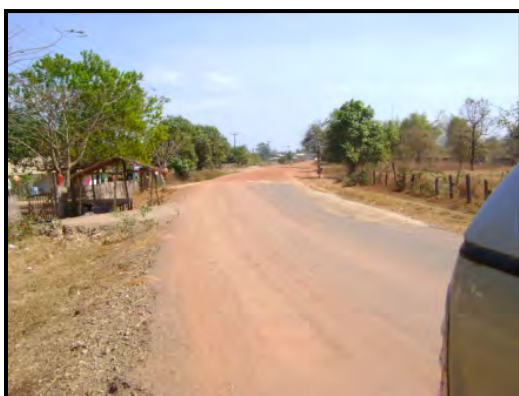
Photo LR-6901/04

Sub-section A – View of village road with surfacing.

Visibility and air quality noticeable better.

Opportunities exist to install horizontal signage though none presently exist.

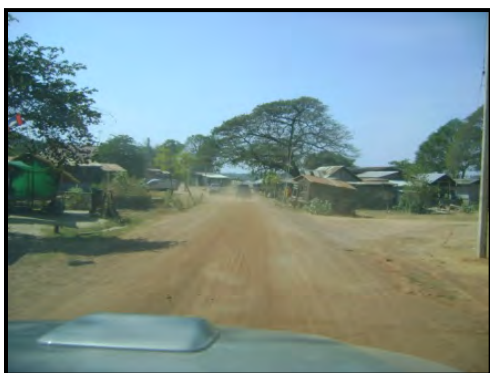
Photo LR-6901/05

Sub-section A - view of typical minor road junction within the village area.

Lack of surfacing precludes the installation of centre, edge and stop lines.

No vertical signage present.

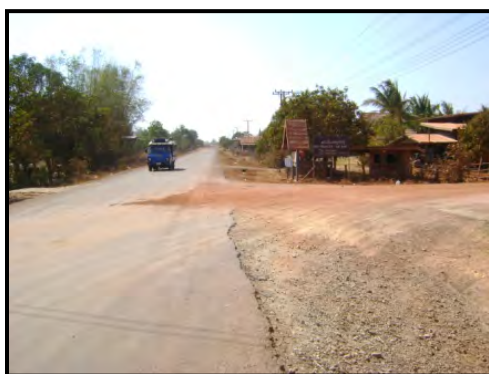
Photo LR-6901/06

Sub-section B junction with Sub-section A.

No vertical signage present.

Loose surface has led to the 'tracking' of gravel onto the through lanes.

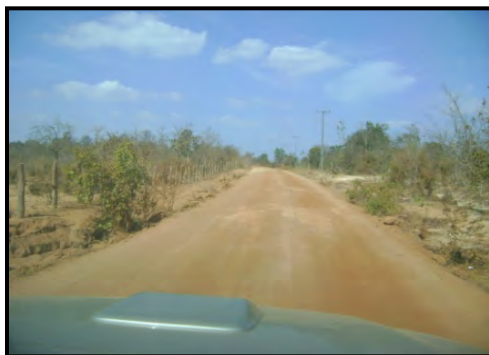
Photo LR-6901/07

Sub-section B - Typical view.

Roadway alignment, width and surface acceptable but encroaching vegetation and drainage ditching need attention.

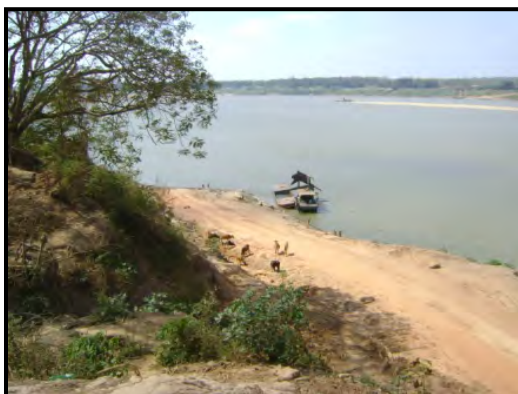
Photo LR-6901/08

Sub-section B – Vehicle ferry landing area.  
Roadway surface poor and no protection  
against drop-off on river edge.

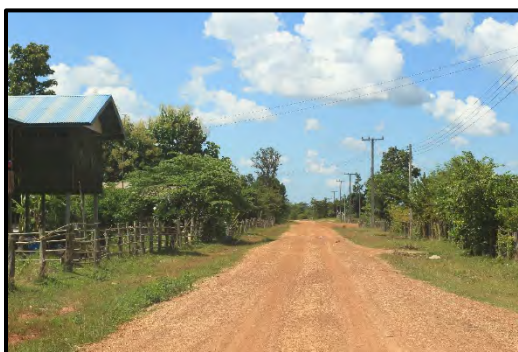
No signage present to control traffic or to  
indicate the presence of an international  
border crossing.

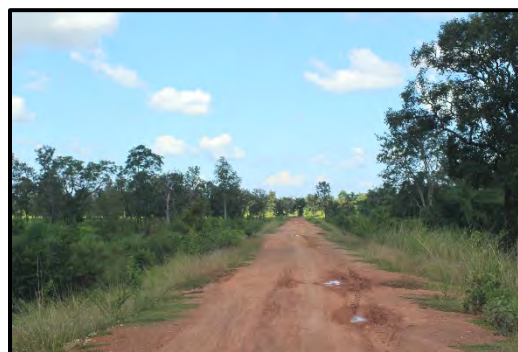
Photo LR-6901/09

Sub-section C – the inter-ferry link.

Roadway surface in good condition but  
needs re-grading.

No separation in village of pedestrians from  
through traffic.

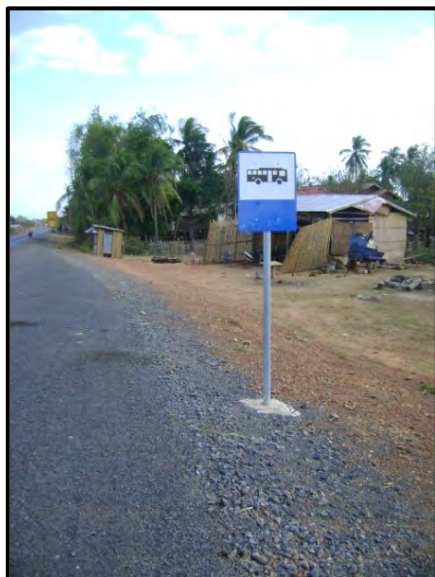
### **2. Bus Stop Sign [at Bus Bay]**

Sign is clear and mounted at the rear of the ‘out-of-lane’ bus bay.

Passenger waiting area surface should be improved.

Edge lines around the bay and its entry/exit tapers would be helpful.

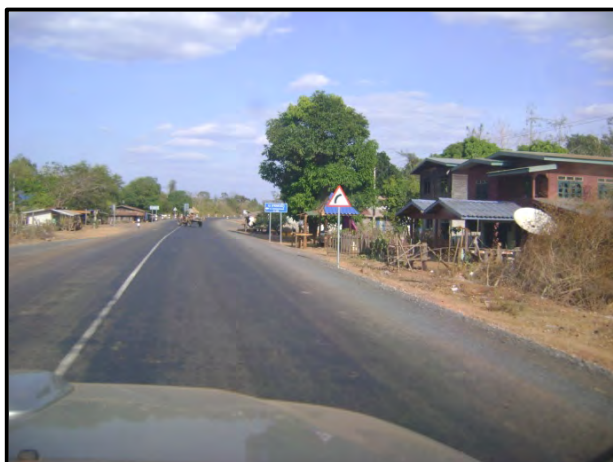
### 3. Sharp Bend and Directional Signs

Example of signage used to indicate sharp bend ahead and the name of the village.

Speed advisory notice also should be placed ahead of particularly for sharp curves.

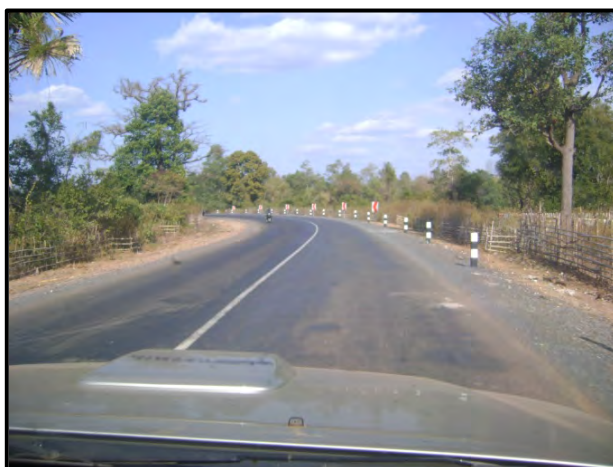
### 4. Chevron Warning Signs

Use of brightly coloured chevron signs to indicate bend ahead is good.

The concrete post delineators installed on the outside of the curve represent a safety hazard.

There should be a minimum of 3 signs be visible to approaching drivers through the curve.

Replacement with reflective edge lines and/or embedded road stud reflectors would be preferable.

- Associated with the above, consideration of the removal of many of the existing concrete delineator posts - or their replacement with less damaging types [e.g. plastic posts, 'breakaway' mountings etc.];
