Project Number: 47085  
September 2015

## Lao People's Democratic Republic: Road Sector Governance and Maintenance Project (Financed by the Asian Development Bank)

**ADB TA-8492 LAO:  
ROAD SECTOR GOVERNANCE  
AND MAINTENANCE PROJECT  
(47085-001)**

**Final Report  
Volume 2: Annexes B – Q  
[Chapters 2, 3 & 4]**

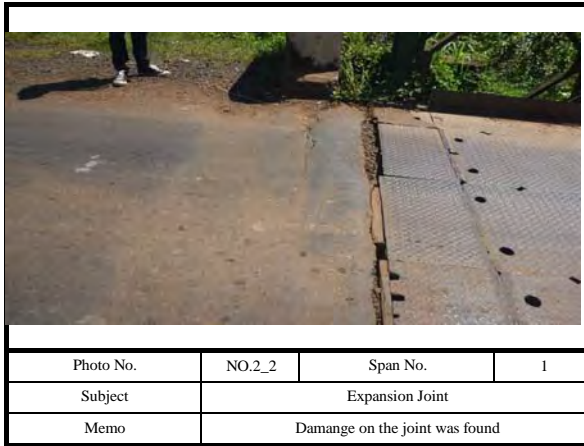
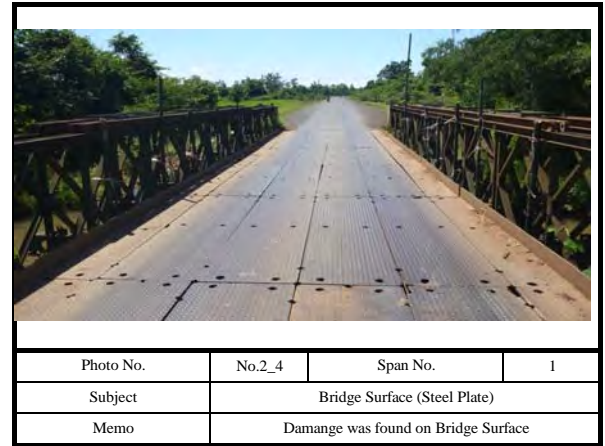
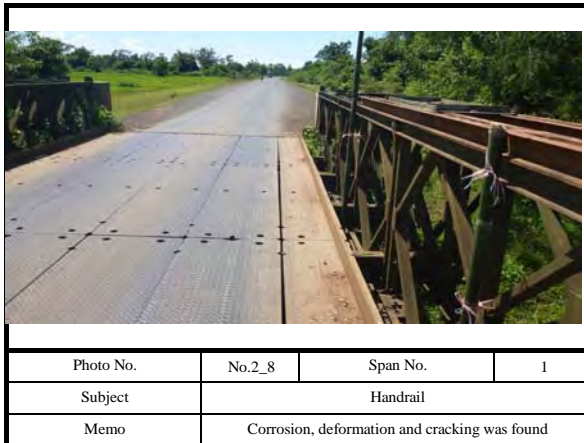
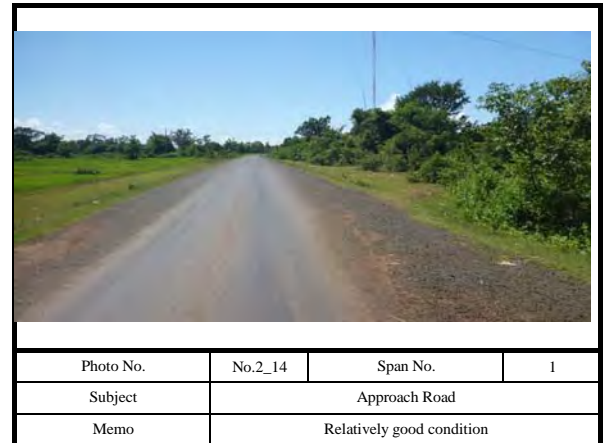
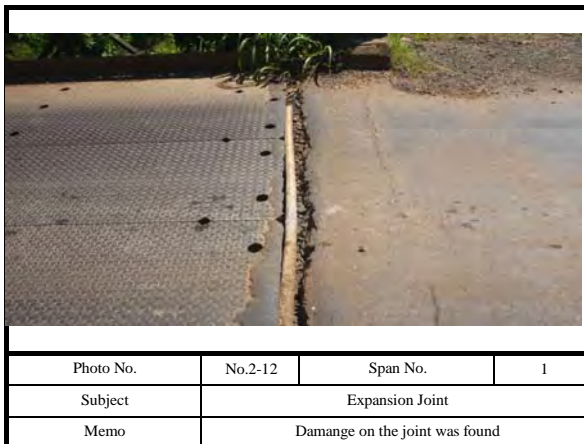
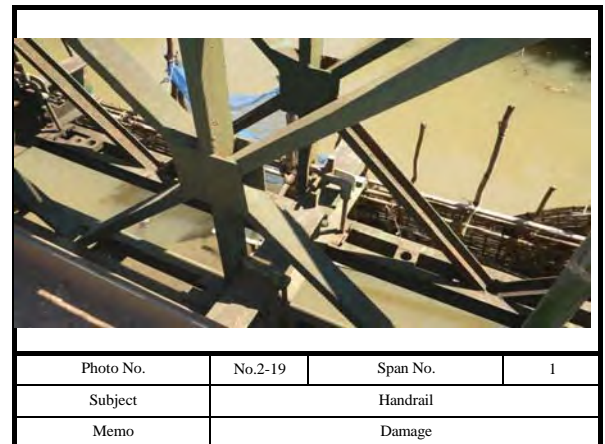
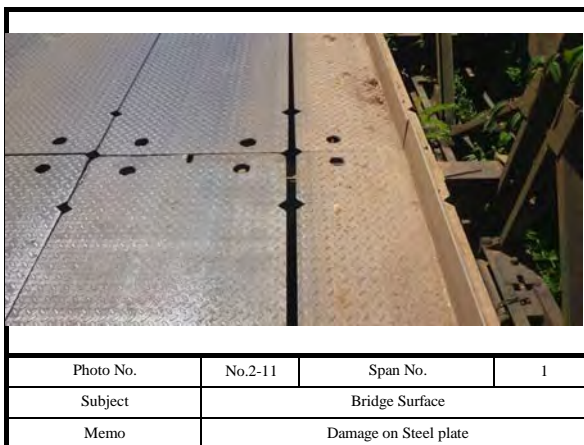
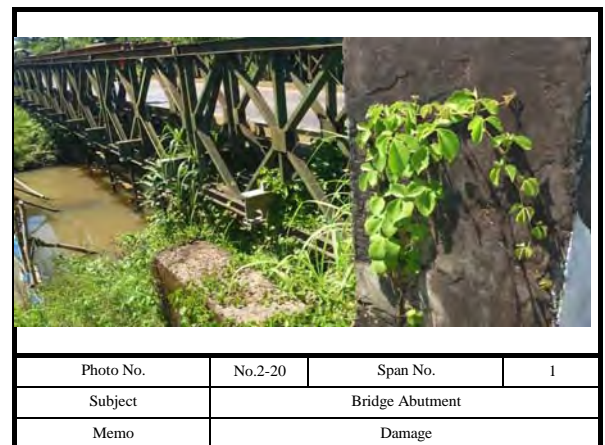
- Temporaly bridge but use as permanent.
- Damage in many element, which is required for replacement.
- Emergency theatment is require for safety reason, such re-bolt, expension joint and bridge surface.

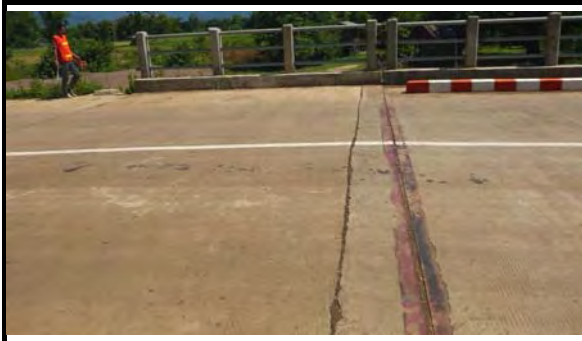
Photo No.	NO.1_2	Span No.	1
Subject	Expansion Joint		
Memo	No significant Damage, installation of drainage system properly is required

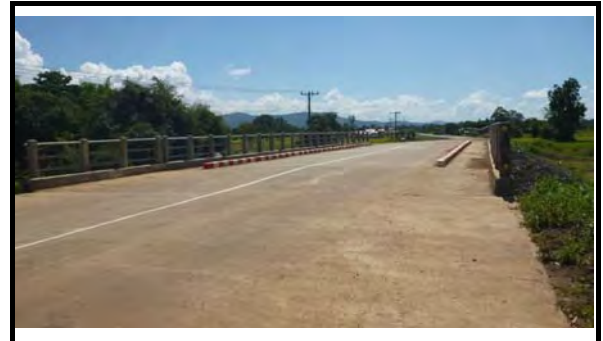
Photo No.	No.1_1	Span No.	1
Subject	Approach Road		
Memo	Good condition

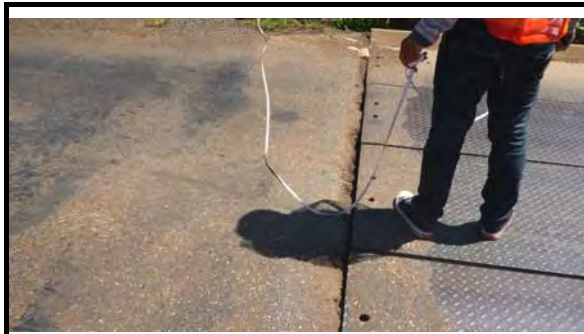
Photo No.	NO.3_2	Span No.	1
Subject	Expansion Joint		
Memo	Damage on the joint was found

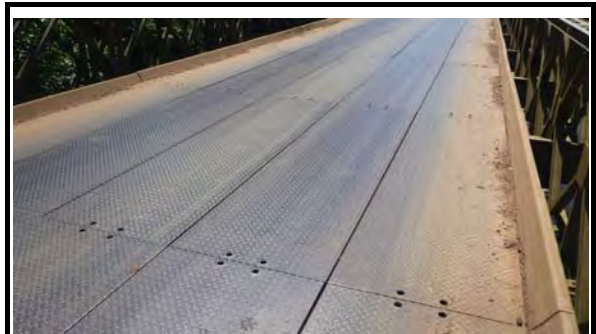
Photo No.	No.3_5	Span No.	1
Subject	Bridge Surface (Steel Plate)		
Memo	No Significant Damage was found

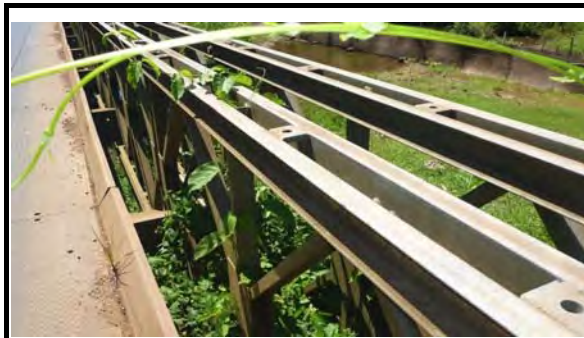
Photo No.	No.3_3	Span No.	1
Subject	Handrail		
Memo	Corrosion, deformation was found

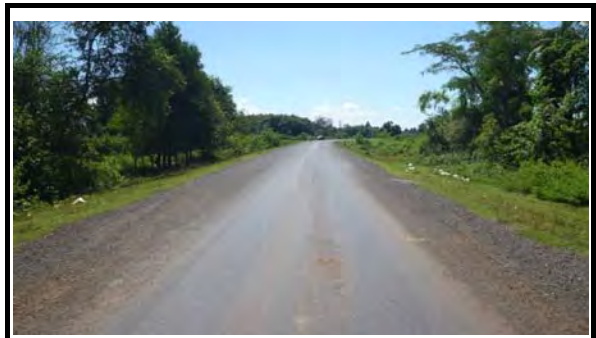
Photo No.	No.3_15	Span No.	1
Subject	Approach Road		
Memo	Relatively good condition

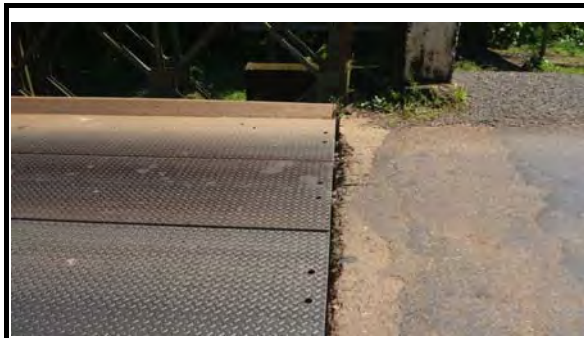
Photo No.	No.3-13	Span No.	2
Subject	Expansion Joint		
Memo	Damage on the joint was found

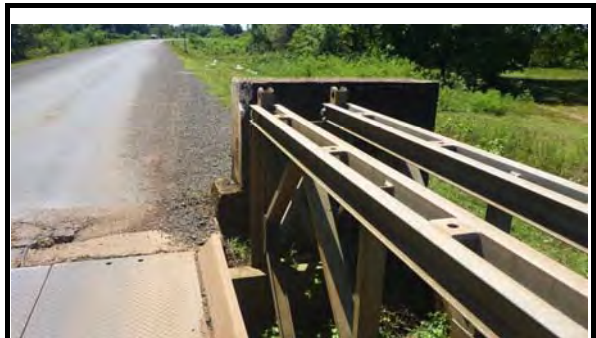
Photo No.	No.3-9	Span No.	2
Subject	Handrail		
Memo	No Significant Damage was found

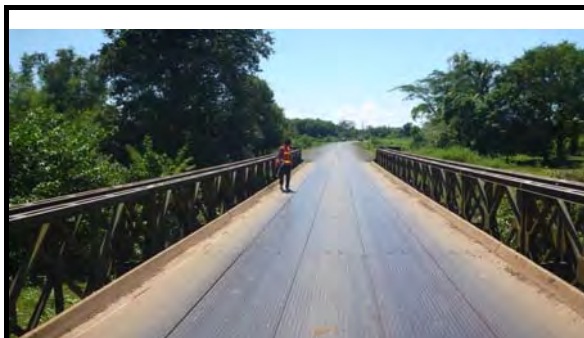
Photo No.	No.3-14	Span No.	1,2
Subject	Bridge Surface		
Memo	No Significant Damage on Steel plate

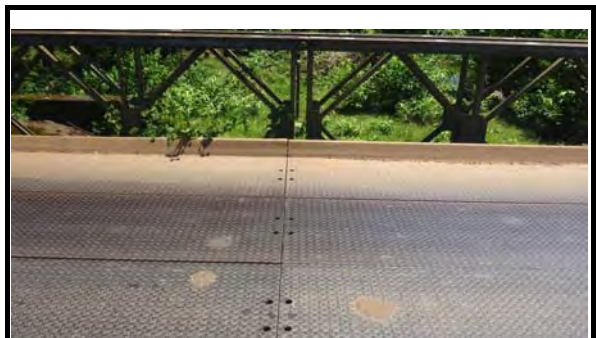
Photo No.	No.3-4	Span No.	2
Subject	Bridge Surface		
Memo	No Significant Damage was found

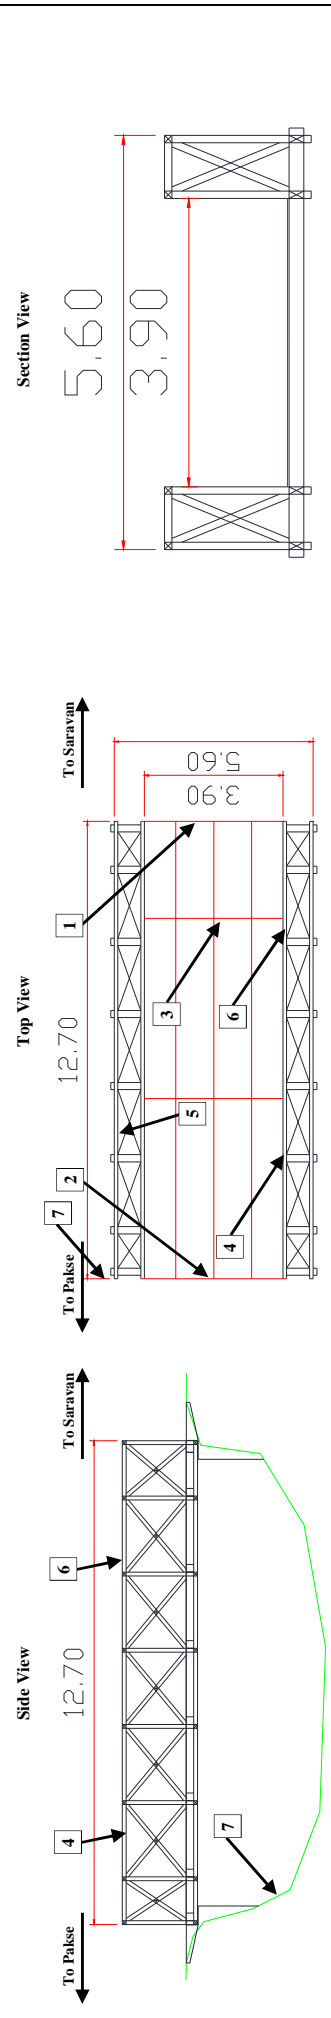
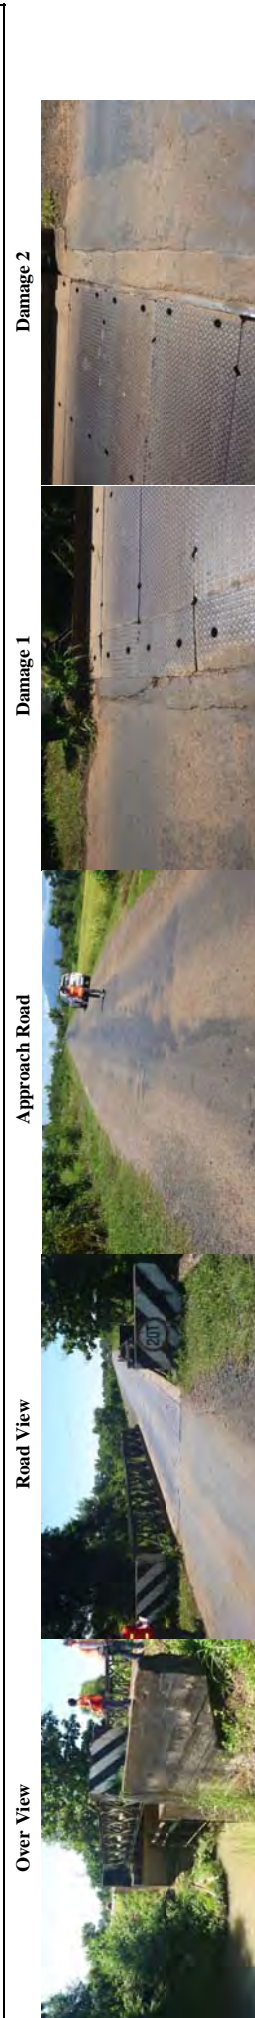
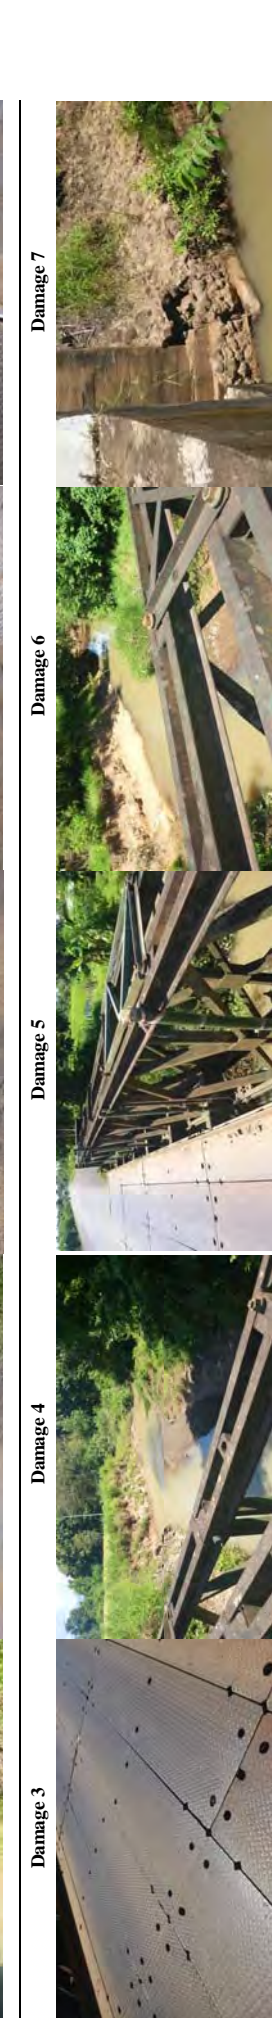
- Corrosion and damage was found on handrail (Structure)
- Scouring and washing out was found on abutment
- Damage on expansion joint was found

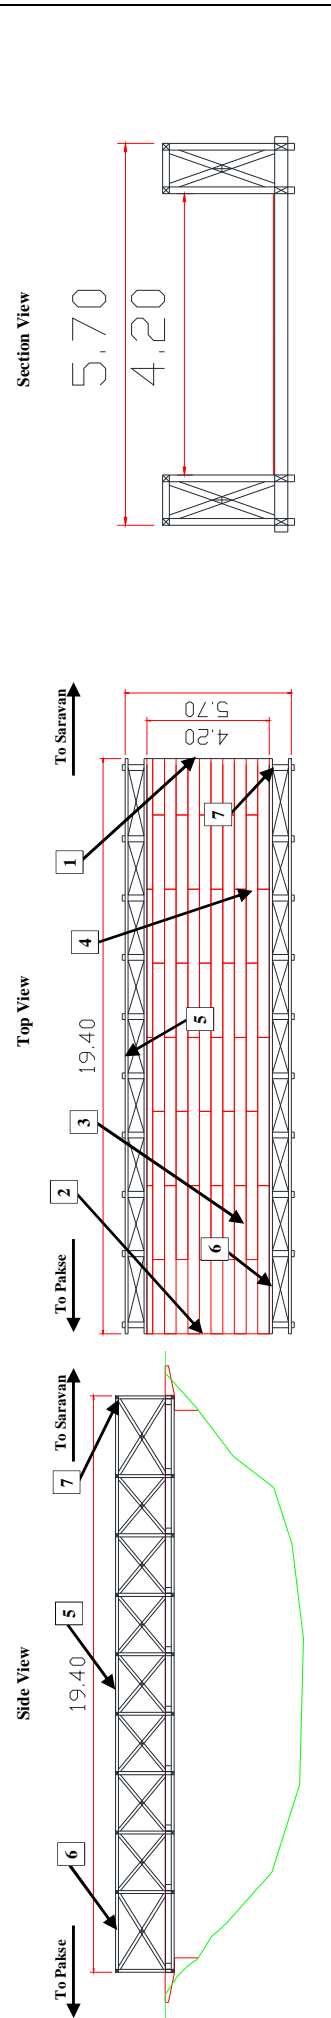
- Significant damage was found on bridge surface which made by woods, and need to be replace as soon as possible for road safety.
- Corrosion, deformation and damage was found on handrail (Structure).

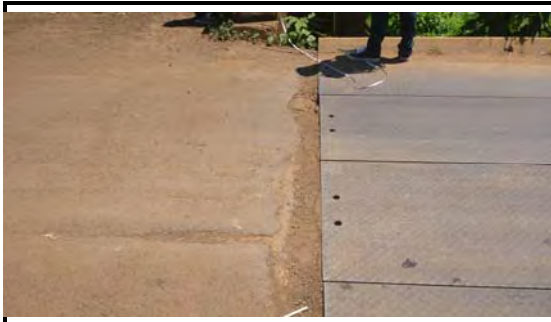
Photo No.	NO.7_2	Span No.	1
Subject	Expansion Joint		
Memo	No Significant Damage on the joint was found

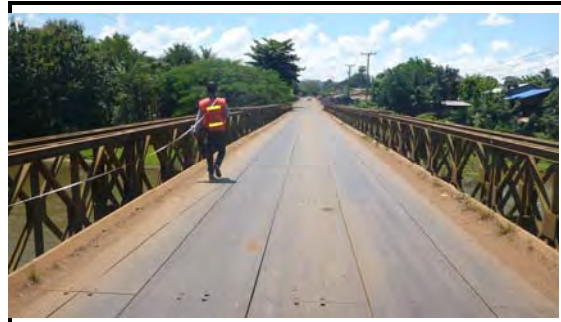
Photo No.	No.7_4	Span No.	1
Subject	Bridge Surface (Steel Plate)		
Memo	No Significant Damage was found on Bridge Surface

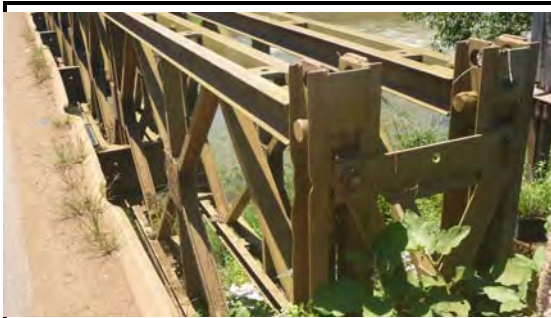
Photo No.	No.7_9	Span No.	1
Subject	Handrail		
Memo	Minor Corrosion, deformation and cracking was found

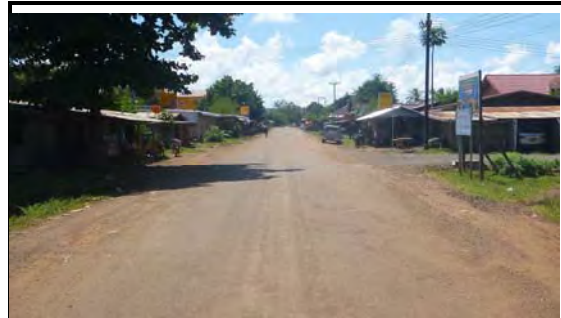
Photo No.	No.7_3	Span No.	1
Subject	Approach Road		
Memo	Relatively good condition

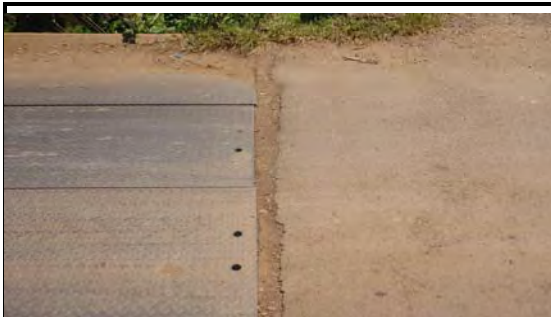
Photo No.	No.7-27	Span No.	1
Subject	Expansion Joint		
Memo	Minor Damage on the joint was found

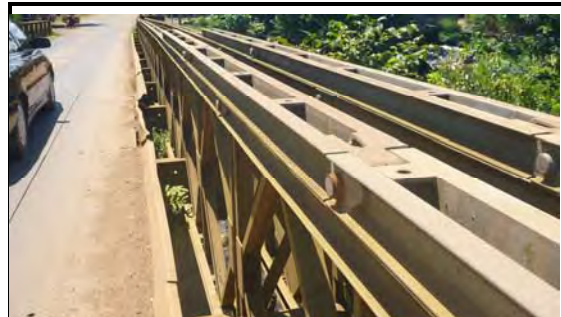
Photo No.	No.7-19	Span No.	1
Subject	Handrail		
Memo	No Significant Damage was found

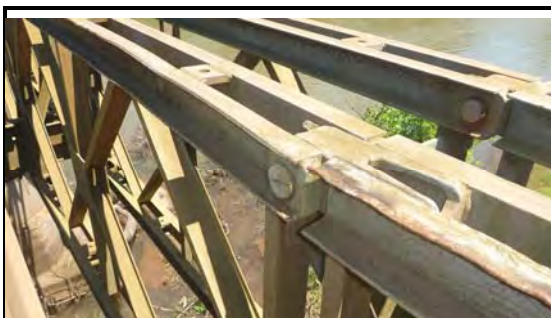
Photo No.	No.7-43	Span No.	1
Subject	Bridge Surface		
Memo	Minor Corrosion, Deformation and Damage

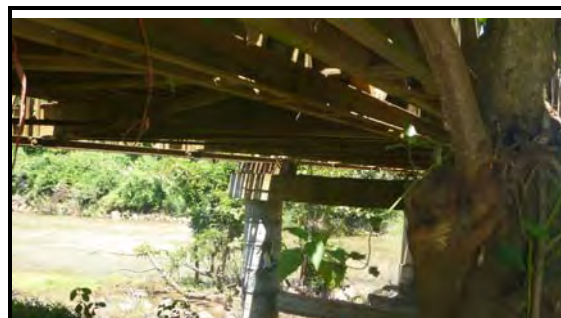
Photo No.	No.7-37	Span No.	1
Subject	Bridge Abutment		
Memo	Significant Corrosion occur under the bridge

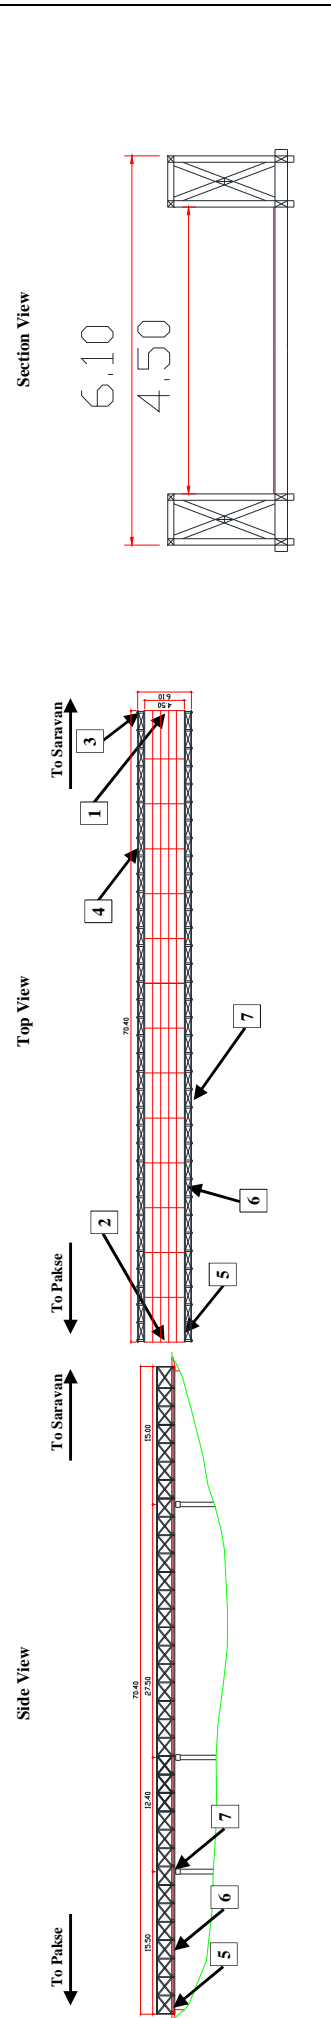
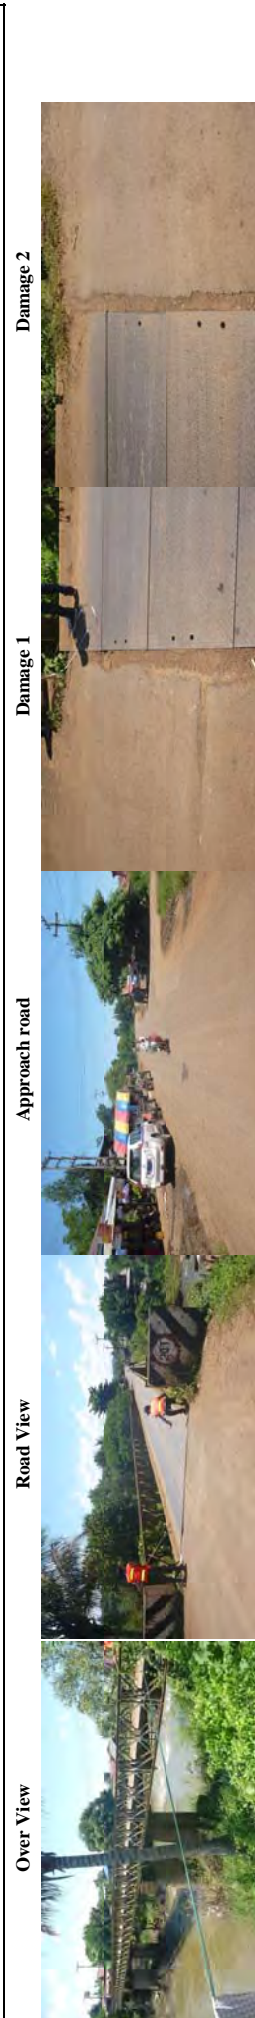
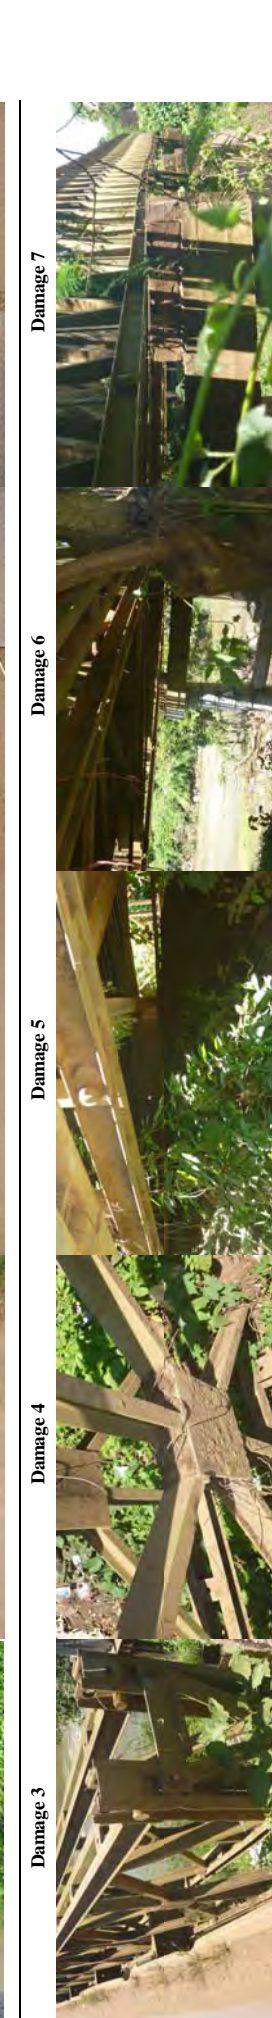
- Minor damage on Bridge Expansion Joint.
- Minor corrosion occur on Handrail.
- Large scale of corrosion was found under the bridge.
- Damage on steel bearing was found.

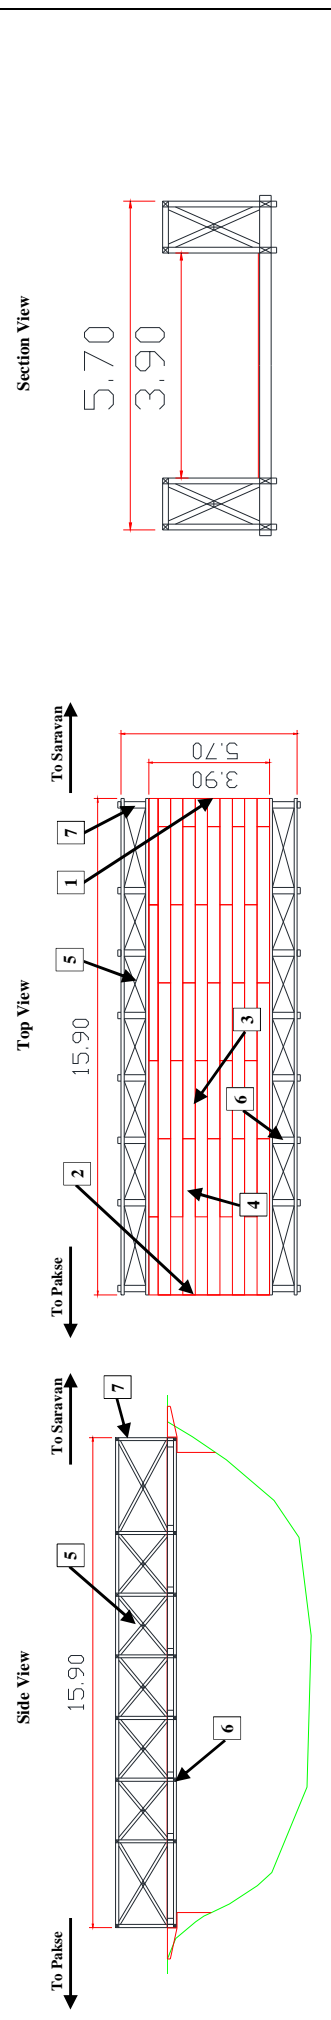
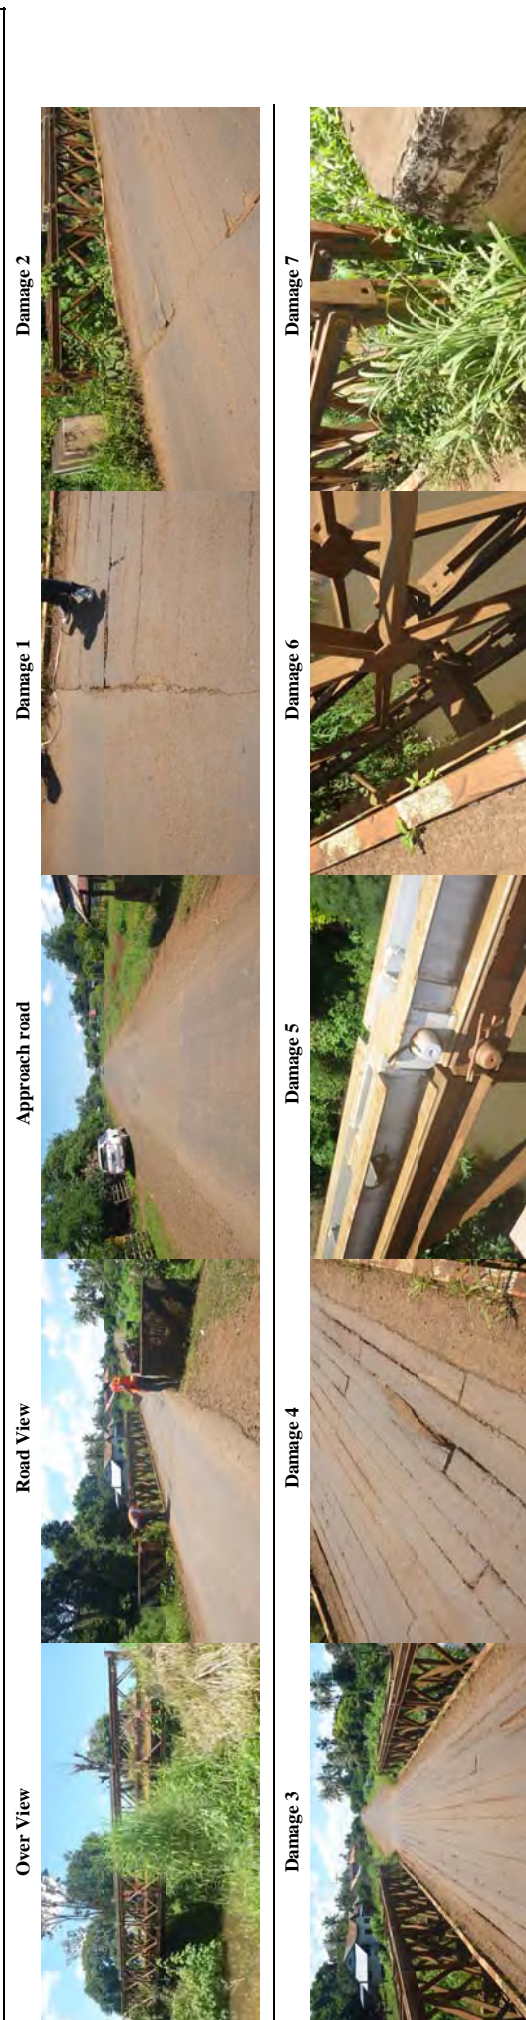
- Significant Damage on Expansion Joint
- Corrosion, deformation and damage occur on Handrail.
- Significant damage on bridge surface (Wood) which is recommended to be repalce as soon as possible for road safety.
- Damage on steel bearing was found.

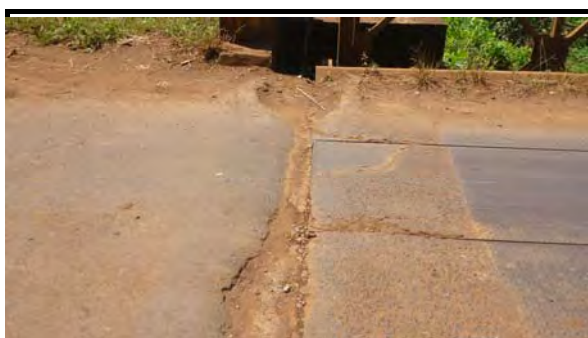
Photo No.	NO.9_3	Span No.	1
Subject	Expansion Joint		
Memo	Damage on the joint was found

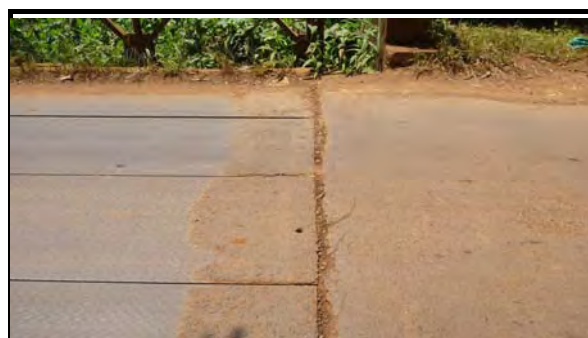
Photo No.	No.9_13	Span No.	1
Subject	Expansion Joint		
Memo	Damage on Expansion joint

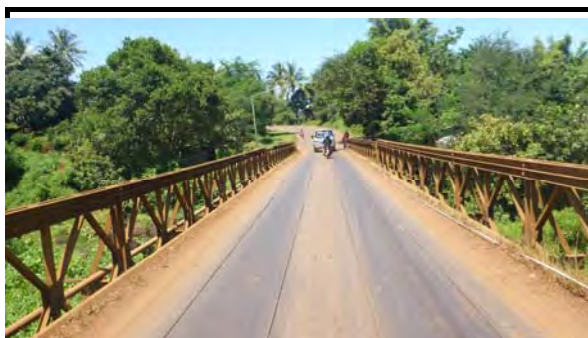
Photo No.	No.9_5	Span No.	1
Subject	Bridge surface		
Memo	Significant Damage on Bridge surface (Wood)

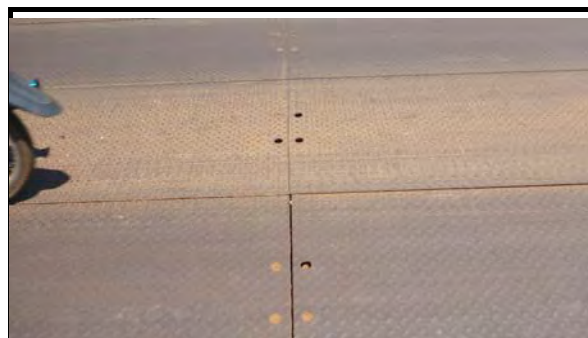
Photo No.	No.9_19	Span No.	1
Subject	Bridge surface		
Memo	Significant Damage on Bridge surface (Wood)

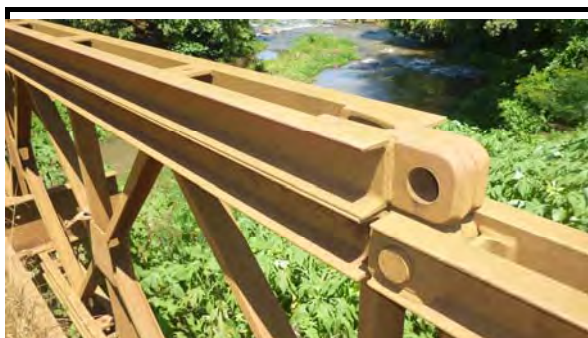
Photo No.	No.9_7	Span No.	1
Subject	Handrail (Structure)		
Memo	Minor Damage on Handrail (Structure)

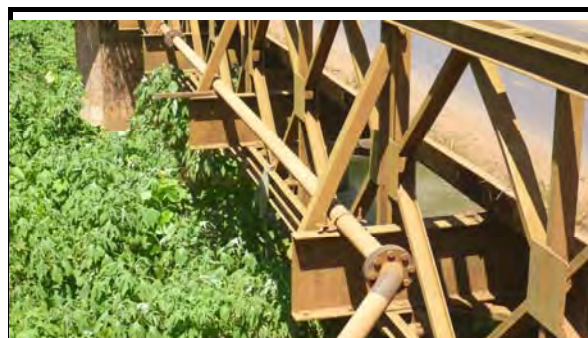
Photo No.	No.9_24	Span No.	2
Subject	Handrail (Structure)		
Memo	Minor Damage on Handrail (Structure)

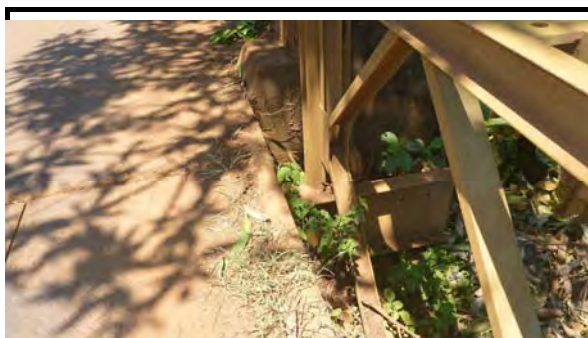
Photo No.	No.9_16	Span No.	2
Subject	Handrail (Structure)		
Memo	Minor Corrosion, Deformation and Damage

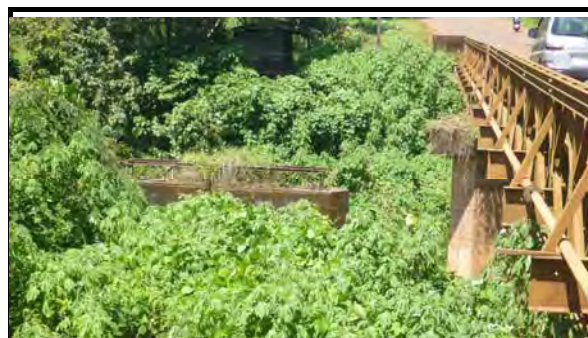
Photo No.	No.9_23	Span No.	2
Subject	Handrail (Structure)		
Memo	Significant Corrosion occur on Handrail

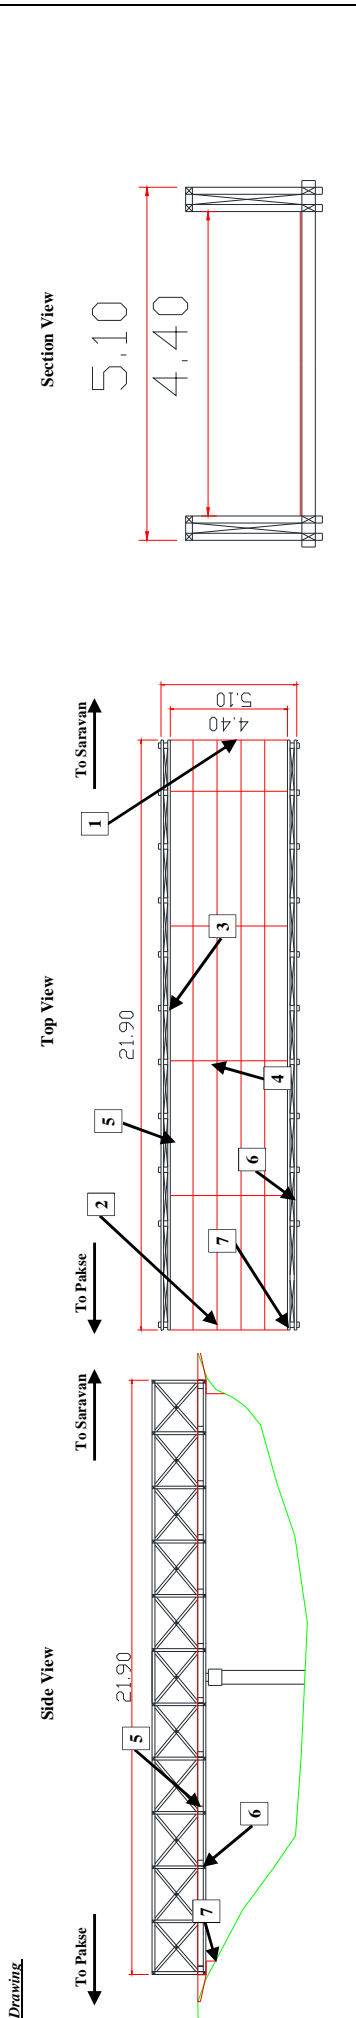
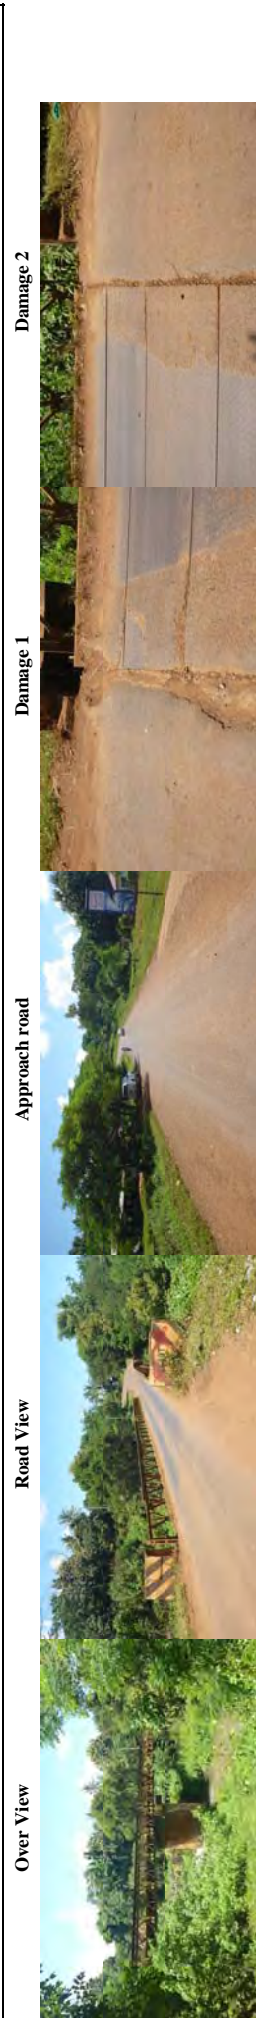
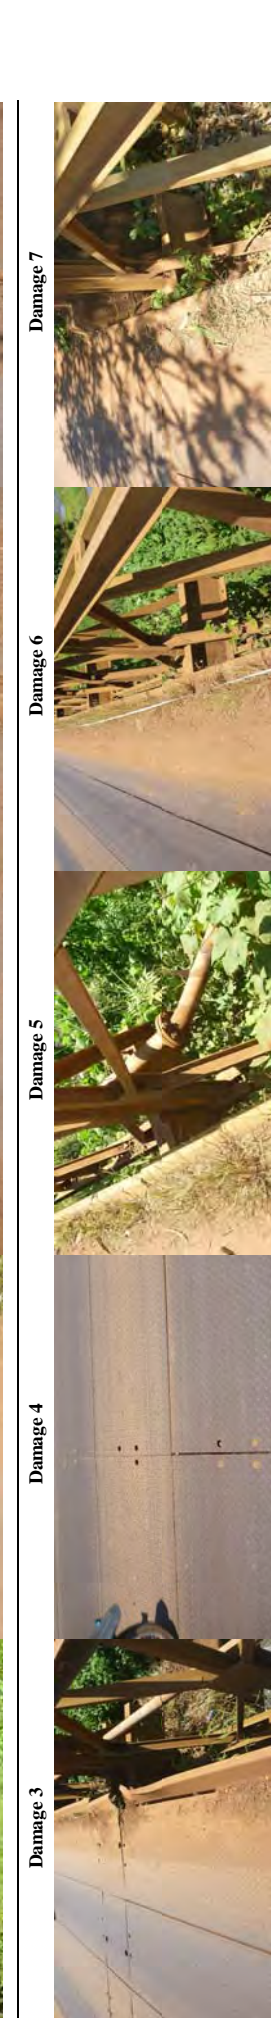
- Significant Damage on Expansion Joint.
- No significant damage was found on Handrail (Structure).
- No Significant damage was found on Bridge surface (Steel Plate).
- Lack of Load Capacity was estimated, replacement of the structure is recommended for permanent use.
