**Project Number: 48192**

Tonga: Cyclone Ian Recovery Project

Initial Environmental Examination – Disaster Relief Funding - School Reconstruction Projects

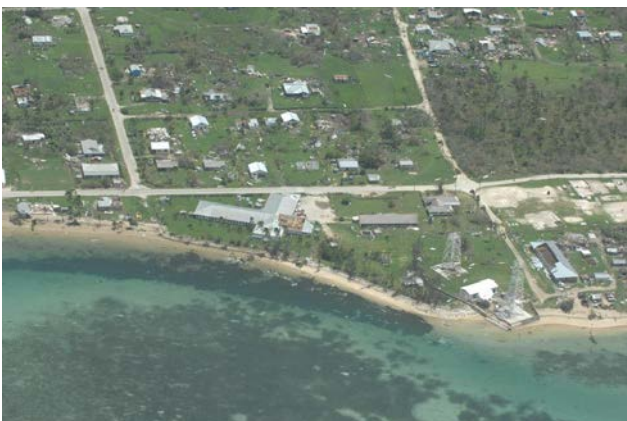
**Figure 1 Long Distance shot showing damage at Niu'ui Hospital post Tropical Cyclone Ian (Jan 2014) - Photographs courtesy of the New Zealand Air Force**

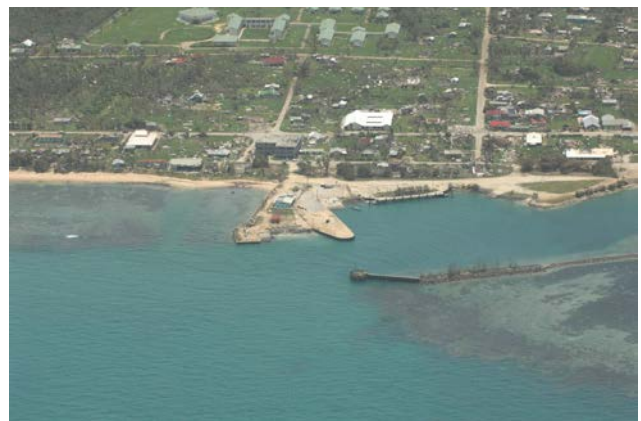
**Figure 2 Damage at Pangai Port post Tropical Cyclone Ian (Jan 2014) - Photographs courtesy of the New Zealand Air Force**

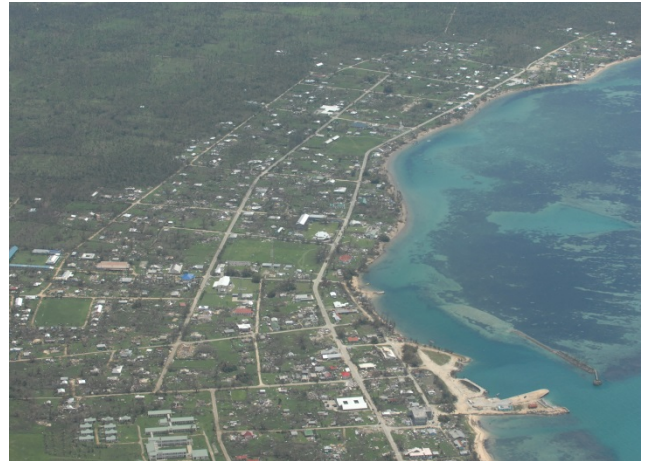
**Figure 4 Long Distance shot showing damage in Pangai post Tropical Cyclone Ian (Jan 2014) - Photographs courtesy of the New Zealand Air Force**

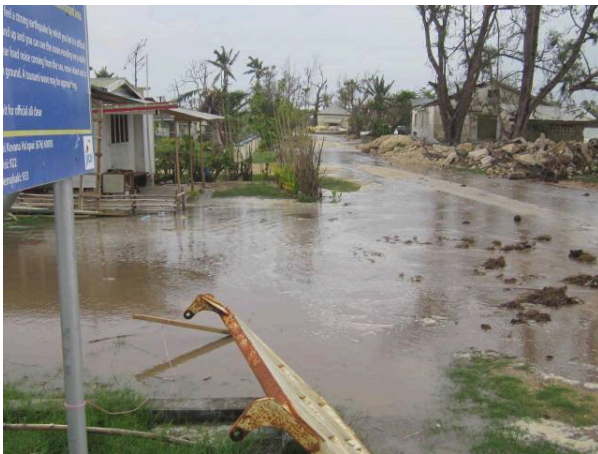
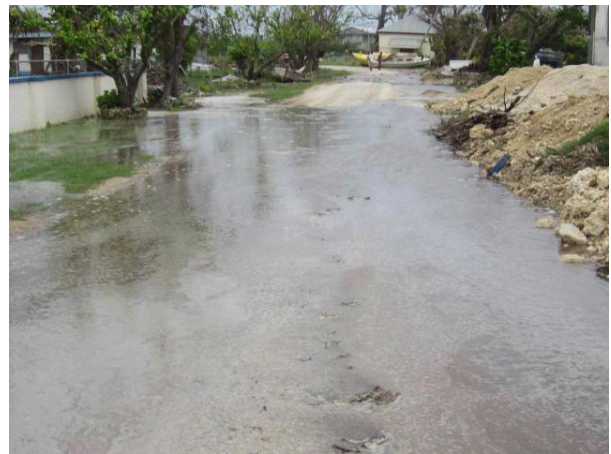
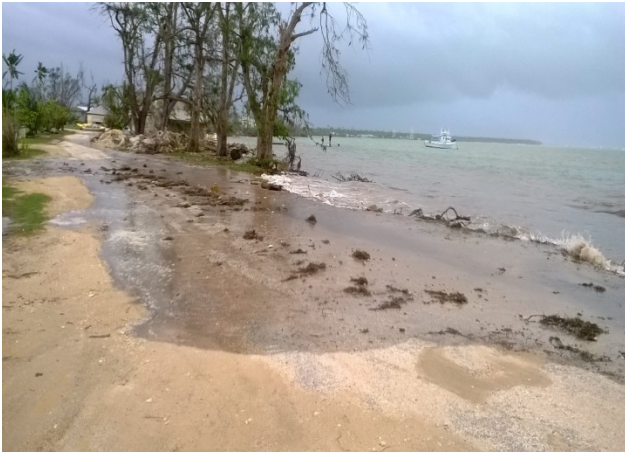
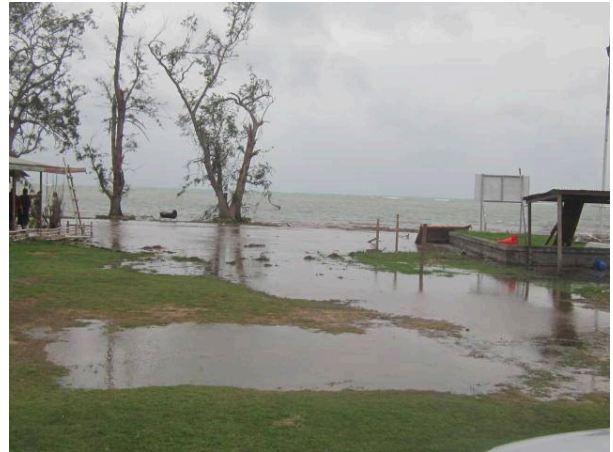
7. Category One Tropical Cyclone Kofi impacted the Kingdom of Tonga on 1 through 4 March 2014. Winds of up to 100km/h (54 knots) were experienced. A number of coastal land based impacts resulted from Tropical Cyclone Kofi. This included the impacts of flash flooding including sea flooding in the low lying areas, particularly during the extreme high tide on the evening of 2 March 2014. Anecdotal evidence from school staff in Pangai indicated that sea flooding/storm surge resulted in coastal roads and school properties being inundated and water remaining in school properties (School Principal, Catholic Church, St Joseph Community High School, April 2014).

**Figure 5 Storm Surge and Sea Flooding associated with Cyclone Kofi**

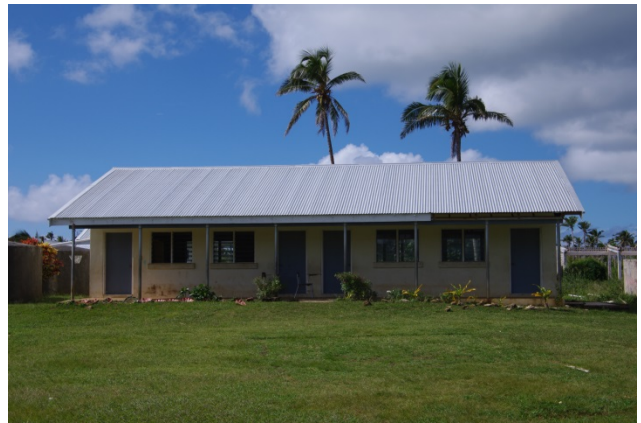
21. Prior to Tropical Cyclone Ian, Koulo GPS had three buildings designated for classrooms plus an additional building, the purpose of which was unknown. Two of the buildings, these being the main classrooms are a three classroom design, built with block bricks on a concrete slab (Figure 14). The newer classrooms were funded by and built consistent with Japanese standards in about 2012. The older classroom appears to be of a similar design; however there was no identification as to the funder, builder and/or year of construction.

**Figure 14 Koulo Government Primary School – newer Japanese Designed Classroom**

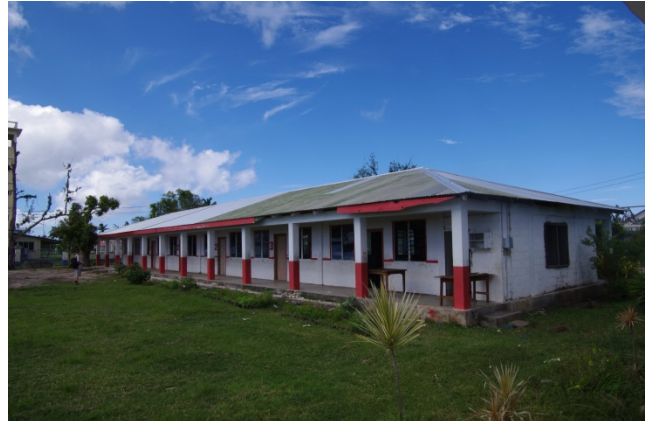
29. Prior to Tropical Cyclone Ian, Pangai GPS had three buildings designated for classrooms plus an additional building, which appears to have been an office along with two toilet blocks. Two of the buildings, these being the main classrooms are a six classroom design, built with block bricks on a concrete slab (Figure 20). These buildings were built pre 1974.

34. All classrooms show a minor to higher degree of structural damage in that the post and beams have significant cracks and corrosion. Previous attempts to patch the columns as an example; have been unsuccessful. The two main classrooms, based on a rapid assessment,

are structurally unsound particularly given its age. This leaves these buildings in an unstable condition with requires replacement immediately.

**Figure 20 Pangai Government Primary School – Main Classroom Building**

- 35. It is recommend that all existing structures left from the cyclone damages be demolished and the school be rebuilt consistent with earthquake and cyclone design. Based on conversations with Pangai GPS staff during a visit to Ha'apai High School, the would be pleased to retain dividing classrooms as it gave them flexibility with class sizes.
- 36. Considerations should also be given to the specific design and potential location of new buildings given Pangai GPS's location within the Coastal High Hazard Area based on the SOPAC modeling.

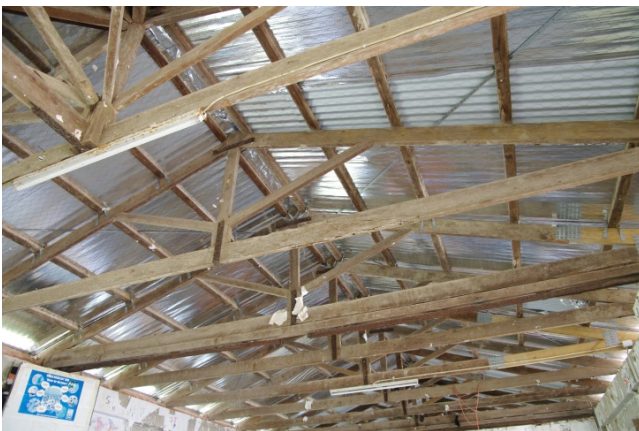
30. The first of these classrooms lost its roof during Tropical Cyclone Ian although this has been replaced with new sheeting. The roof trusses are currently exposed as the ceiling was also lost (Figure 21). The internal dividing doors are made up of movable partitions although the fixtures have rusted significantly overtime and were unmovable during the assessment. The internal and external walls of this building have suffered overtime with extensive concrete rot, corrosion and cracking.

**Figure 21 Pangai Government Primary School – Internal Roofing of Main Classroom Building**

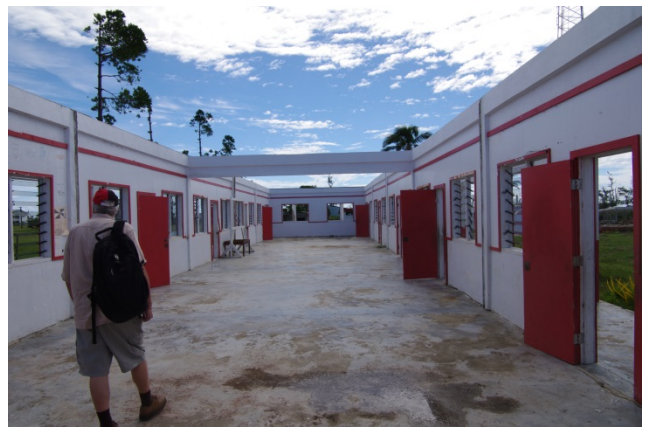
31. The second of these classrooms lost its roof and timber frame during Tropical Cyclone Ian (Figure 22). There are no longer any internal dividing walls and as with the other main classroom, the internal and external walls of this building have suffered overtime with extensive concrete rot, corrosion and cracking.

**Figure 22 Pangai Government Primary School – Second Classroom Block that has been totally destroyed**

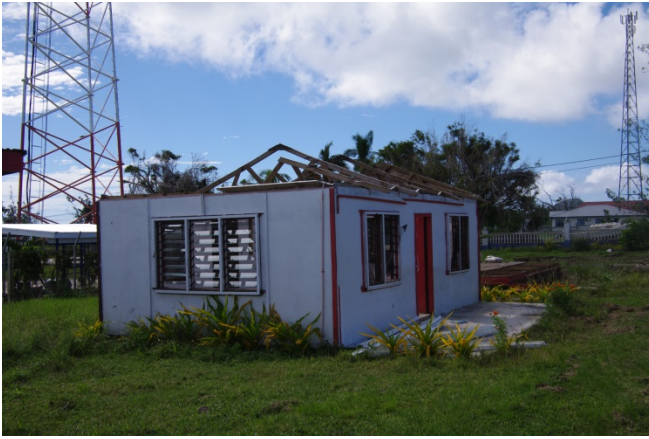
32. The school office library lost its roof and suffered extensive damage although the walls appear to have withstood the main force of the cyclone (Figure 23). A building adjacent to the school office was totally destroyed with the sub-frame being the only remaining component of the building (Figure 24). The footings of this building are unsound.

**Figure 23 School Office at Pangai Government Primary School**

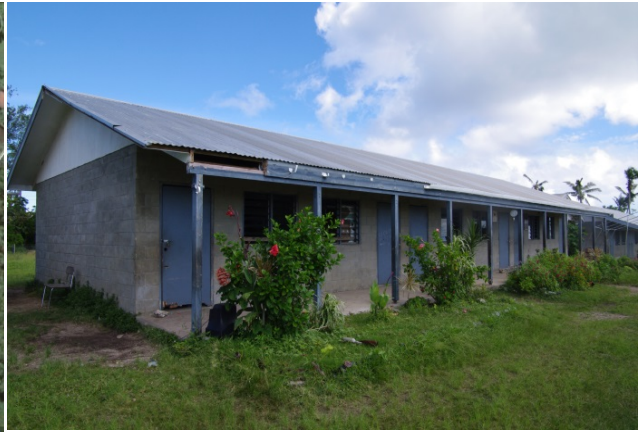
38. Tongoleleka GPS has two buildings designated for classrooms plus a toilet block between the two classroom blocks. The main classrooms are a three classroom design, built with block bricks on a concrete slab (Figure 26). The classrooms were funded by and built consistent with Japanese standards although there were no details of the year of construction.

**Figure 26: Tongoleleka Government Primary School - Japanese Designed Classroom**

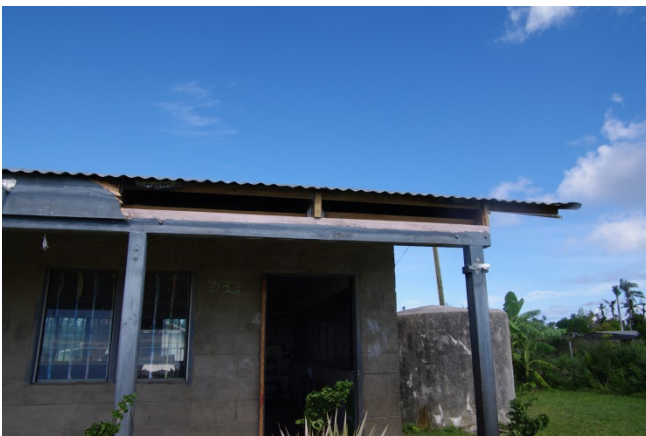
39. The two buildings are relatively undamaged and there appears to be no earthquake or cyclone structural weaknesses. The main damage to the two buildings was to the loss of fascia, gutters and about 50% of the eaves and ceilings have also been damaged (Figure 27). The roof has been repaired for any damage and lost sheeting that may have been sustained although there has been no work undertaken to the fascia and gutters. A number of louvers will also be lost and additional strapping is required to make the buildings cyclone proof.

**Figure 27 Tongoleleka Government Primary School – Lost fascia and guttering**

42. The proposed work at the school includes the replacement of gutters and fascia to the two main classrooms and toilets. The walls inside the classroom will also be painted with water proof paint to reduce the future impacts on intrusion. All debris should be removed from the school compound to a waste facility for recycling and reuse where possible. This work should provide safe schooling facilities for the 128 children that attend Tongoleleka GPS.

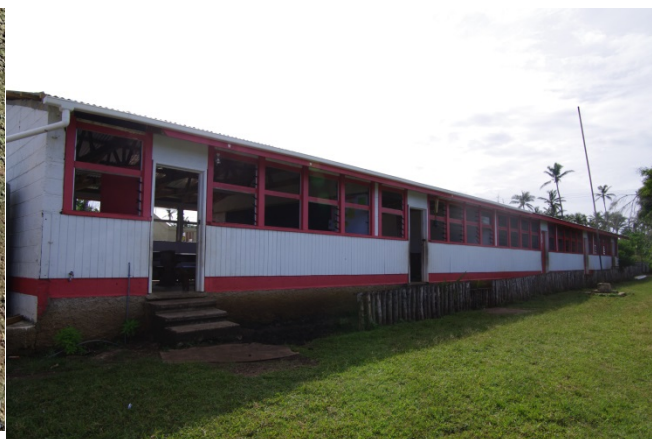
44. Faleloa GPS has one main classroom building with five classrooms (Figure 30) along with a separate classroom building that was destroyed by Tropical Cyclone Ian. There is a separate toilet block with 10 toilets. The school itself was built in about 1980 although an exact date was not available.
45. The main classroom is a wooden structure constructed on block bricks that have cracked significantly. A full engineering investigation is required; however conservatively, it is suggested that the classroom's resistance to earthquakes and cyclones is suspect. The roof was torn off by the cyclone due to a lack of strapping and insufficient fixings which resulted in the ceiling being destroyed with the roof trusses being exposed (Figure 31). Numerous window louvers were also missing. The guttering on the majority of the building is adequate

**Figure 30 Main Classroom at Faleloa Government Primary School**

49. Given the nature and extent of the damage; and in that, the existing five room classroom building is not earthquake and cyclone proof, it is recommended that the whole school be demolished and a new school be constructed on the site. There is significant land available that would allow for temporary repairs to the existing large classroom building while constructing new buildings adjacent to the current buildings that could accommodate all the students within either a single structure, or something similar to Koulo GPS.
50. The site will also need to be cleaned and all the cyclone debris removed. Where possible, recycling and reuse should occur. Any contaminated material should be taken to Tapuhia landfill in Nuku'alofa, Tongatapu.

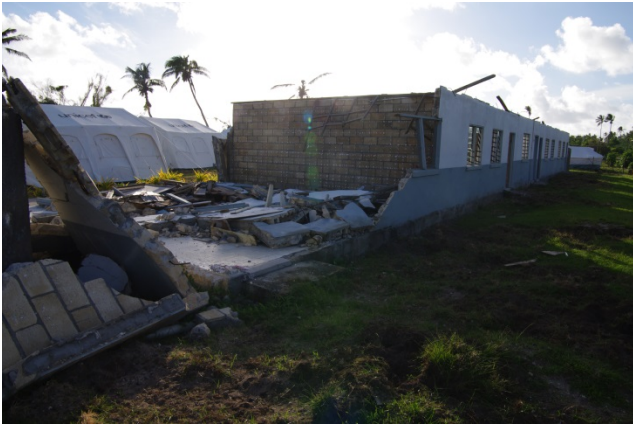
**Figure 43 Collapsed wall in the classroom block at Fakakai Government Primary School**

67. Prior to a final decision being reached on any proposed work, a risk assessment is required and consideration as to the merits of rebuilding the school in its current location. Further, the risk assessment should also investigate whether the school should be repaired or demolished and rebuilt. The Lifuka Hazard Mapping would suggest the school is located within the red zone. A quick evaluation of the area adjacent to Fakakai GPS suggested that alternative land maybe available without the need for any resettlement of local people.
68. It is recommended that in the short terms, the students from Fakakai GPS utilize the school facilities at Ha'ano GPS given the numbers of students currently attending that school and the facilities available (see Ha'ano Government Primary School).

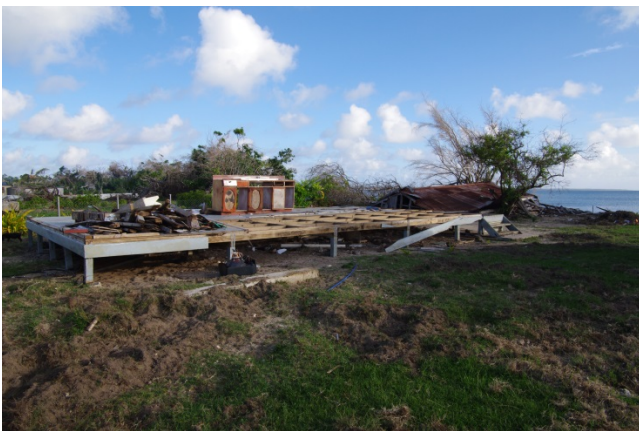
**Figure 45 Destroyed Residential Building at Fakakai Government Primary School**

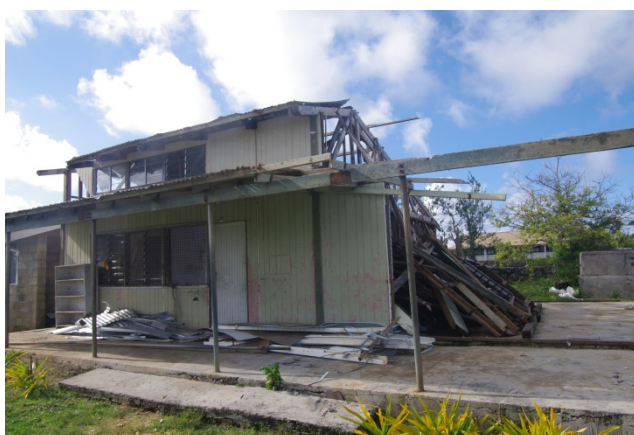
**Figure 52 Destroyed Building at Ha'ano Government Primary School**

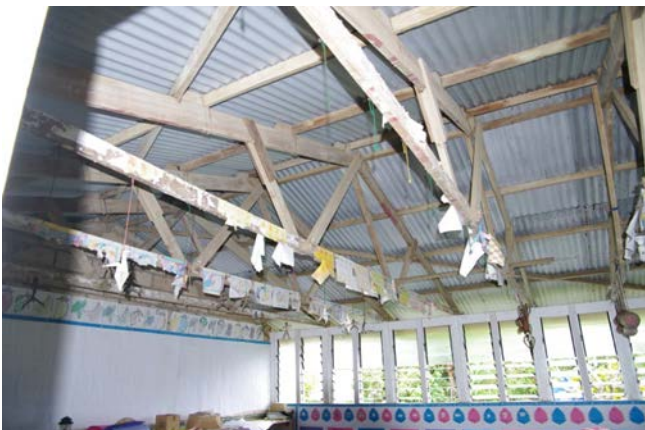
**Figure 56 Recycled Roofing Iron with holes at Lofanga Government Primary School**

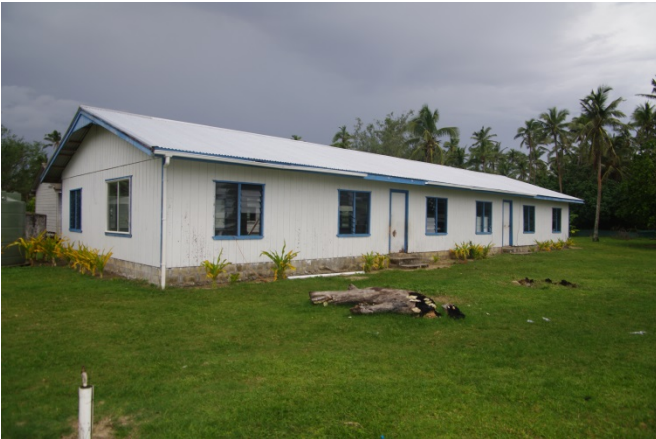
88. The main classroom building is a Japan standard three-classroom block with no evidence of any structural issues (Figure 60). It would appear given carvings in one of the toilets that the buildings were constructed in about 1985. During Tropical Cyclone Ian, the roof sheets were damaged and as a result of the loss of the roof (which has already been repaired), the ceiling in all three classrooms suffered damage and has been removed, leaving exposed roof trusses both inside and outside the classrooms. Some of the guttering were also damaged. Some louvers were missing and water has entered the classrooms through both the roof and windows causing minor damages to furniture.

**Figure 60 Main Classroom Block at Mata'aho Government Primary School**

92. Repairs will be undertaken on the main existing classroom block and the classroom/hall/library. This will include the repairs to the ceiling and guttering. Further, strapping will be undertaken to better secure the roof. This will result in the building being in good working order.
93. The third building will be demolished and removed from the site. The asbestos roof will be removed by trained professionals and transported to the special cell within Tapuhia landfill in Nuku'alofa, Tongatapu. All other debris will be removed off site.

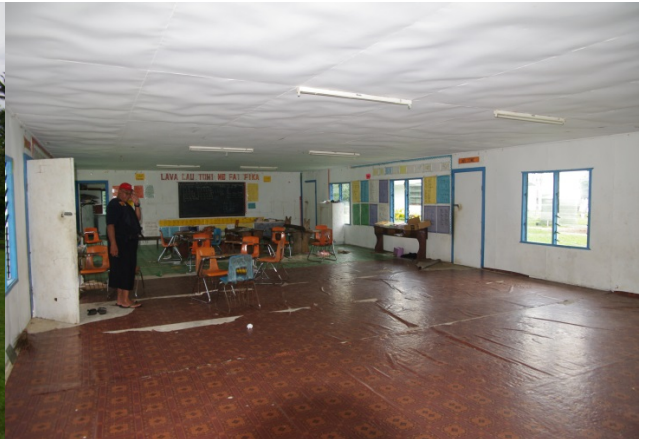
89. A second building acts as a classroom/hall and has a library at the southern end (Figure 61 and Figure 62). This building suffered minor damage and requires roof frame strapping, gutter replacement and minor fascia repairs.

**Figure 61 Second Classroom/Hall/Library Building at Mata'aho Government Primary School**

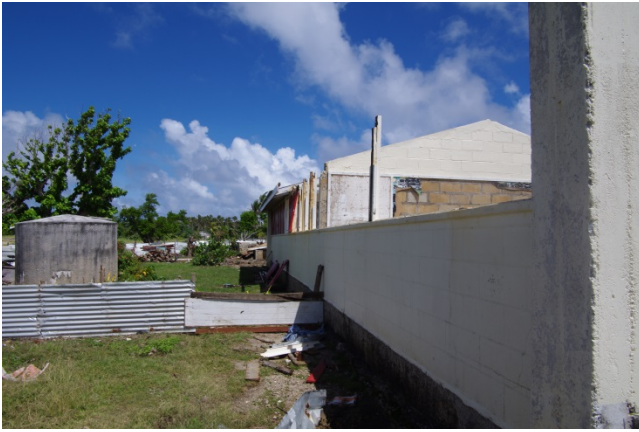
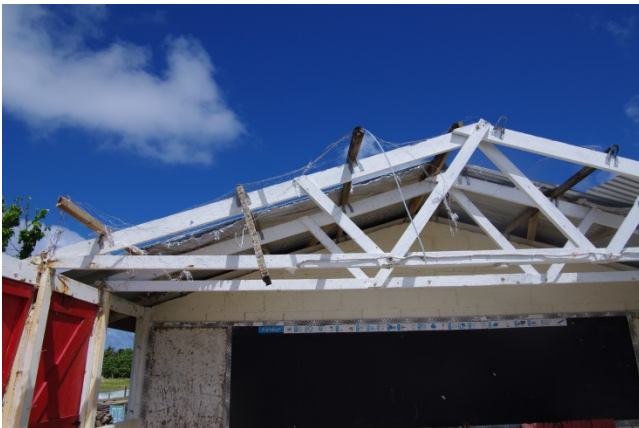
95. Mo'unga'one GPS consisted of a three classroom building; one residential building and a toilet block.
96. The school suffered significant damage as a result of Tropical Cyclone Ian (Figure 66, Figure 67 and Figure 68). The classrooms were constructed with concrete block walls. A section of the walls collapsed as a result of Tropical Cyclone Ian which suggests that the structural stability and quality of the construction should be evaluated prior to any repairs being carried out. It was noted that the building was missing reinforcing ties and poor concrete infill. The northern half of the classroom block lost its roof and structural trusses during the cyclone (Figure 69 and Figure 70). Most of the doors and wooden shutters are missing/damaged. The southern end of the classroom building appears to have withstood the main impacts of Tropical Cyclone Ian; however the rest of the building is unsafe. This area is used as both an office and for the second teacher's accommodation.

**Figure 66 Destroyed Classroom Building at Mo'unga'one Government Primary School**

**Figure 68 Destroyed Classroom Building at Mo'unga'one Government Primary School**

100. Given the damage sustained to the existing building and that is considered unsafe, the school will be demolished and replaced with a new school building to cater for the small number of students that attend the school.
101. The site will also need to be cleaned and all the cyclone debris removed. Where possible, recycling and reuse should occur. Any contaminated material should be taken to Tapuhia landfill in Nuku'alofa, Tongatapu.

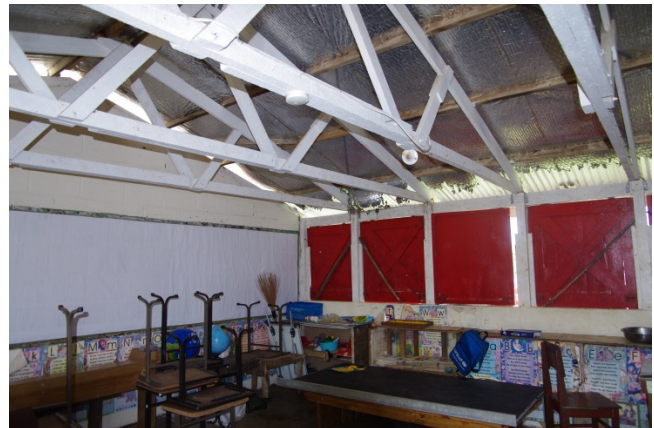
**Figure 69 Destroyed Classroom Building at Mo'unga'one Government Primary School**

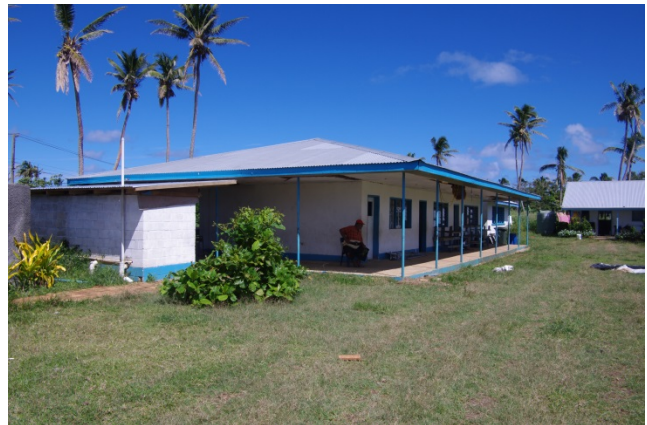
112. The first building contains three classrooms and an office. This building is constructed of rendered block work on a concrete slab (Figure 78). The roof has been replaced on this building although the gutters were also lost but are yet to be replaced. There are numerous window frames and louvers missing in the classrooms which require replacing (Figure 79). Overall the building itself is in good condition.

**Figure 79 Damaged windows in the Primary Classroom Block at Ofamo’oni Primary and Secondary School**

116. The proposed work includes the replacement of the ceiling in the second classroom block and the replacement of gutters, window frames and louvers in all three buildings. Further, strapping will be undertaken to better secure the roof. This will result in the building being in good working order.

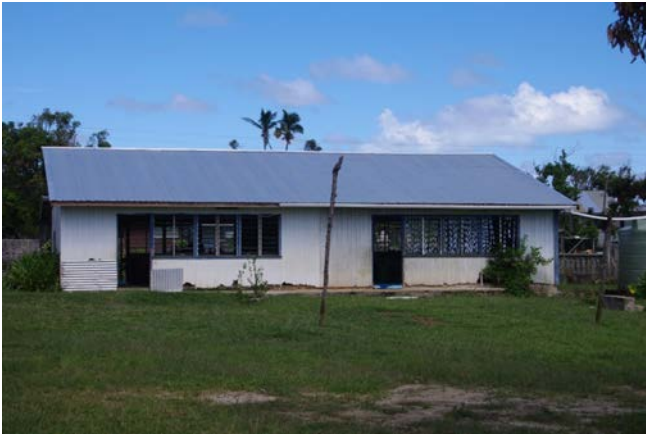
119. The first classroom block is an older building containing two large classrooms. This building is constructed of wood with steal posts on a concrete slab (Figure 84). The building is in a dilapidated state with the wood cladding exhibiting rot and near the end of its life. The roof trusses are wooden with some strapping. The fascia has been damaged and the gutters were torn off by Tropical Cyclone Ian (Figure 85 and Figure 86). The roof has been replaced although there is no ceiling within the two classrooms (Figure 87). There are numerous window frames and louvers missing in the classrooms which require replacing. Overall the building itself is in poor condition.

**Figure 84 Main Classroom Building at Petani Bilingual Free Wesley Church School**

122. Repair work is currently underway following Tropical Cyclone Ian. The main repair work is in the form of maintenance including but not limited to the repair of the wooden cladding on the older building as well as the replacement of gutters on both buildings.

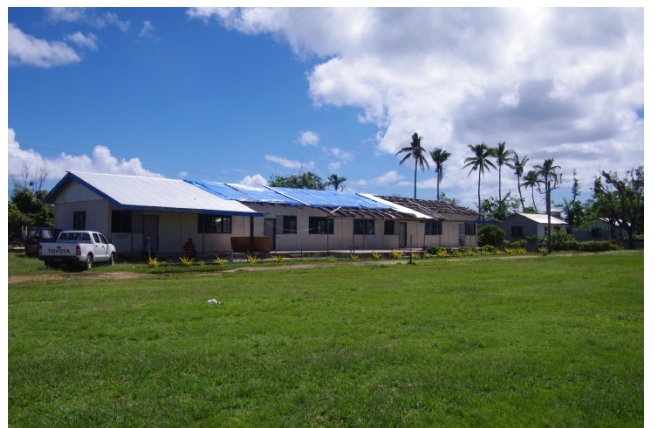
**Figure 105** Destroyed Canteen at the Girl’s Dormitory at Taufa’ahau Pilolevu Free Wesley Church School

158. During the April 2014 mission, work had already commenced at the school itself to install replacement guttering and louvers. The Free Wesley Church appears to have this under control and the majority of the repairs have been commenced. However rebuilding is required particularly in relation to the girl's canteen and the boy's dormitory and associated infrastructure. Specifically with respect to the boy's dormitory, this will require the relocation of the students during the construction period and therefore alternative accommodation will be required.
159. Based on discussions with the Principal, it is unlikely that Building Five will be rebuilt as it is not an essential component of the School.
