# Environmental Monitoring Report

Semi-Annual Report (January-June 2016)  
October 2016

## MYA: Maubin-Phyapon Road Rehabilitation Project

## **SEMI-ANNUAL REPORT NO. 1**

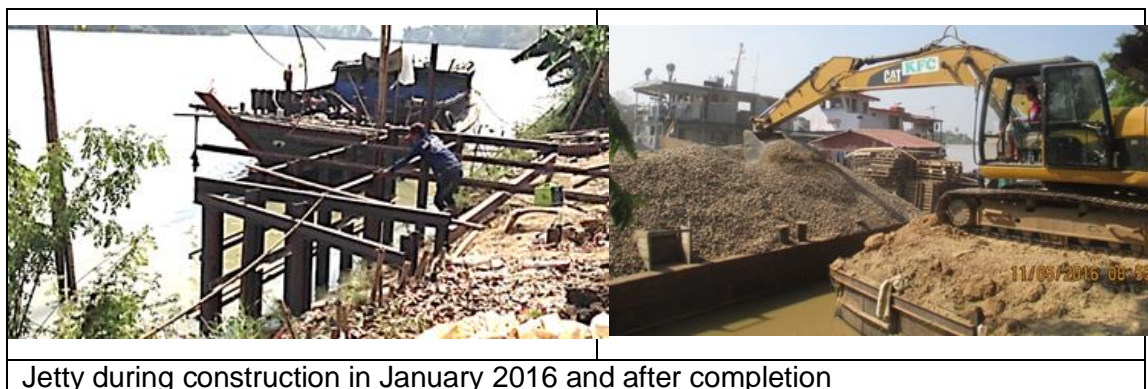
Jetty during construction in January 2016 and after completion

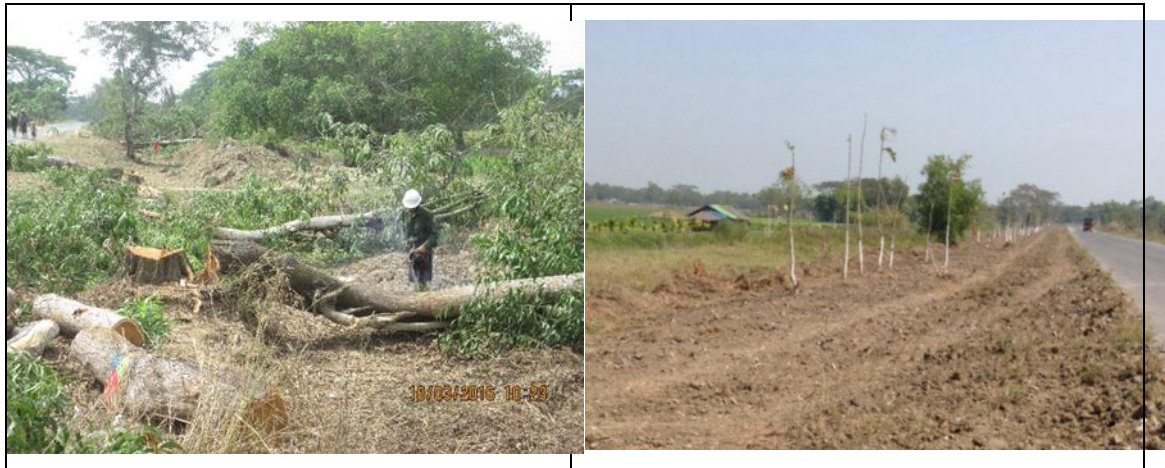
Figure 3. Clearing of ROW, ICB-1

As of June 2016, 33 Teak trees and 116 other tree species have been removed. Removal of the remaining trees will take place during the succeeding period. The removal of trees and clearing of ROW in particular section of ICB-1 is shown in the following figure.

The cutting of tree has been granted permission (see Attachment 1) and disposal of wood from cut trees is managed by the Forestry Department. There are no EMP concerns noted in this activity during the reporting period.

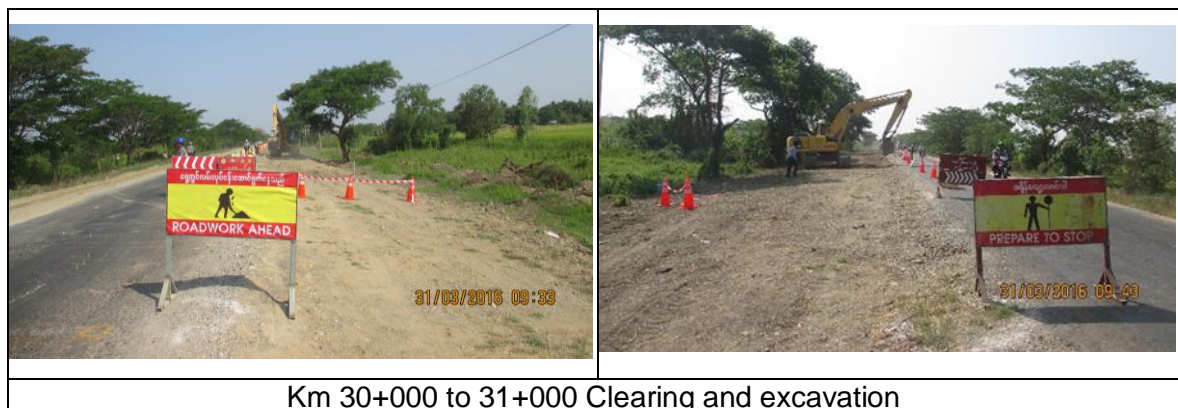
Excavation of the widening section from Km30+00 to 31+00 and lime stabilization was likewise carried out during this period. The following photographs in Figure 10 show clearing of a section of the ROW of ICB-2 during this reporting period.

Km 30+000 to 31+000 Clearing and excavation

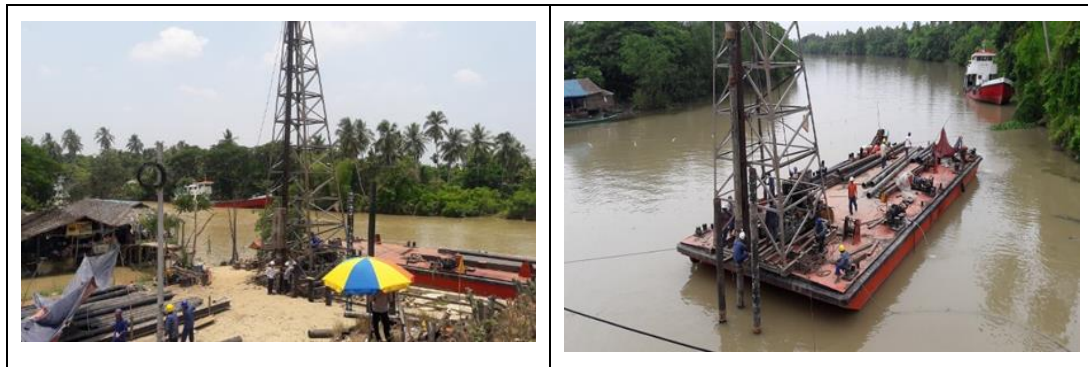
The construction of Oo Yin Chaung Bridge has commenced with the construction of the temporary bridge before the existing steel bridge is removed. The piers of the temporary bridge have now been installed.

Figure 11. Installation of the piers on the river bank and in-the-water for the temporary Oo Yin Chaung Bridge

The approach of Oo Yin Bridge is a village transport hub that connects the river transport with the road transport. River boats ply the Pyapon River and tributaries and dock at Oo Yin Bridge where passengers catch bus rides. The gathering of passengers (small number though) and the picking of passengers by buses at the bridge approach creates a public safety concern now that construction work is on-going. The boat station along the eastern bank of Pyapon River within the construction site has been temporarily relocated immediately downstream of the bridge. But the passengers still wait for the bus at the approach of the bridge. The Contractor needs to consult the village people for the designation of a temporary bus stop safely away from the construction site. Additionally, now that the piers have been installed at the middle of the river, the other concern is navigation safety. For this purpose, the Contractor has set up signages to warn boaters.
