PAKISTAN: New Bong Escape Hydropower Project Laraib Energy Limited Environmental and Social Issues Compliance Report (January 2014 to March 2014)

New Bong Escape Hydroelectric Power Project

Environmental and Social Issues Compliance Report

Jan 01, 2014 – Mar 31, 2014

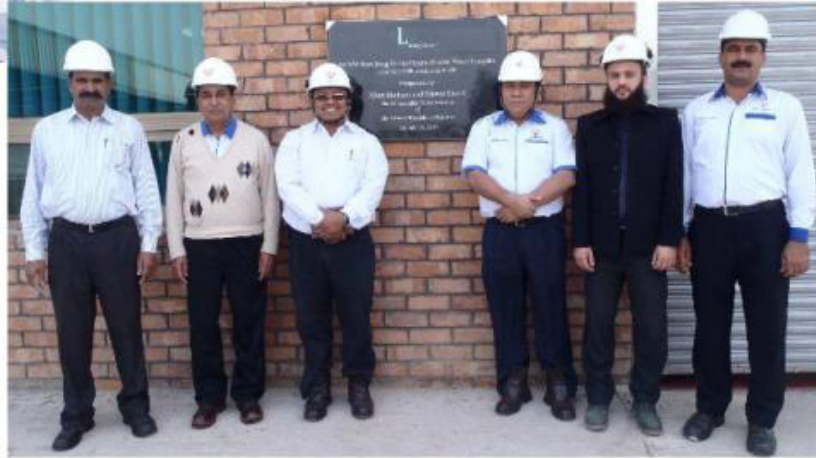
Management Safety Walkabout

In March, HSE walkabout was conducted by Head of Operations (Acting PGM) on 20th March. The report of all observations during the walkabouts was prepared by Head of Operations and communicated to all relevant staff.

They were all requested to take necessary remedial actions as advised in the report and revert back with the updated status through HSE department.
