Draft Environment and Social Compliance Audit – Part 2

GEO: Adjaristsqali Hydropower Project

Prepared by Mott MacDonald for Adjaristsqali Georgia LLC

Environmental and Social Compliance - Verification Audit

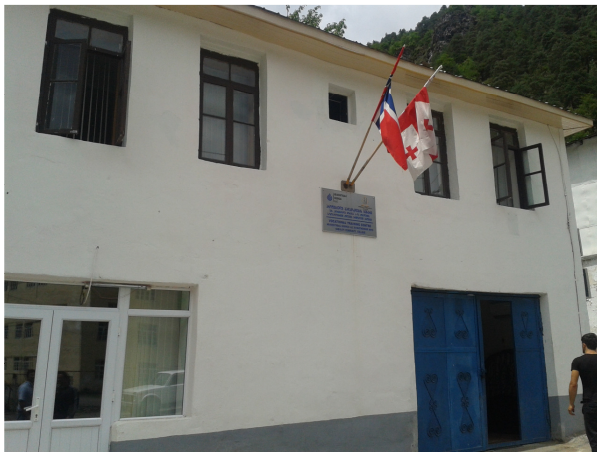
Photo A.3: Outside of the training centre in Shuakhevi Photo A.4: Desks, signage and PPE at the training centre in Shuakhevi
