Environmental Monitoring Report

Project No. 42122-013 and 42122-016
Biannual Report
August 2017

Loan 2761 & Loan 3256-BAN(COL): Third Primary Education Development Project and Third Primary Education Development Project- Additional Financing

REPORT ON ENVIRONMENTAL SCREENING AND MONITORING OF
WATER SOURCES AND WASH BLOCKS INSTALLED AND HANDED
OVER TO PRIMARY SCHOOLS FROM (JANUARY 2017 TO JUNE 2017)

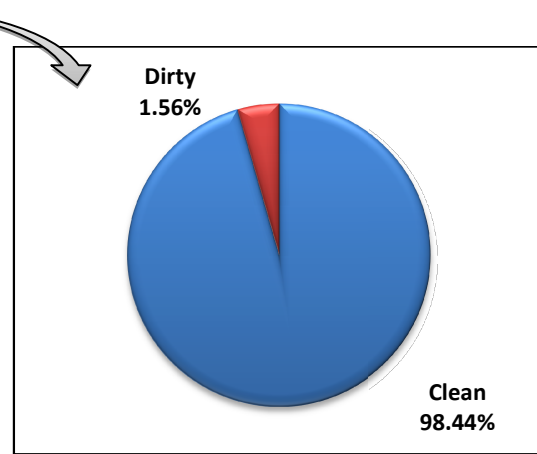
Figure 8: Impact after Implementation

All the divisions have more or less minor environmental concerns. However, they were taken into consideration and mitigation measures were suggested during implementation and monitoring phase. Figure-7 & 8 shows that, because of taking mitigation measures during

It has been revealed that even after several caretakers' training, monitoring and routine maintenance, 1.56% of the water points sites were found unclean/dirty. However, the overall situation improves from the previous three of four submitted environmental reports (6%, 4% & 1.7% in the earlier reports) produced but close to the last report (1.45%).

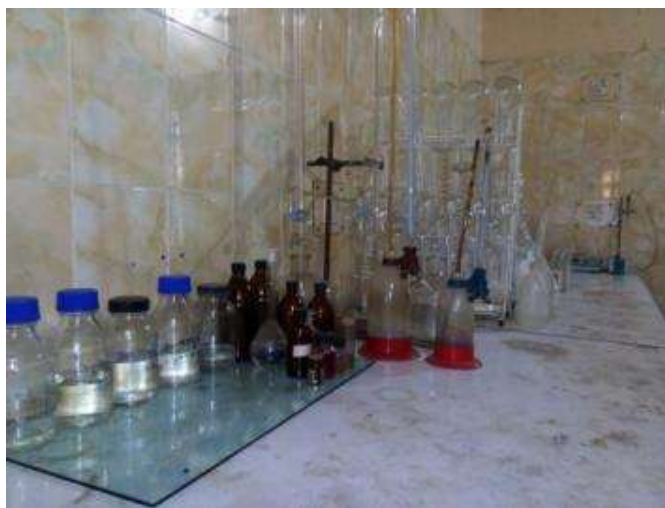
Figure 9: DPHE Zonal Laboratory setup for water testing

None of the said 92 newly installed water points by DPHE under PEDP-3 have any concern about water quality i.e., the arsenic, iron and chloride content were found below 50ppb, 10mg/l and 600mg/l (1000 mg/l in coastal belt) respectively. Tests were conducted in those schools during post monitoring phase by DPHE and third party appointed by DPE. The reports were found in the very closer range to the reports of DPHE laboratory test.

After installation of new water point in the said 4,034 schools, laboratory tests were conducted to identify potential hazards of Arsenic, Iron and Chloride in water. The tests were done by the laboratory circle of DPHE and the reports are stored in the DPHE MIS database. [Copy of sample report is provided in Annex D of this report]. Figure below shows laboratory testing facilities of DPHE.

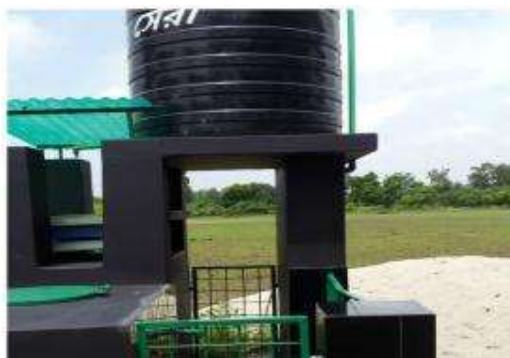
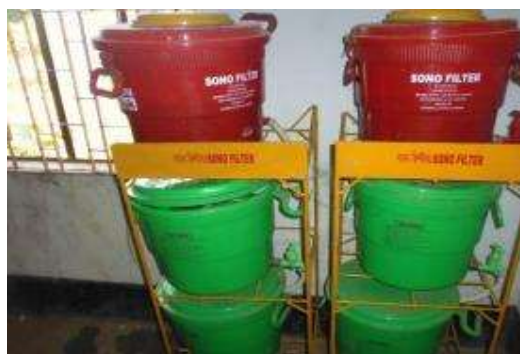
Figure 11: AIRP & Sono Filter

In some cases all the options in hand fails, i.e., boring in greater depth becomes impossible, arsenic is found even in deep tube well and none other option is feasible, DPHE started implementing 'SONO Filter' As piloting DPHE implemented these options in the affected schools of Sylhet & Sunamganj district and AIRP in Meherpur, Chuadanga, Kushtia and Netrokona district. Figure of which is shown below.

In cases where arsenic/iron/chloride is found beyond allowable limit in installed water source, DPHE adopts other approved alternate water options DPHE goes for options like deep tube well of greater depth, ring well, pond sand filter, rain water harvesting, AIRP etc. whichever is feasible.

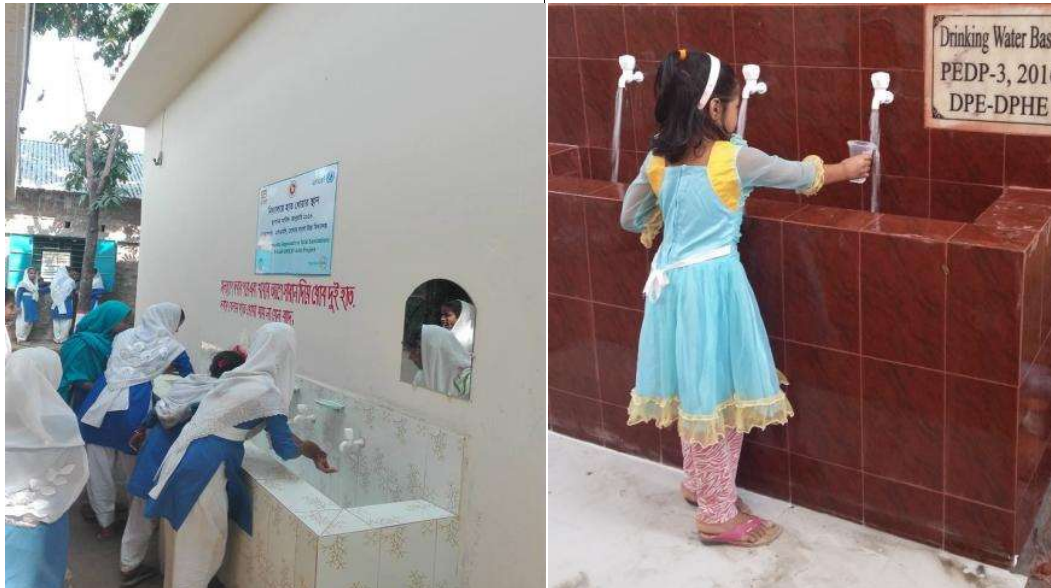
Figure 18: Multiple user Hand Washing System

It was found during the monitoring phase that, even after providing hand washing facility, out of 42 handed over wash blocks, 4.76% (2 nos.) are out of operation. The major reason is theft of tap, submersible pumps etc.

DPHE ran extensive awareness program to the schools through its officers and staff. Moreover, during monthly and quarterly meeting officers from DPEO and UEO were informed about the scenario. During the post monitoring stage, it was found that, of the 4.76% wash blocks where hand washing facility was poor, improves and percentage drops down to 0% after mitigation measures taken from DPHE. It has to be kept in mind that, running water supply should be kept uninterrupted in order to continue the facility of hand washing.

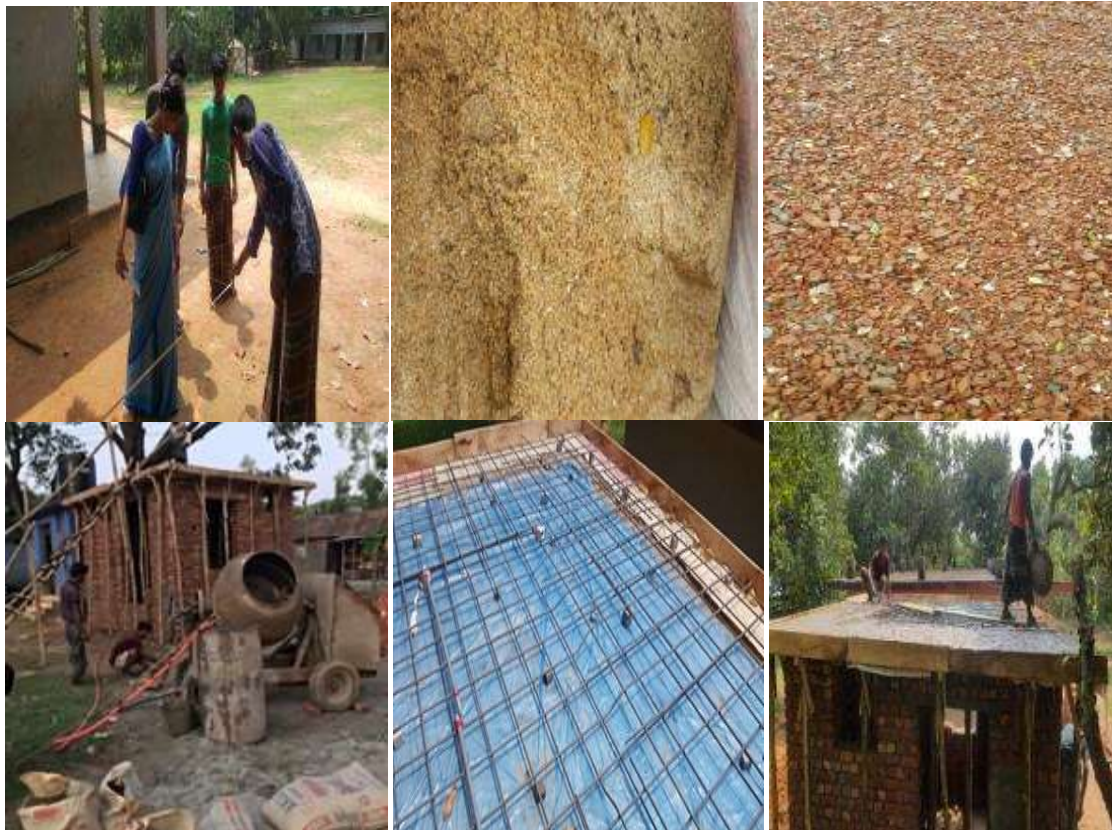
Figure- 19: Construction Supervision From Lay Out to Roof Casting of Wash Block.

based on approved layout plan and structural design without hampering the environmental and social safeguards. Figure-20 depicts the visit of DPHE's Engineer to a primary school from layout to roof casting including checking of major construction materials, checking of rebar binding and shuttering prior roof casting work.

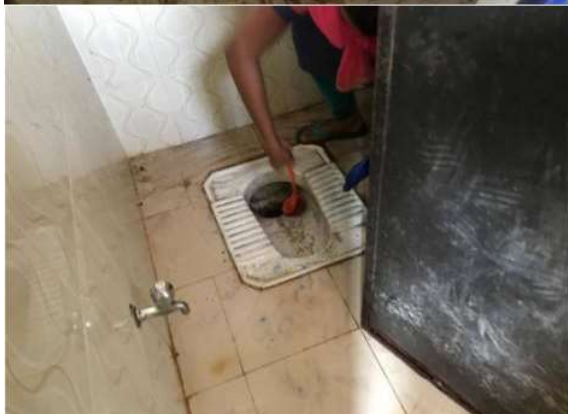
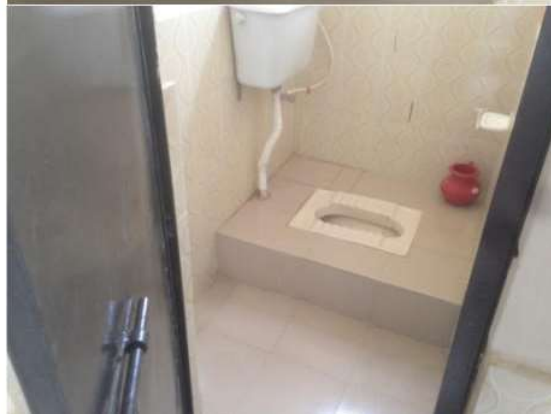
The post monitoring visit on June, 2017 by SAE of Kamalganj Upazilla shows that the school is following the maintenance scheme properly.
