# **PNG: Highlands Region Road Improvement Investment Program (Project 2)**

## **Mendi to Tambul Road Sub-project**

### **ENVIRONMENTAL SAFEGUARDS MONITORING REPORT No.1**

**(January to June, 2016)**

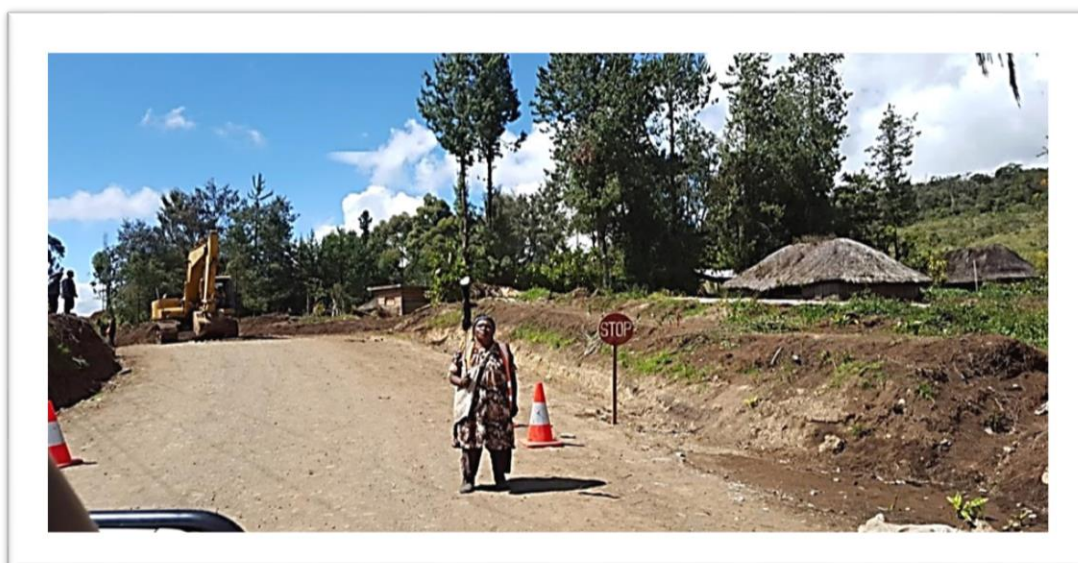
59. The contractor had prepared and implemented a traffic management plan. The local community members were employed (see photo 8) to hold “GO” and “STOP” signs throughout construction period. The traffic management was in order where there were no major issues or accidents reported during the review period. Moreover, sign posts to the approach of the camp, quarry sites other risk sites were established by the contractor.

**Photo 8 Mrs Sony Kil employed as a Traffic Warden at Malke, Tambul**
