Targeted Environmental Assessment Temporary Sewage Treatment System Caracol Industrial Park (PIC) Northern Haiti

Submitted: January , 2014

**PARC INDUSTRIEL
DE CARACOL**

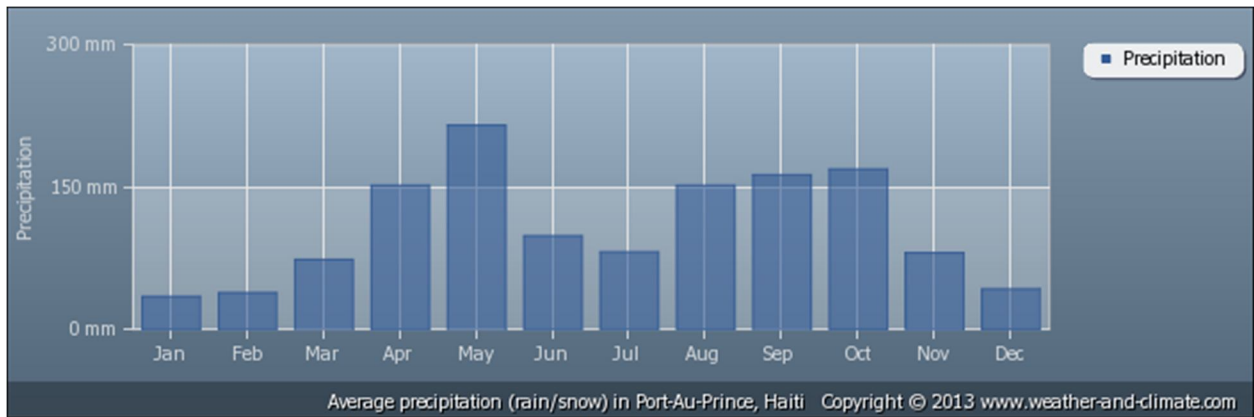
The flooding potential at this site is unknown. The two existing flood risk studies reviewed have conflicting conclusions. The Consultants are aware of another study that is being undertaken by the IDB however the findings will not be ready before June of 2014. How the system will behave during periods of heavy rainfall is unknown. The period November to March is usually a dry period in this part of the Caribbean with January and February having the lowest rainfall, however if the new permanent treatment system is not ready by March, 2014, one of the wet seasons begins in April and extends into June and the start of the hurricane season.

The performance of the system in such conditions is highly uncertain. This compounded by the signs onsite of restricted percolation in the immediate vicinity of infiltration pond for WWTP#1 and WWTP#2. The consultants therefore recommend the application of caution in the use of the system. The established cap of 150 m³ for the WWTP#2 should therefore not be exceeded as the plant as designed is already at its maximum capacity at the drainage field.

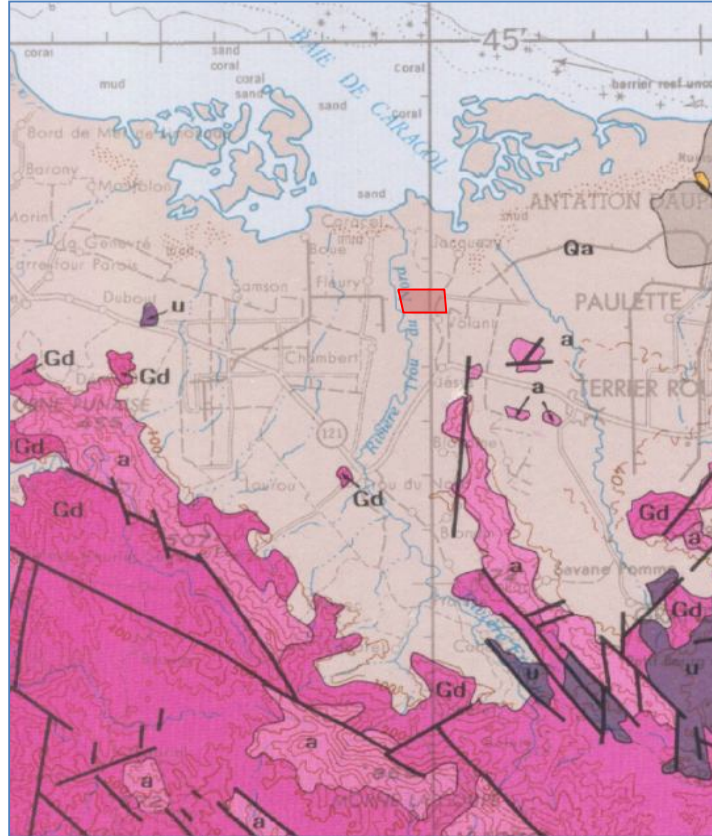
Figure 2 - Geology Map Showing Location of PIC (Red Polygon)

The geology at the site is largely Quaternary Alluvium deposits from the Riviere Trou du Nord whose headwaters originates in the Cretaceous granodiorite massifs to the south. The geological map in Figure 2 shows the existing geology with the approximate site location. Alluvium consists of typically, gravels, sands, silty sands, clays and organic matter.

The on-site tests suggest that the upper 3m of the alluvium at the PIC consists of alternating layers of sandy clay loam, silty sand to gravelly silty clay with zones of high plastic clay between 1-2m below ground. This variability is typical of alluvial systems.

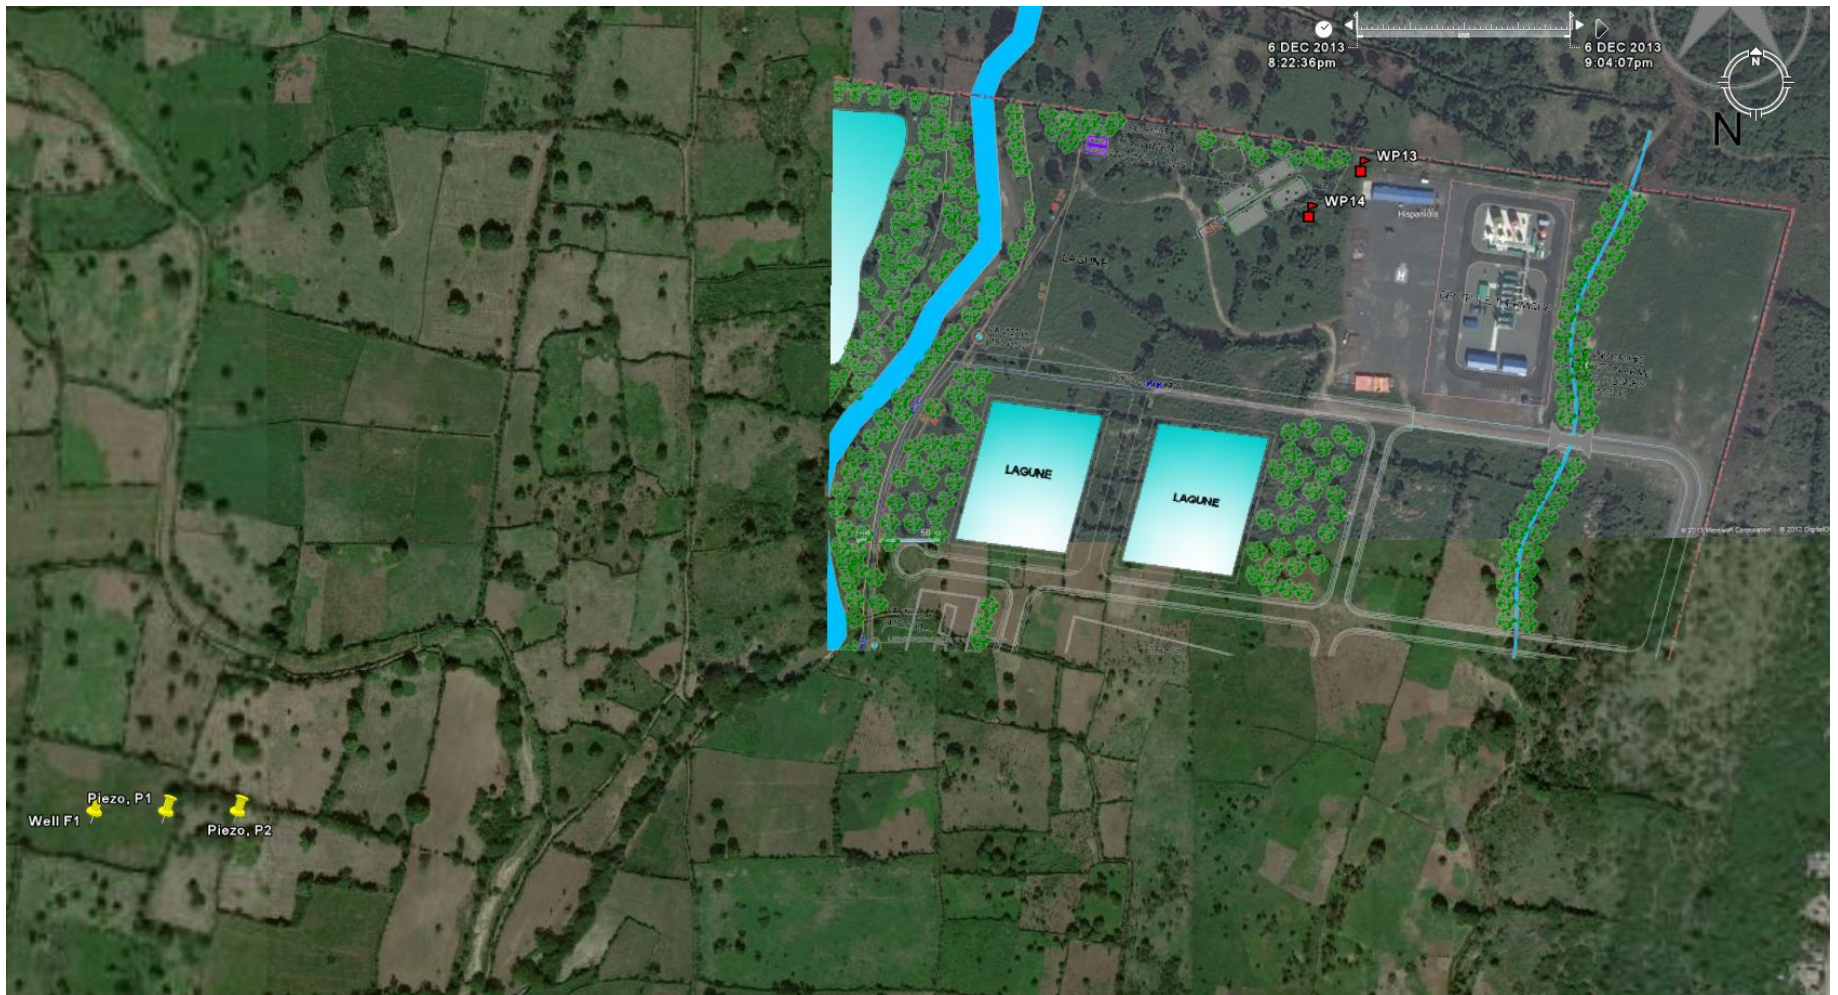
Figure 5 – Location of Production Well at the PIC in Relation to the WWTP 1km to the North-East. The Well is Approximately 380m from the Bank of the Riviere Trou Du Nord.

Earlier in September 2011 a hydrogeological investigation to inform the construction of a groundwater production well to supply the PIC was undertaken by Foratech Environment, SA. The production well and its adjacent piezometers were installed approximately 380m south-west of the proposed WWTP#2 and on the western side of the Riviere Trou du Nord. The ground elevation at those locations was recorded at 16m above sea-level and static groundwater level before pumping was recorded between 5.18m and 5.21m below ground surface at the piezometer locations P1 and P2 respectively (see Figure 5 below). Based on this it is likely that the static groundwater level at the proposed WWTP#2 on the eastern side of the river is likely to be within the same general depth of 5m below ground surface.
