FINAL REPORT HERITAGE IMPACT ASSESSMENT

METRO CORRIDOR-I AND II AGRA

Prepared for:
Lucknow Metro Rail Corporation
December 2019

HERITAGE IMPACT ASSESSMENT (HIA): OF PROPOSED METRO CORRIDOR- I AND II AND ITS THE HERITAGE RESOURCES OF AGRA INCLUDING THE TWO WORLD HERITAGE PROPERTY OF TAJ MAHAL AND AGRA FORT

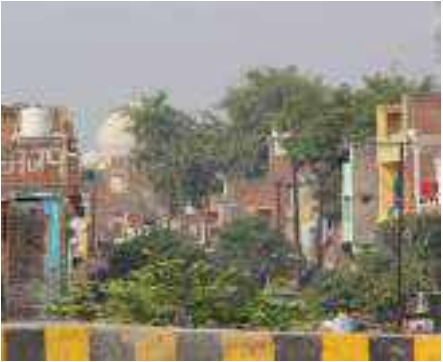
| Sr.no. | Heritage Resource | Image showing existing visual connection | Existing visual connection | Impact on visual connection |
|---|--|--|---|--|
| 1 | Taj Mahal | | <p>Viewpoint locations were established through Research identified 16 viewpoints of Taj (TMV1, TMV2, TMV3, TMV4, TMV5, TMV6, TMV7, TMV8, TMV9, TMV10, TMV11, TMV12, TMV13, TMV14, TMV15, TMV16) which is then verified through fieldwork. (View from Fatehabad road at Taj ganj, looking North of the site) one viewpoint (TMV17) was identified on Fatehabad Road. At present the dome and a part of Taj Mahal is partially visible from this point. Located 1.08 km south of the site, this point on the Fatehabad provides the first views of Taj Mahal.</p> | <p>1. Proposed Underground Metroline in Taj area do not have any impact of Taj view points as well as visaul relationship of Taj Mahal, Red Fort and Jama Masjid . 2. It has been observed from the study that the proposed elevated alignment on Fatehabad road do not causes any visual impact on these 16 viewpoints. 3. An elevated Metro line is proposed over Fatehabad road, is likely improve the visual connections of the visitors which is at present hidden behind modern constructions 4. The net result will potentially provide the historic building with an improved visual character.</p> |

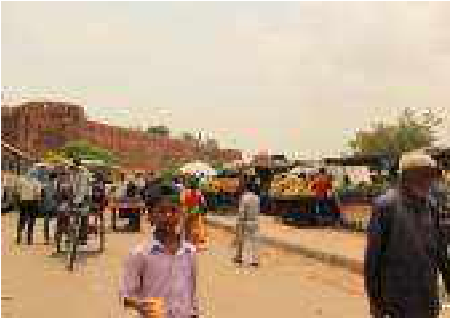
| Sr.no. | Heritage Resource | Image showing existing visual connection | Existing visual connection | Impact on visual connection |
|---|--|--|---|--|
| 2 | Agra Fort | | <p>The visual analysis is based on views from external spaces within the public domain and not from inside buildings or private spaces. (View from Red Fort road, looking north of the site) A highly trafficked road, the northern stretch of the Red Fort Road is the portion of the site visibility, this location lies 100m from the site and is a primary entry point for Agra Fort. South wall of the Agra Fort is visible from road along the proposed Metro station of Agra Fort.</p> | <p>1. An underground Metro line is proposed along the stretch of Agra Fort therefore do not impact the existing visual coonectivity. 2. Underground alignment parallel to the road do not impact the visual connecticity between the two World Heritage Sites 3. There are two proposed Metro stations in close vicinity to the Agra Fort. After visual analysis it can be concluded that the location of these two stations do not pose any visual obstruction to the monument.</p> |

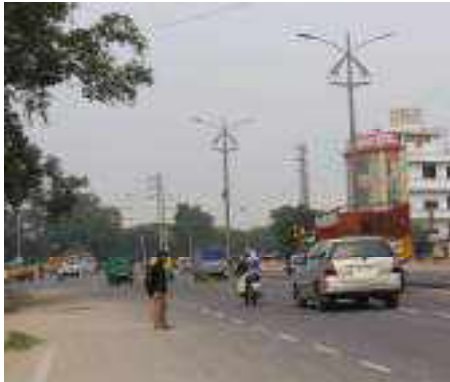
| Sr.no. | Heritage Resource | Image showing existing visual connection | Existing visual connection | Impact on visual connection |
|---|--|--|---|--|
| 3 | Akbar's Tomb, Lodhi tomb and Kanch Mahal Sikandara | | <p>(View from the NH19 looking northeast) Located 600 m from the site. This viewpoint is taken from the newly constructed building at the edge of the road, located adjacent to the site without intervening structures or vegetation to mitigate the view, multiple structures of the proposals become visible. The main gate of the complex is visible from NH19 (viewpoint SKV1) along the proposed Metro station of Sikandara. Another viewpoint was identified on NH19, located 700m from the site, from this view point Minarets of the gate are visible.</p> | <p>1. Elevated Metroline on Sikandara road will not have any impact on the visual connectivity. 2. Elevated Metroline would provide better views of the Akbar's tomb and enhance the visitor's experience 3. There will be no visual impact on Kanch Mahal 4. The context of Lodhi tomb would be changed sue to elevated Metro station and Metro line at a distance of 103 meters.</p> |

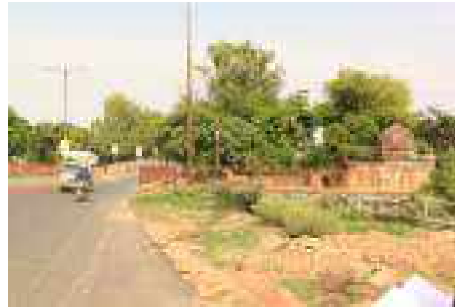
| 5 | Pathar Ka Ghoda and Itwari Khan mosque | | <p>(View from the NH19 looking south of the site) Located 40 m from the site. Pathar ka Ghoda is visible from the road(NH19).</p> | <p>Proposed Metro line on NH19 is elevated, the Metro line will have a negative impact on the view of Pathar ka Ghoda. As Metro line passes through the close proximity to the monument.</p> |

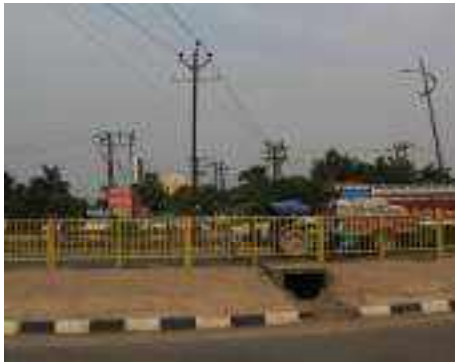
| 6.1 | Tomb of Salabat Khan | | <p>(View from the NH19 looking north of the site) – Although not visible from the road itself.</p> | <p>1. Visual analysis of the area it can be concluded that the proposed elevated Metro line would impact the context of the complex (refer Fig. VII/SQ/01) 2. Elevated Metro line would provide complete view of the complex</p> |

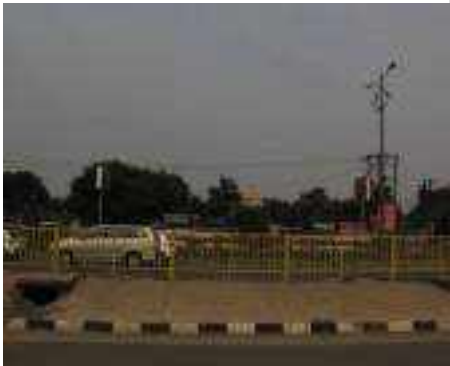
| 6.2 | Tomb of Sadiq Khan | | <p>(View from the NH19 looking north of the site) – Located 100m south of the site (view point SQV1), the NH19 is the primary access point in to Sadiq khan tomb for those travelling on the NH19 from the Sikandara. At present, the dome of Tomb of Sadiq Khan is visible from the road. and main entry of the tomb.</p> | |

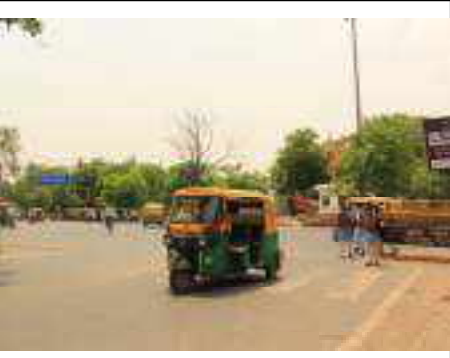
| 7 | Barah Khamba | | <p>The structure in the the Taj ganj area near the Taj Mahal so the building is cover with residennce and the is vesy dence No any visual connection from the Fatehabad road.</p> | No impact on visual connectivity |

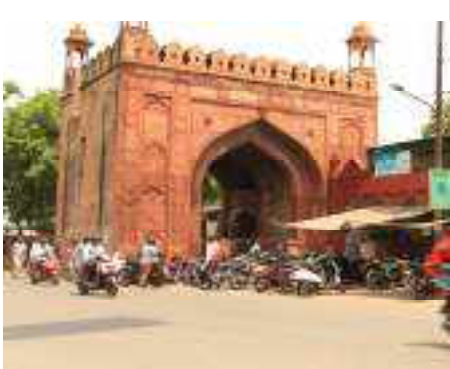
| 8 | Old Delhi Gate of City | | <p>(View from the hariparwat road looking south site of the site) Old Delhi gate viewpoint was identified on hariparwat road. At present the whole structure visible from the Raja ki mandi railway station road.</p> | <p>1.Metro line to be underground this stretch and no visual impact on visual connections and context 2.There are one proposed Metro stations in close vicinity to the Delhi gate. After visual analysis that the location of station do not pose any visual obstruction to the monument.</p> |

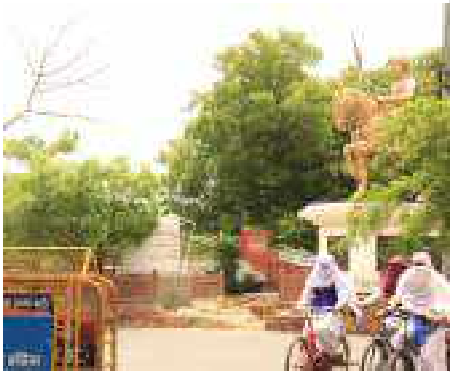
| 12 | Fatehpuri mosque | | (View from Fatehabad road, looking south of the site) No visual connection from the fatehabad road. | No visual impact |

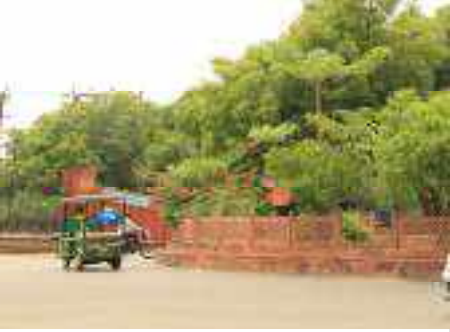
| 13 | Satti-un-Nissa's Tomb | | (View from Fatehabad road, looking south of the site) No visual connection from the fatehabad road. | No impact |

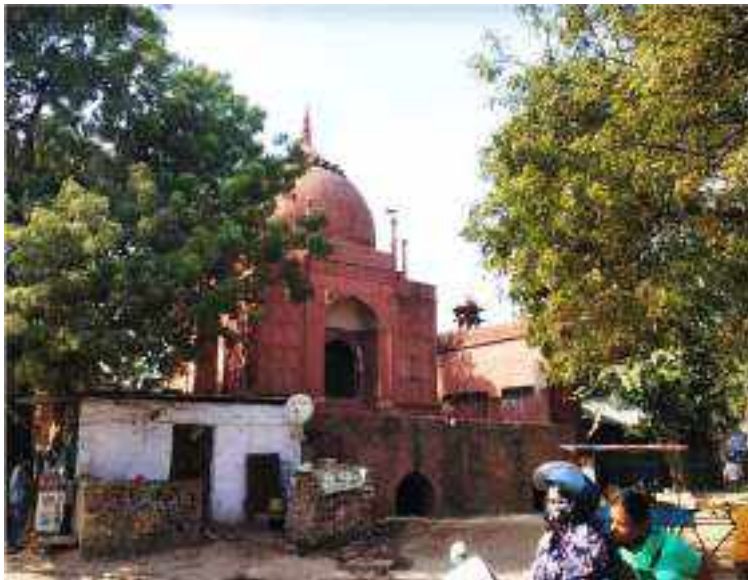
The tomb view from the road with adjacent shop structure in immediate surrounding

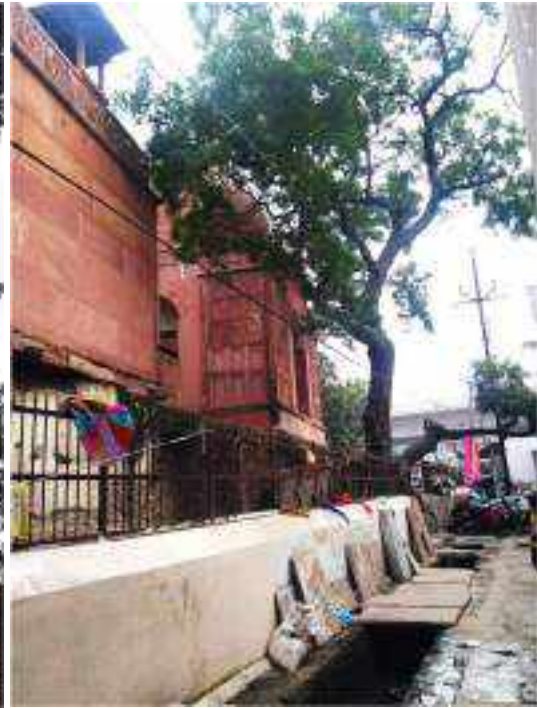
The rear view of the tomb with drainage nala along boundary wall

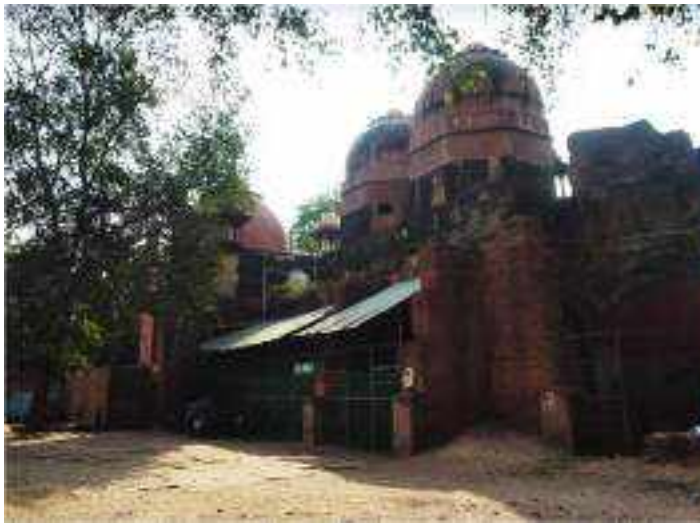
The view Shahi Lal mosque from north east direction which got partly collapsed. As the mosque is in use, temporary shed has been added at entry

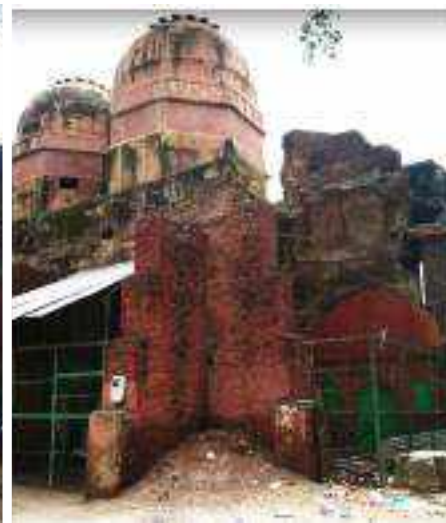
The image showing collapsed third dome of the mosque and temporary supports of brick masonry.

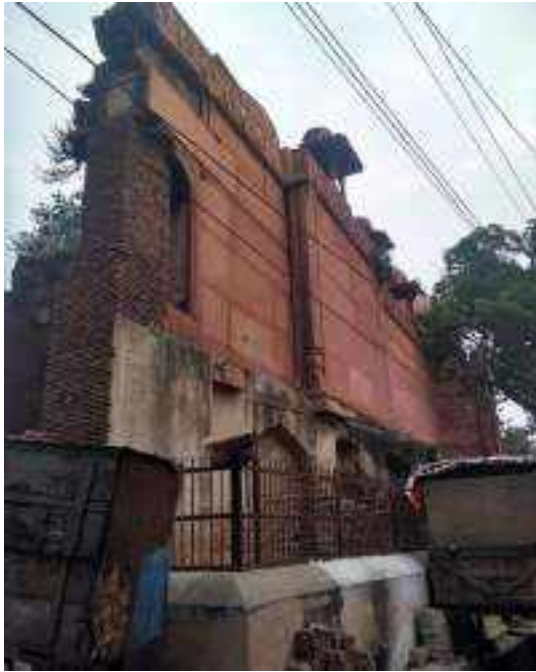
The view of mosque from north west direction showing a brick masonry supporting the mosque from further collapse

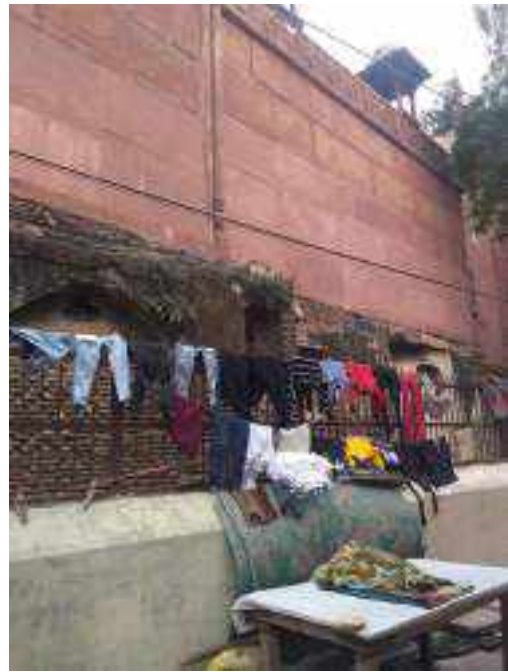
The rear view of the mosque there used to be a larger platform which does not existing anymore.

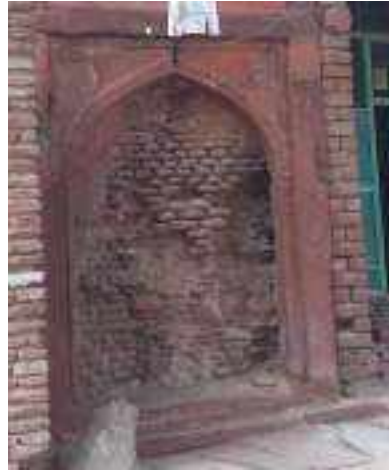
The loose masonry and deteriorated stones of the exterior wall surface

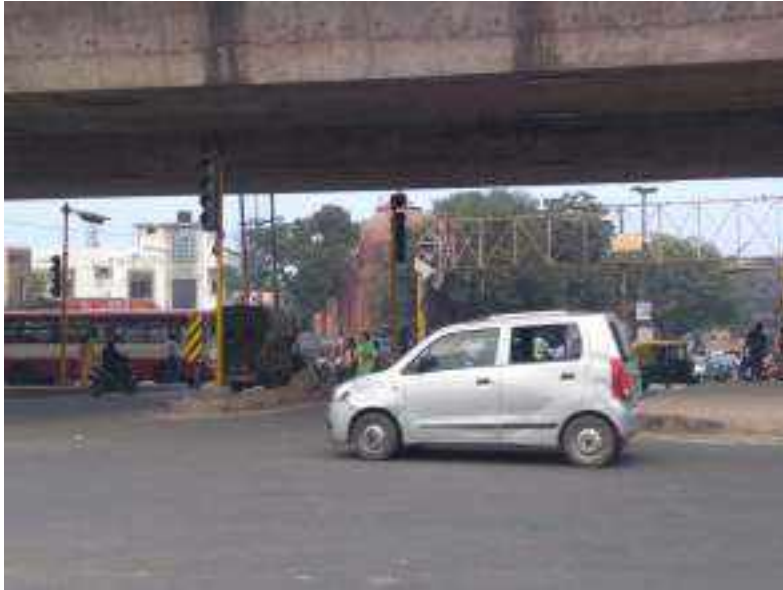
SHVI View of Shahi Lal Masjid and Tomb from the nursery across the road

Presently the flyover on National Highway 19 and other street infrastructure blocks the view from the proposed location of metro line. The building structure is partially visible as of now.

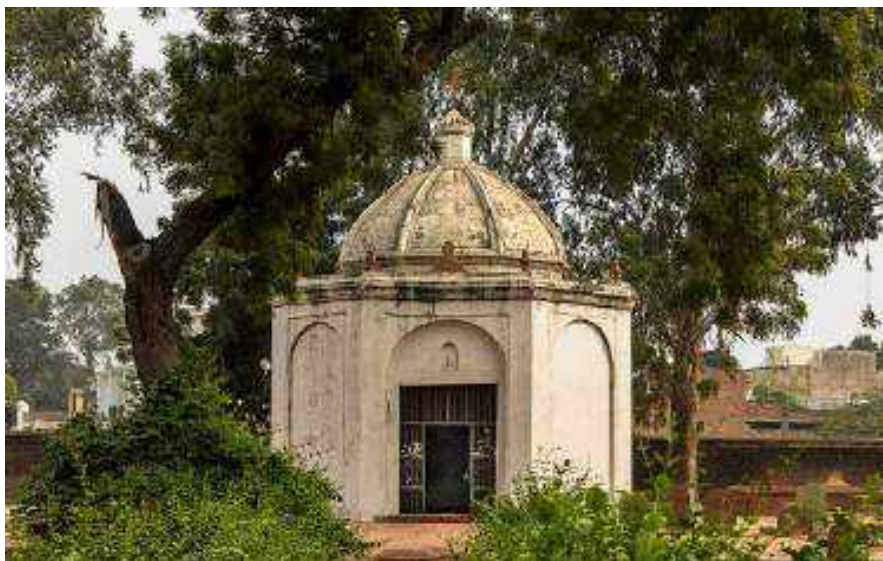
1. Marty's Chapel

The view of Marty Chapel in cemetery complex

Marty's Chapel is the oldest structure inside this cemetery. It gets its name from Khoja Mortinepus, an Armenian merchant who was buried here in 1611 AD. The octagonal, domed monument has an arched entrance and jaali screens on two sides. The structure is maintained by visitors who light candles and incense sticks and leave flowers on the tombstones. The structure is structurally stable and safe. There is algae deposits on the exterior wall and dome surface. Overall condition of the monument is good.

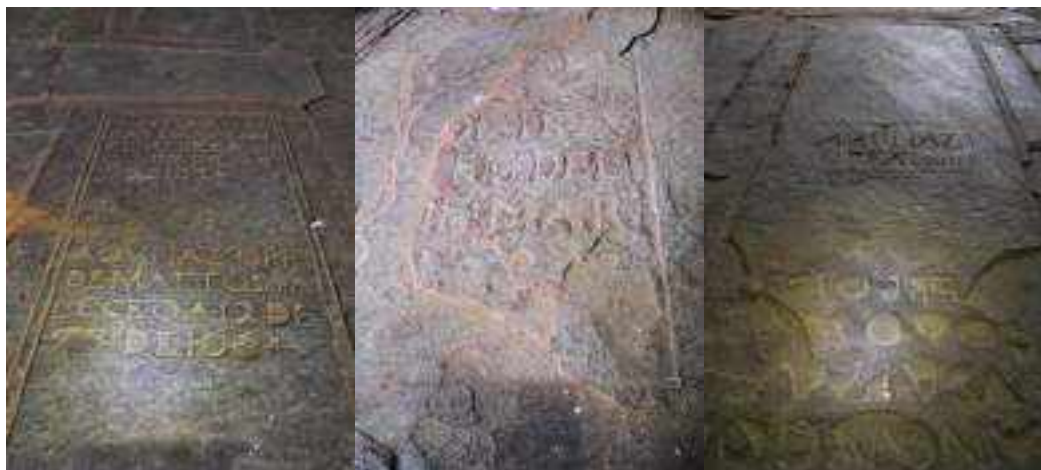
There are many inscriptions in Portuguese inside the chapel. Many on these have which have partially vanquished.

Portuguese inscriptions inside the chapel

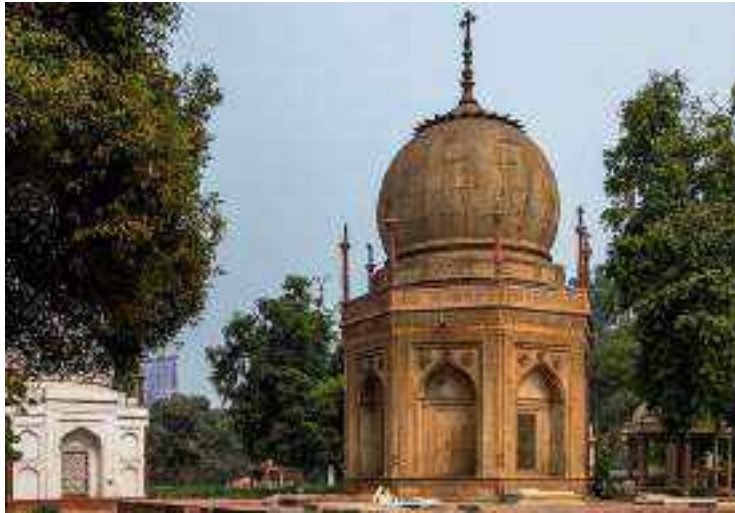
3. Ellis Family Tomb

View of Ellis family tomb

This octagonal domed tomb is from the 18th century. But this beautiful monument is actually the Ellis family tomb. The yellow mausoleum was built on a red sandstone plinth. Inside is the gravestone of Francis Ellis who died in Agra in 1868 AD. Surrounding the edifice, on the plinth are the markers of seven more members of the Ellis family. The final burial is comparatively recent: Christopher Ernest Ellis died on 9 April 1921 AD. The built structure and even decorative features and finials are in good condition.

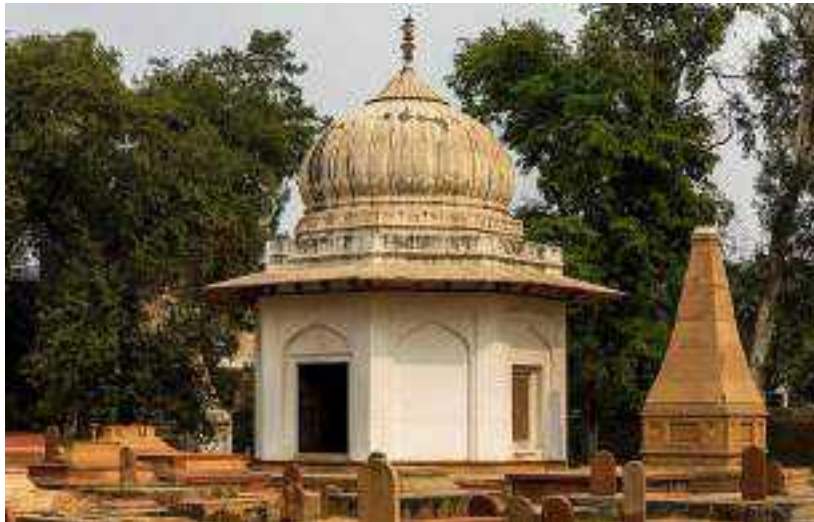
4. Walter Rhinehardt Sombre(Samru's) Tomb

View of Samru's octagonal tomb structure

The interior wall plaster is deteriorated and there are plaster cracks on exterior surfaces. The tomb and original gravestone are in good condition.

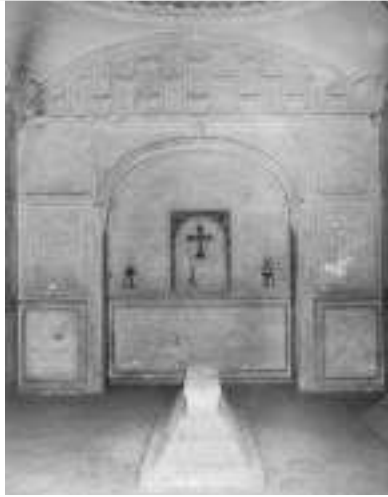
Interior view of Samru Tomb

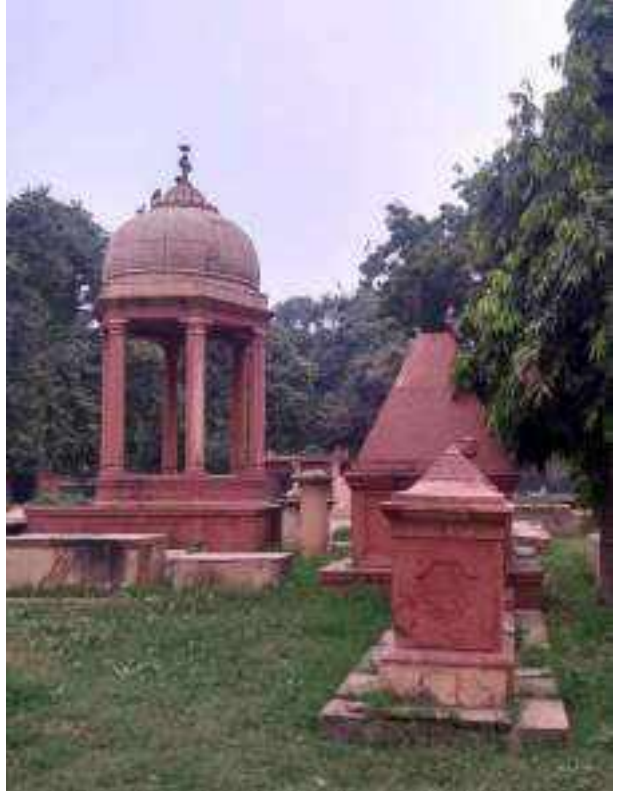
Other small tombs are in stable condition

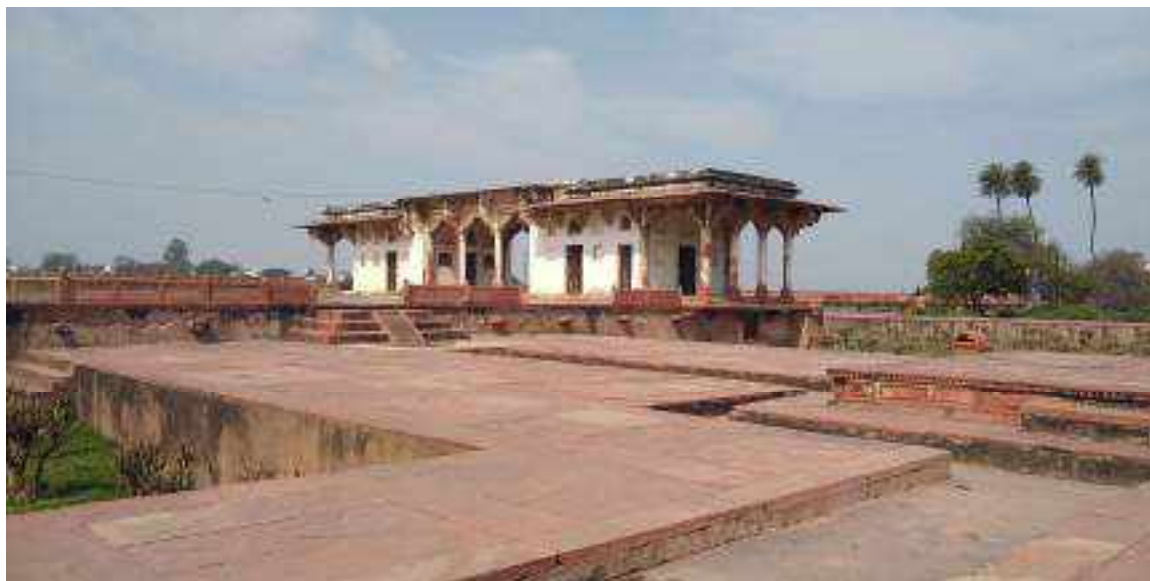
Image showing Ram Bagh houses and terraces

Condition of terraces of charbagh are stable. Signal storey houses are also in stable condition. There are signs of stone deterioration.

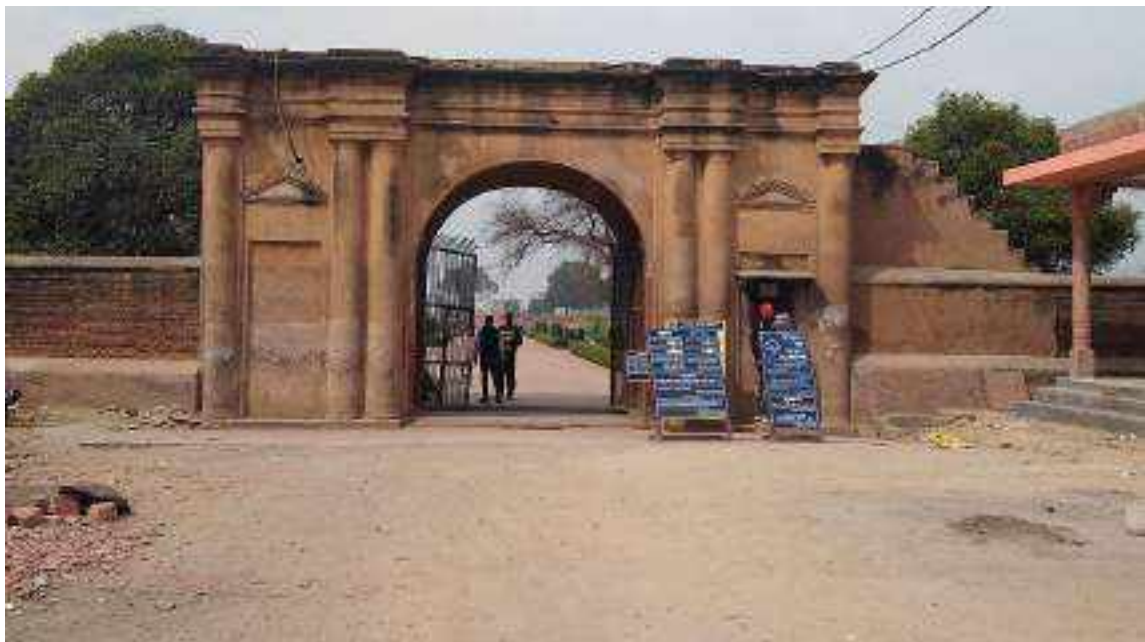
A colonial gateway to Rambagh complex

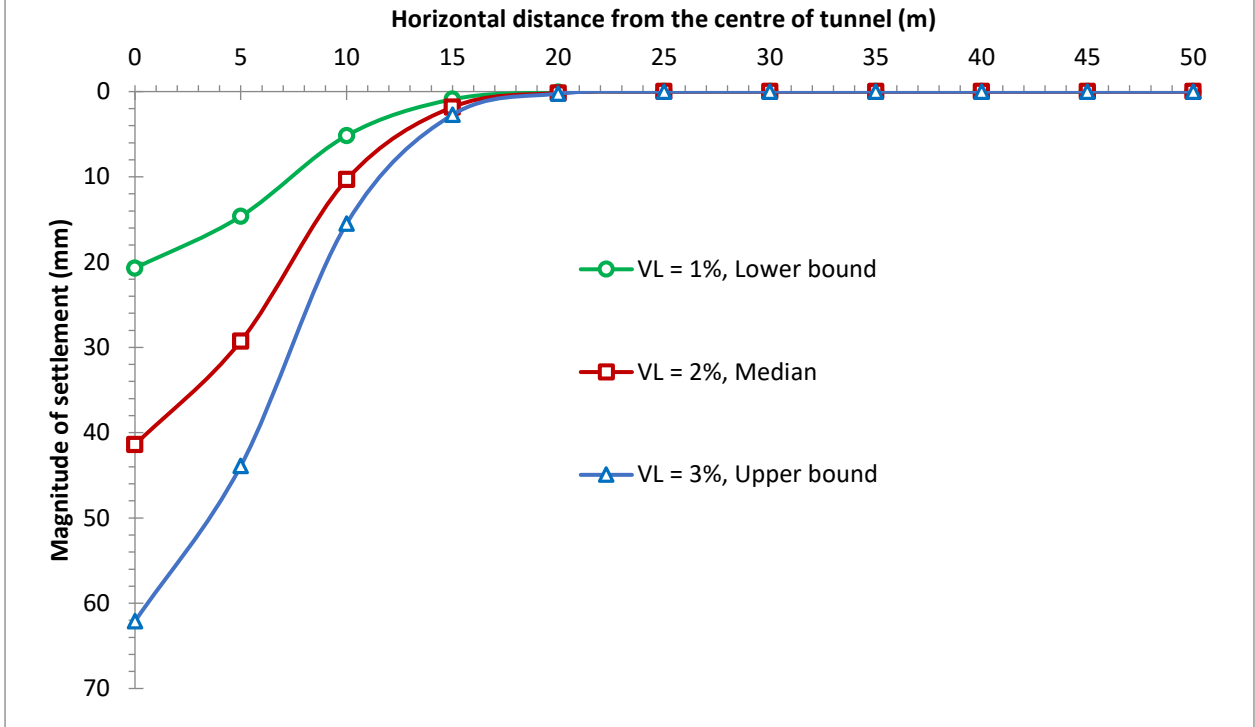
The load factor LF for the specified C/D ratio is identified and the Volume loss (V_L) is calculated for the corresponding load factor based on the Volume Loss- Load Factor graph given in Macklin (1999) (See Figure 9). The tunnel induced ground settlement for Volume loss of 1%, 2% and 3% is then calculated (Table 1) and plotted (Figure 10).

Figure 10: Tunnel induced settlement profile

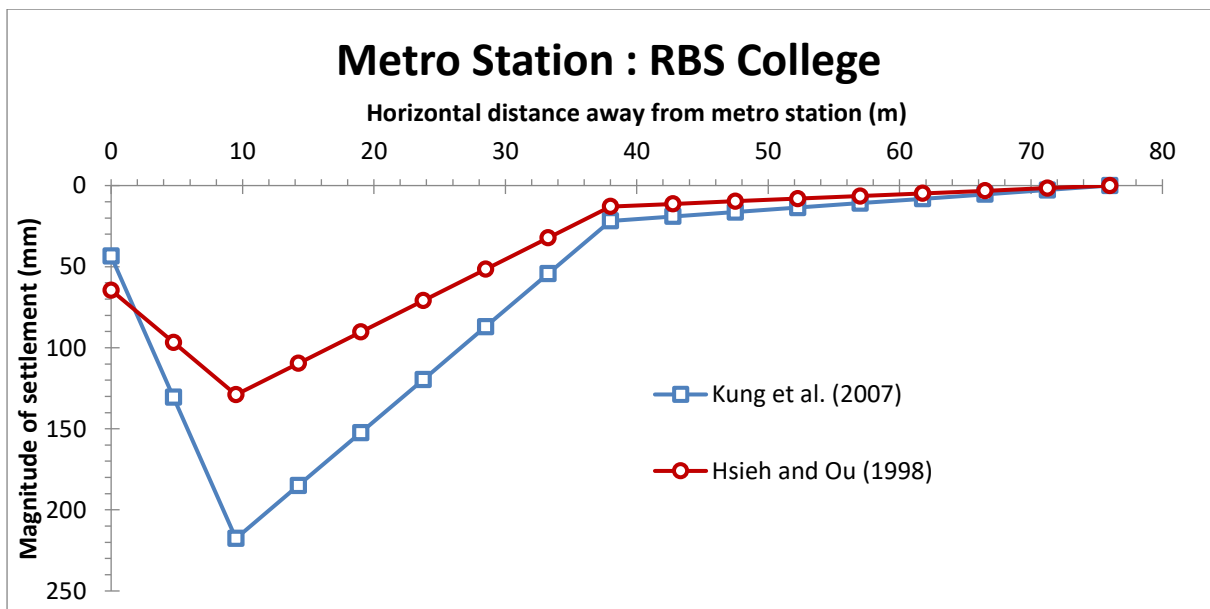
Figure 12: Excavation induced settlement for RBS College Metro Station

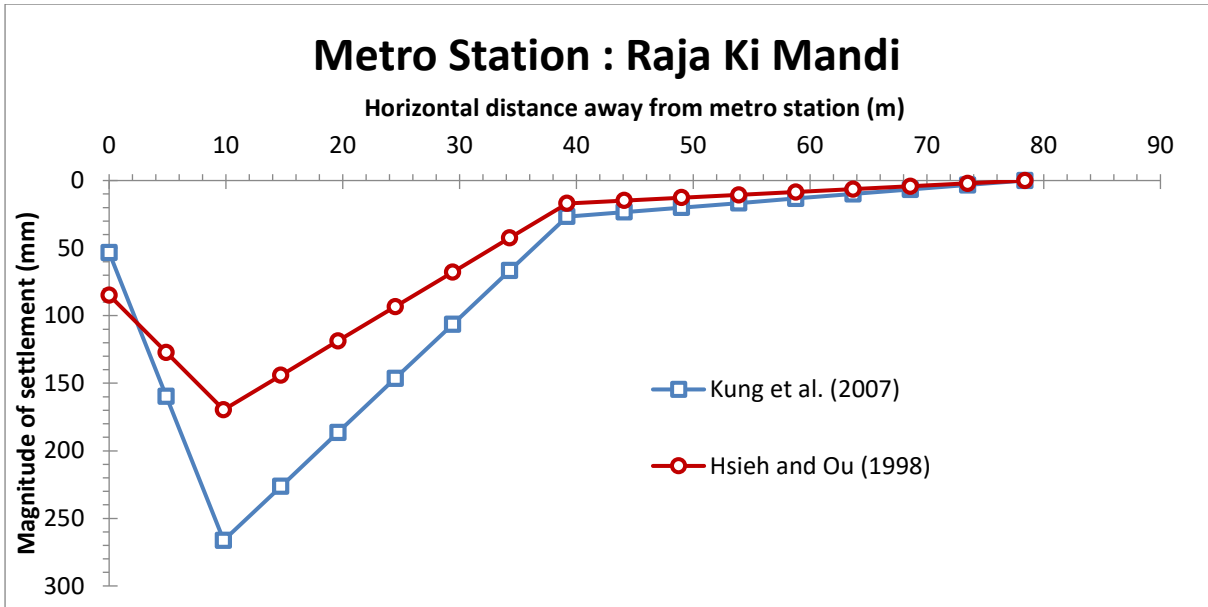
Figure 13: Excavation induced settlement for Raja Ki Mandi Metro Station

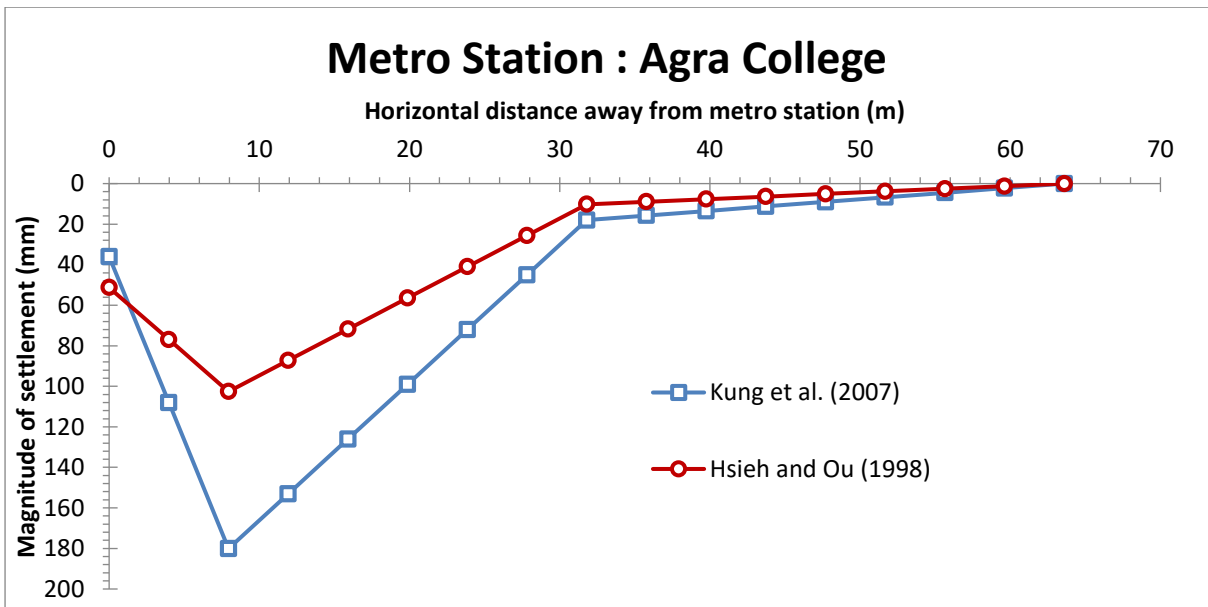
Figure 14: Excavation induced settlement for Agra College Metro Station

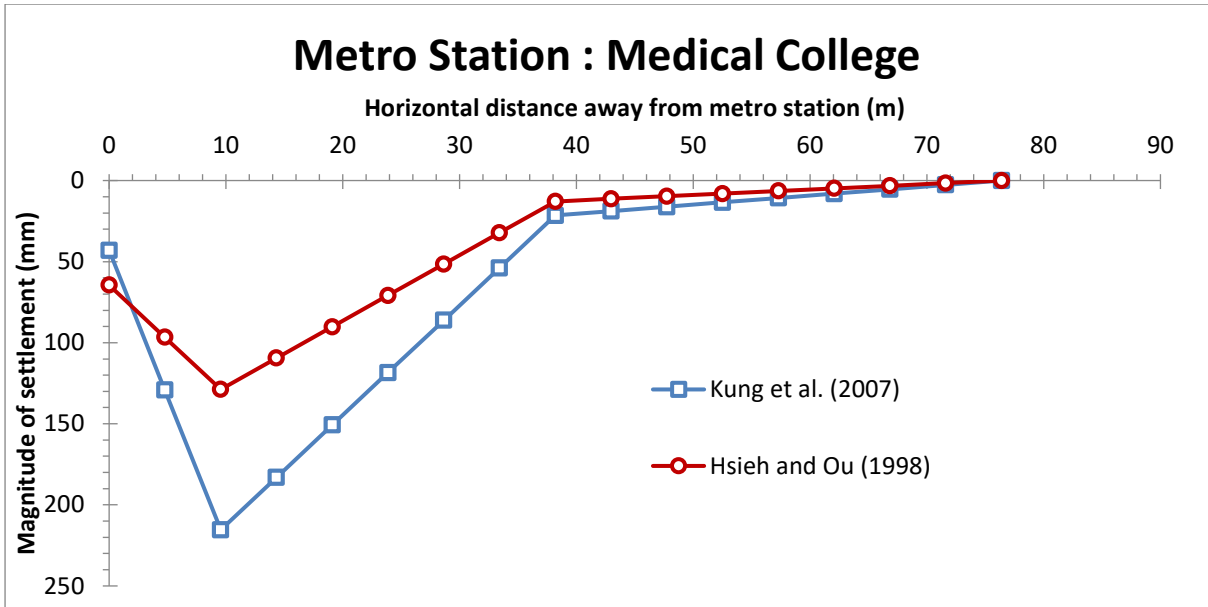
Figure 15: Excavation induced settlement for Medical College Metro Station

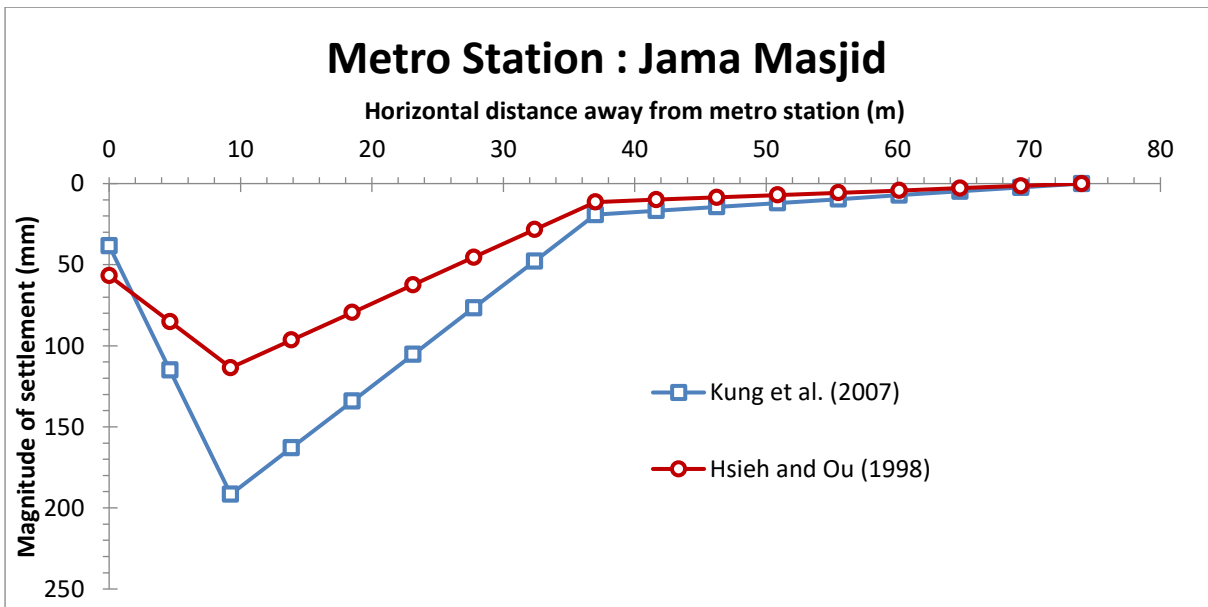
Figure 16: Excavation induced settlement for Jama Masjid Metro Station

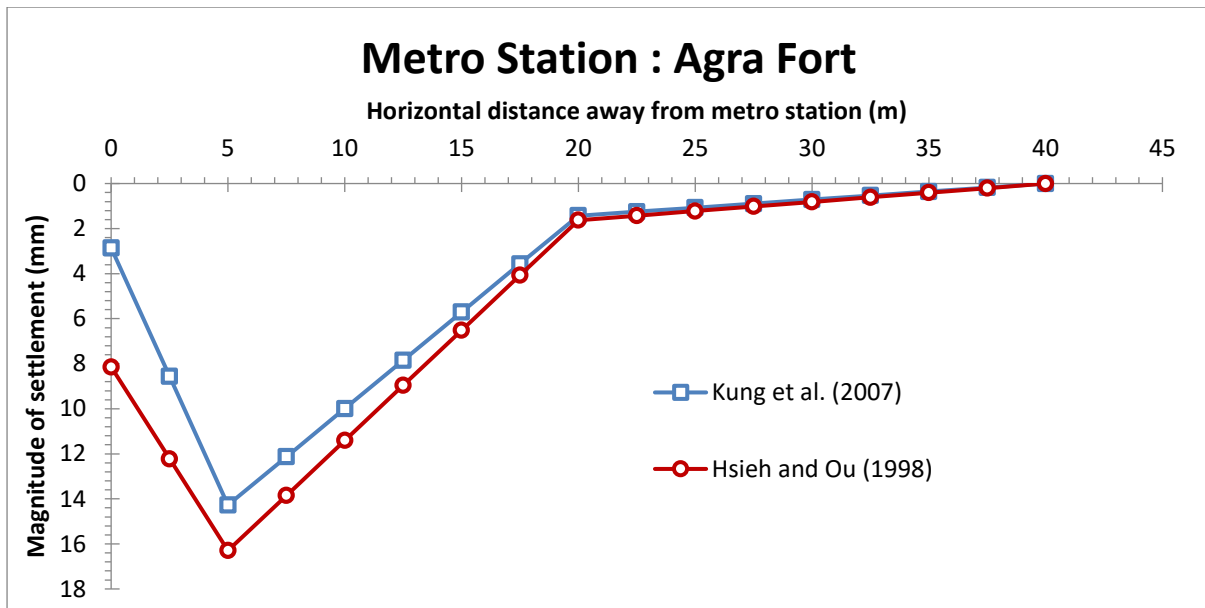
Figure 17: Excavation induced settlement for Agra Fort Metro Station

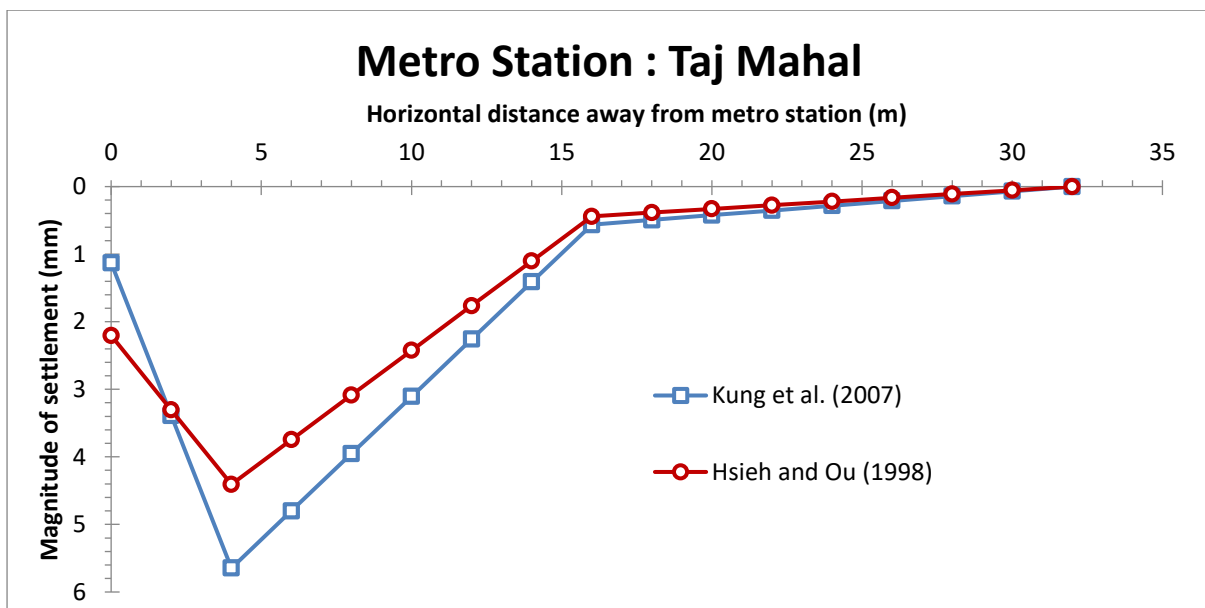
Figure 18: Excavation induced for Taj Mahal Metro Station

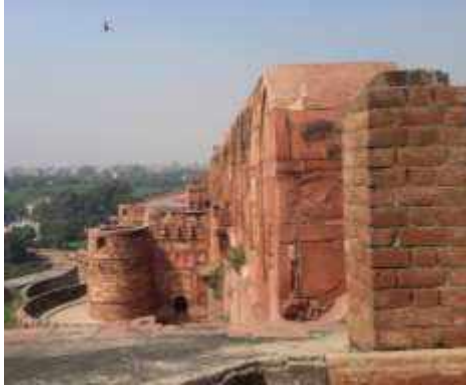
Figure 21: Agra fort

8. **Expected settlement:** 0
9. **Permissible limit:** Negligible
10. **Proposed scientific studies:**
 - Trial pit excavation to understand the foundation typology

- Vibration test at a point closest to the road, during peak activity hour and low activity hour during a working day
11. **Category of risk:** Low
12. **Recommendations:** The proposed alignment of the metro corridor does not pose any threat to this protected structure.

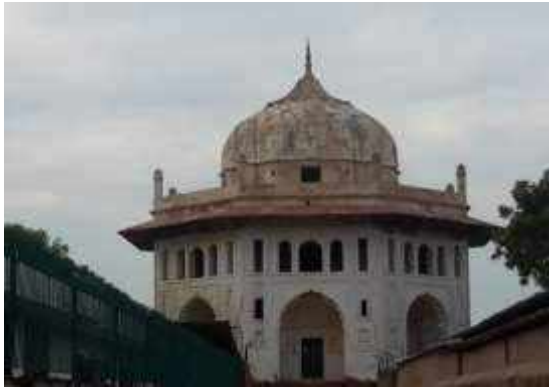
Figure 48: Tomb of Sadiq Khan

Cracks were observed on the dome interiors and in the entry archways which might be plaster cracks.

No structural distress was observed.

11. **Category of risk:** Low

12. **Recommendations:** The proposed alignment of the metro corridor does not pose any threat to this protected structure.

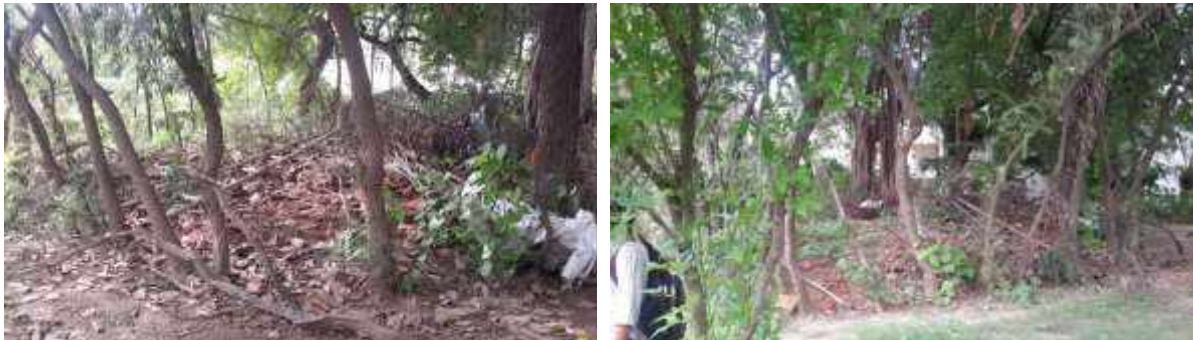
Figure 53: Ladli begum's tila

1. **Protection status :** ASI
2. **Proposed development actions:** Elevated metro line
3. **Structural system**
An archaeological park
4. **Condition :**
The site does not have a structure.
5. **Level of distress:** Not applicable
6. **Expected impacts**
 - Impact of soil settlement : Not applicable
 - Impact of vibrations : Not applicable
7. **Permissible limit:** Not applicable
8. **Expected settlement:** Nil
9. **Proposed scientific studies:** Not applicable
10. **Category of risk:** Low
11. **Recommendations:** The proposed alignment of the metro corridor does not pose any threat to this protected structure.

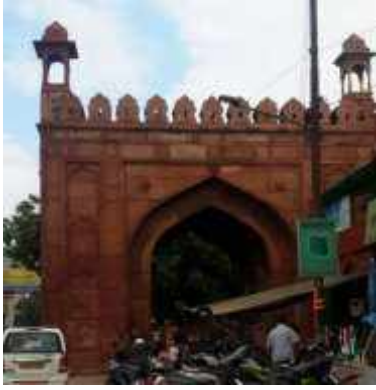
Figure 54: Old Delhi Gate

Cracks were observed on the dome interiors and in the entry archways which might be plaster cracks.

No structural distress was observed.

11. **Category of risk:** Low

12. **Recommendations:** The proposed alignment of the metro corridor does not pose any threat to this protected structure.

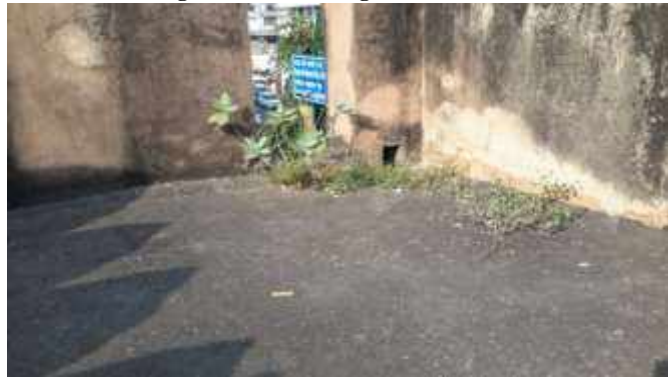
Figure 58: Vegetation Growth

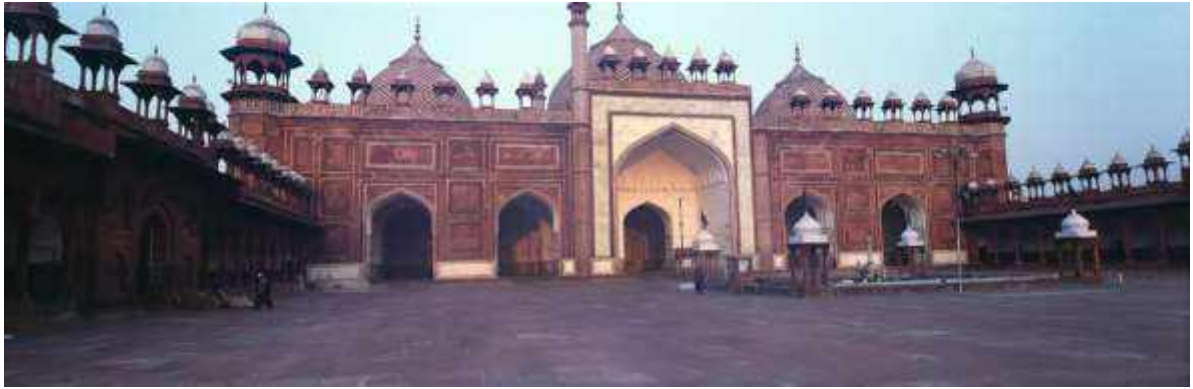
Figure 59: Jama masjid

No structural distress was observed in the structural members but other defects such as blackening, fine cracks, vegetation, delamination and dampness was observed.

No structural distress was observed in the structural system

11. **Category of risk:** Low

13. **Recommendations:** The proposed alignment of the metro corridor does not pose any threat to this protected structure.

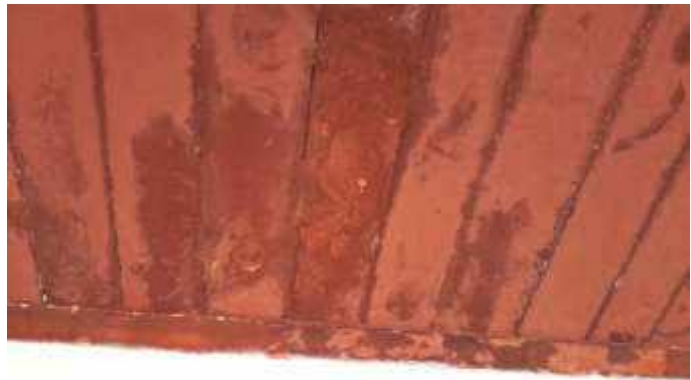
Figure 62: Water Ingress in roof

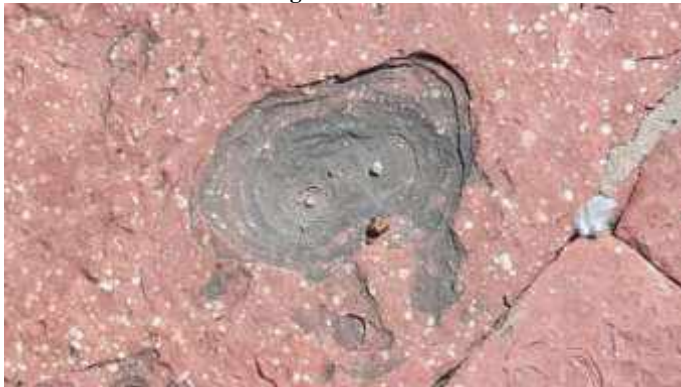
Figure 63: Contouring in stone
