# Vol. 6: Draft Environmental and Social Impact Assessment

## GEO: Nenskra Hydropower Project

# Nenskra Hydropower Project

### Volume 6 Natural Hazards & Dam Safety

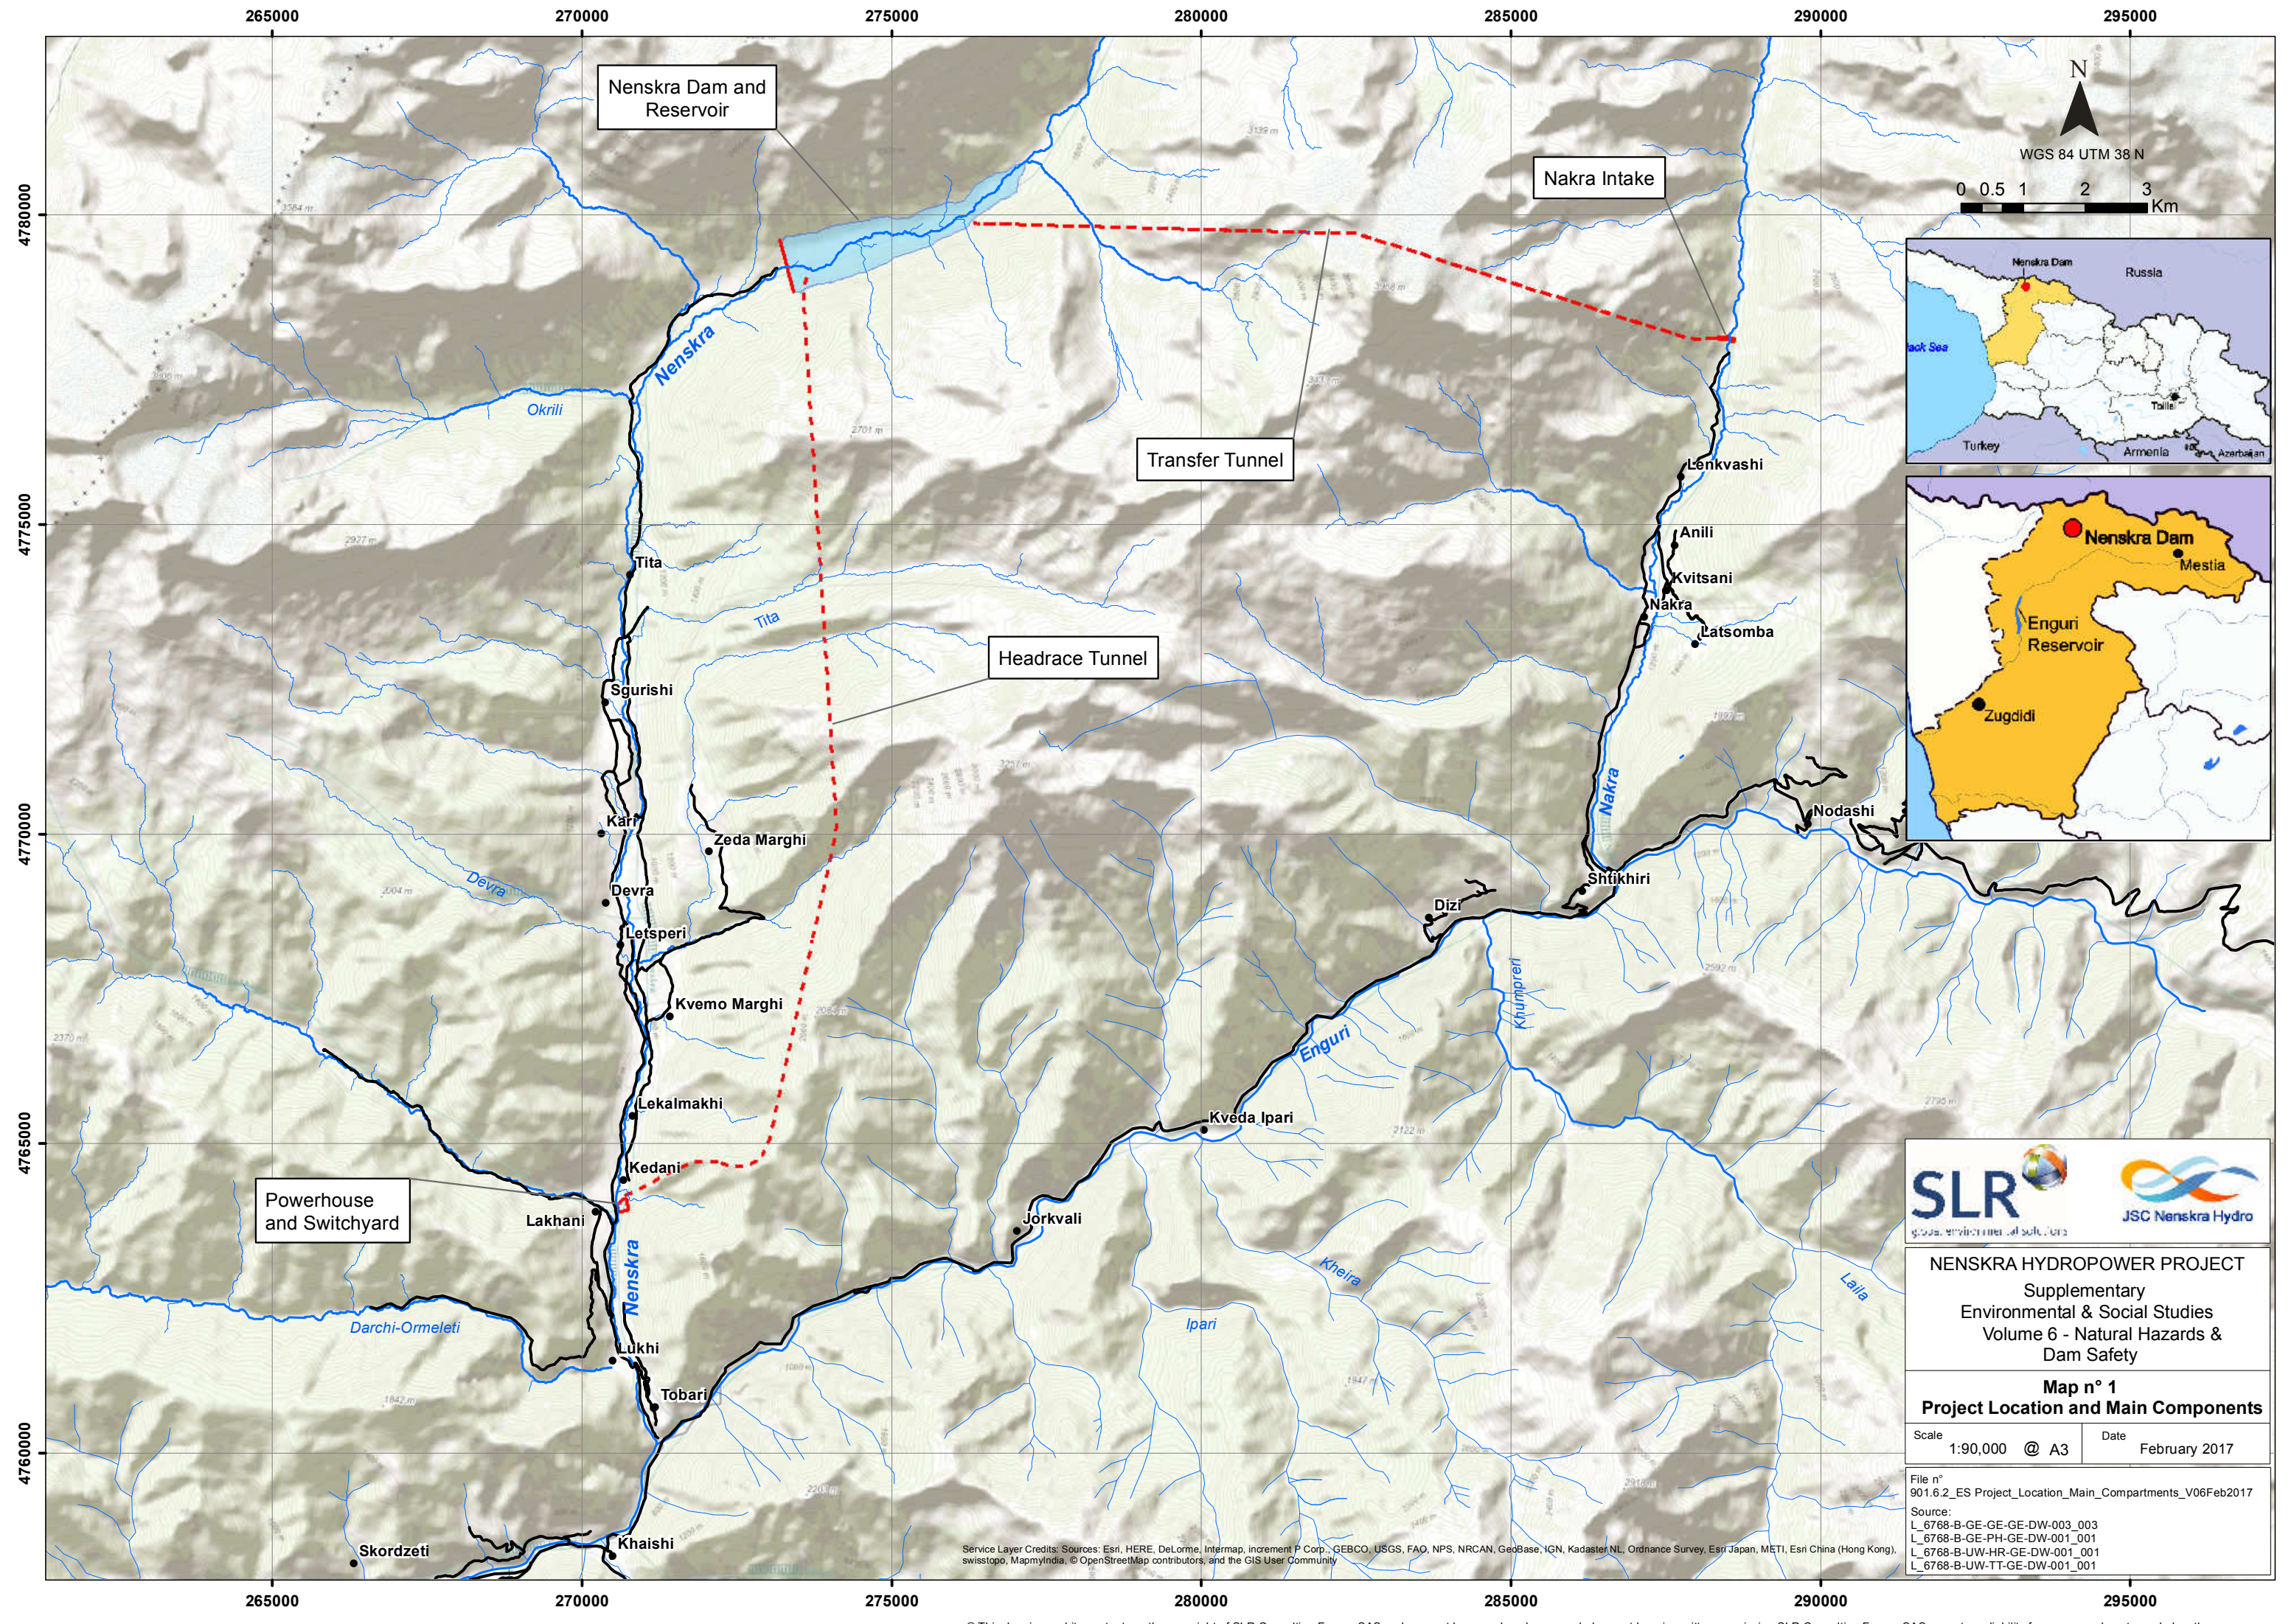
**Map n° 1**  
**Project Location and Main Components**

Nenskra Dam and Reservoir

Nakra Intake

Headrace Tunnel

Powerhouse and Switchyard

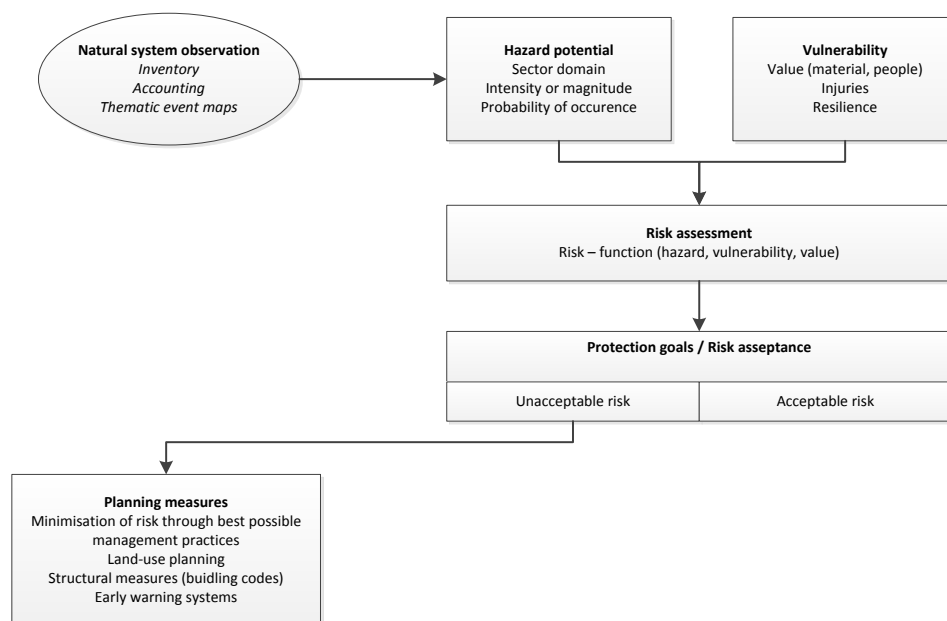
Figure 1 – Framework for risk assessment and risk management

The risk management follows the framework developed by the Swiss system of natural hazard risk assessment (SDC/PLANAT, 2005). and comprises a complete framework for risk assessment of natural hazards (World Meteorological Organisation, 1999) including schemes for hazard and risk assessment, definition of protection goals and planning of protective measures (*Kantonale Gebäudeversicherungen*, 2005 & 2007) as illustrated in the schematic below.

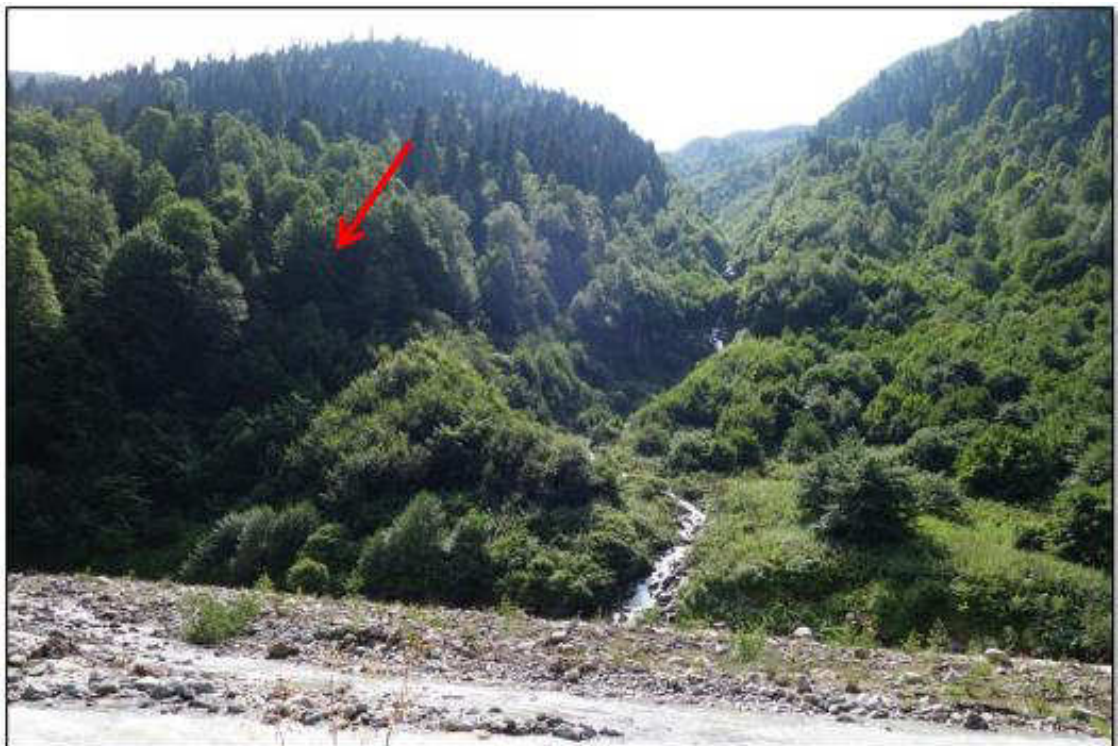
Figure 2 – Location of Nakra transfer tunnel outlet portal

- [SAF 8] Nakra transfer tunnel outlet portal structure protected from potential rockfall. The protection measures are included in the design and installed during construction.
- [SAF 9] Nakra transfer tunnel outlet portal worksite and construction workers are protected from potential rockfall. The protection measures are included in the design and installed at the start of the construction.

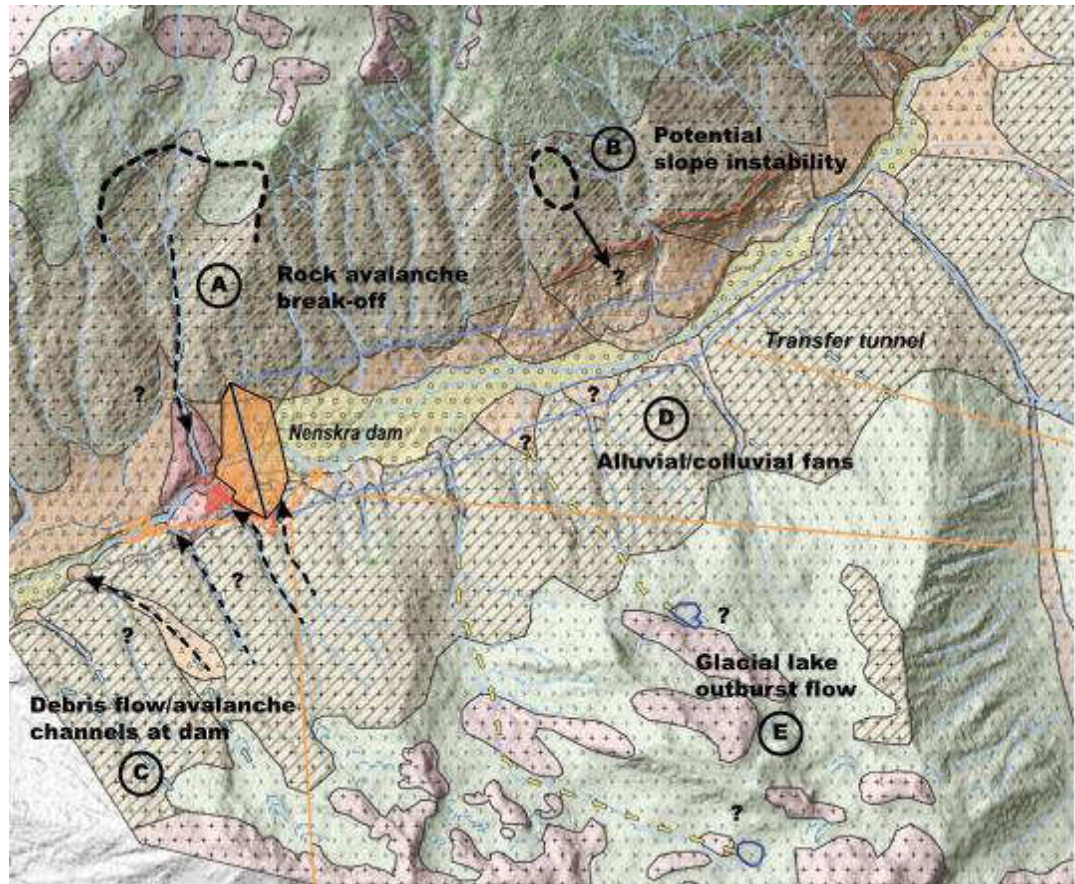
Figure 3 – Geomorphology of the Nenskra reservoir – indicating major hazards

The Nenskra dam and reservoir are exposed to a number of natural hazards as illustrated by the map below and described in the following subsections.

The dam resides partially on post-glacial deposits originating from a deep-seated landslide event that was followed by regular debris flow events triggered by rainfall (see Figure 3). The deposits on the valley floor were detached from the upper right slope above the right dam abutment, and deposited immediately downstream of the current dam emplacement, running up on the opposite, left valley slope. The slope collapse was probably due to the presence of destabilizing, slope-parallel, sheet or exfoliation joints that can be observed in the area of where the landslide occurred.

On the left bank (see Figure 3). There are 3 alluvial/debris channels which align (i) with the upstream dam face in the left abutment, (ii) the downstream dam face or spillway area and (iii) the Bottom outlet tunnel portal area. A fourth channel probably points downstream of the project area (Figure 5).

A potential area of slope instability in the area of the future reservoir has been identified and evaluated. A field examination was made in August 2016 including a helicopter overflight. The area is located in the middle right slope approximately 2.5 kilometres upstream of the dam area (see Figure 3).

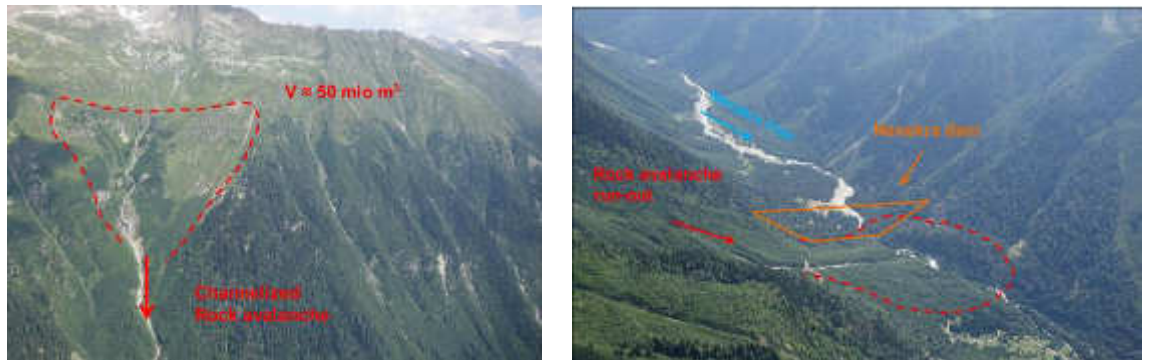
Figure 4 – Historical evidence of landslide at the dam site

Visual evidence of an historical landslide deposit at the dam emplacement. Left: View from the left bank towards the detachment zone of the landslide event. The volume of the material is probably significantly less than 50 million cubic metres. Right: Maximum extension of the landslide and run-up area on the opposite slope.

Figure 4 below shows the detachment and deposition areas. **The possibilities of further slope collapses are considered low** according to an inspection of the possible source areas by means of a satellite image inspection and helicopter overflight and a slope stability assessment using satellite radar interferometry (see Annex 5 and section 3.1.3.4).

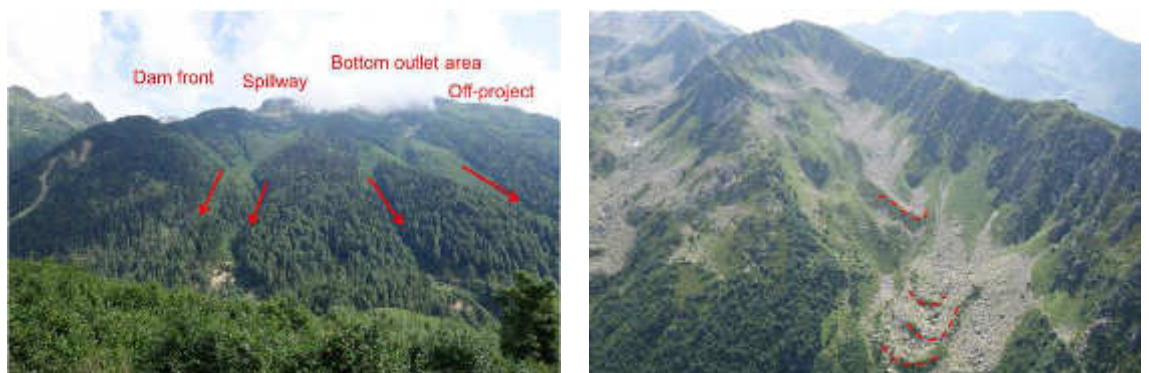
Figure 5 – Debris flow/avalanche channels in the area of the dam

Debris flow/avalanche channels on the left slope above the dam (left) and uphill area of the rightmost channel (right).

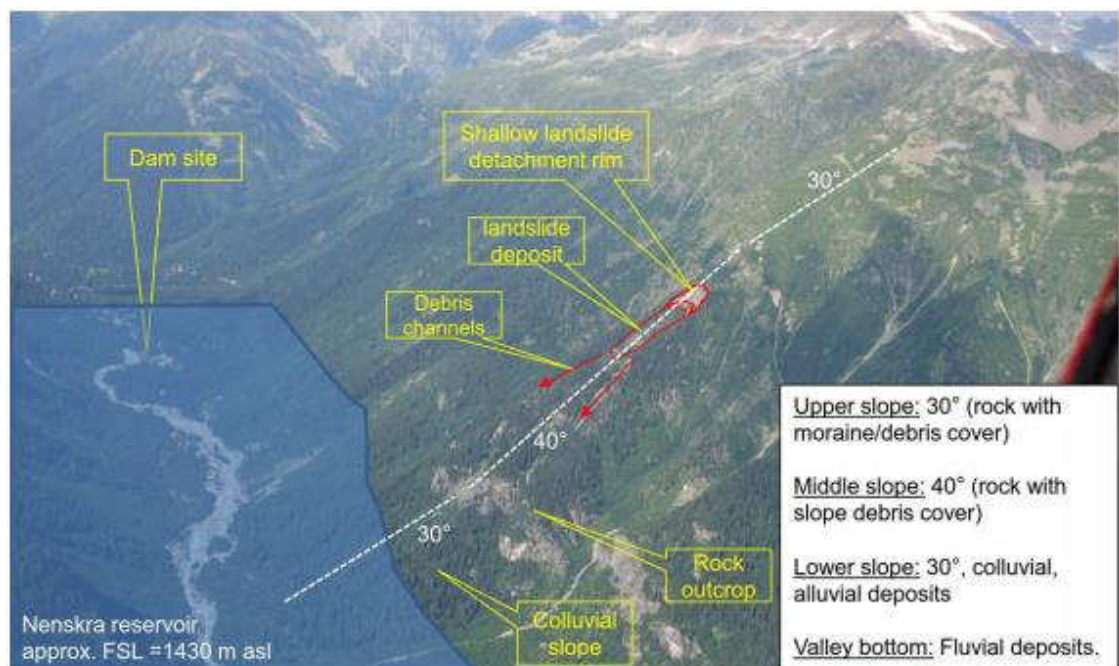
Figure 6 – Aerial view of the area of uncertain slope stability

An aerial view of the area of interest is provided in Figure 6. The area extends from an altitude that is above the reservoir full supply level (1,440 metres asl) to the upper slope (2,330 metres), where the vegetation changes from forest to grass land. The change in vegetation coincides with a change in slope inclination and geological conditions:

- The lower, forested part is steeper (40 degrees) and is composed of bedrock with a variable soil cover made of a mix of glacial deposits and slope debris.
- The upper, grass covered part is less inclined (30 degrees), its substratum is composed of sub-outcropping bedrock with a thinner soil cover principally made of glacial deposits and pre-glacial erosion remnants.

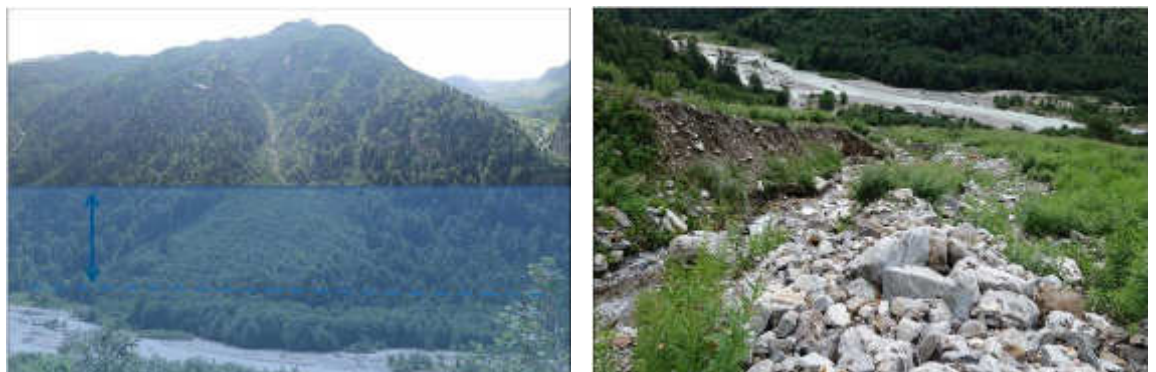
*Figure 7 – Submerged alluvial/colluvial fans*

Typical situation of a alluvial/colluvial fan which will be submerged by the reservoir and subject to reservoir draw-down (left) and soil structure of such a fan, composed of large-scale granular material (cobbles to blocks) in a sandy-gravelly matrix (right).

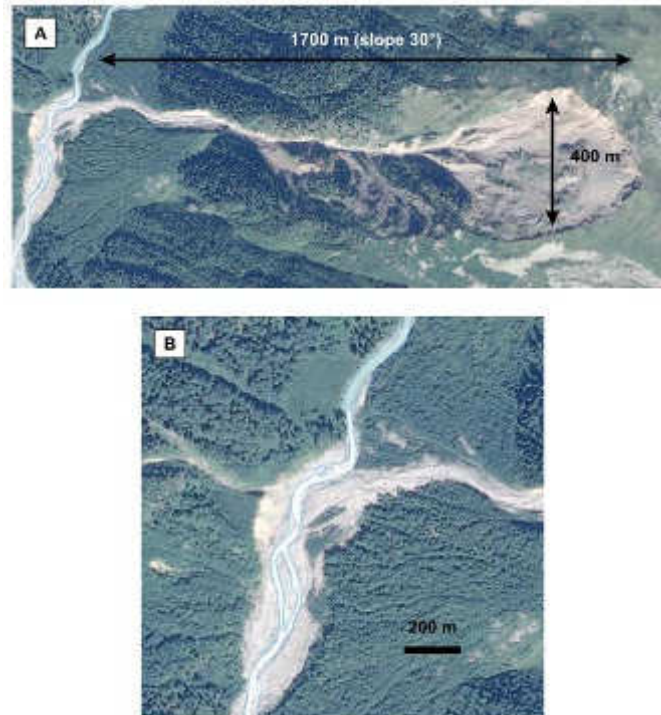
Figure 8 – Area 2.2 kilometres upstream of reservoir end. Overview (A) and detail at the confluence with the river Nenskra (B).

- A larger alluvial fan enters from the left slope about 800 metres upstream of the reservoir end and leads to a larger lateral valley. According to the morphology and vegetation the fan does not seem to be active.
- Another alluvial fan is entering from the left slope about 2.2 kilometres upstream of the reservoir end (Figure 8). According to the reporting of the local population, the corresponding upstream slope instability was (re-) activated during the snow-melt after the avalanche winter of 1986/1987. The superficial slope instability is active and probably produces regular debris flow phenomena.

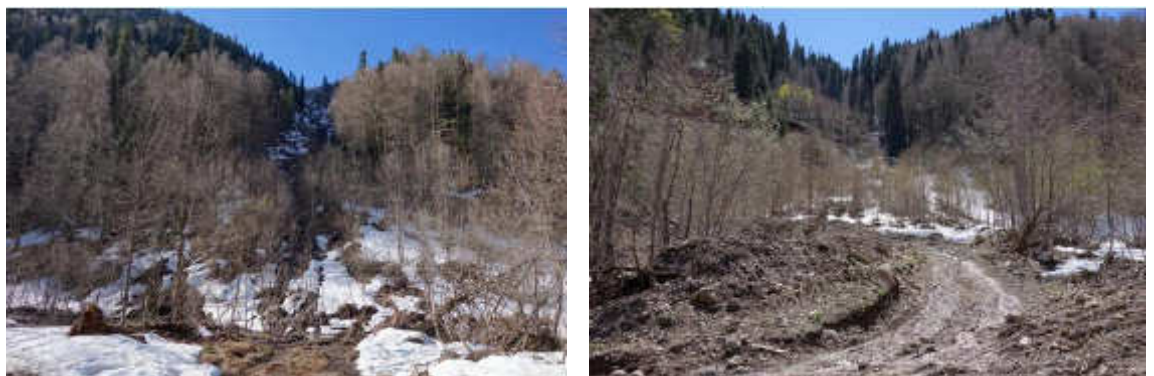
Figure 9 – Reservoir spillway – and avalanche and debris flow channels

The reservoir spillway will be a tunnel spillway. It is well protected against surface processes such as avalanches, debris flows and spontaneous earthquake-triggered soil slides, but is vulnerable to clogging from floating debris. However the spillway inlet is a risk of blocking from avalanche and debris flow events and protection measures will be included in the design.

Alluvial/debris fans with possible debris flow and snow avalanche activity which point towards the upstream face of the dam (left) and the initial and middle/final part of the surface spillway (right).

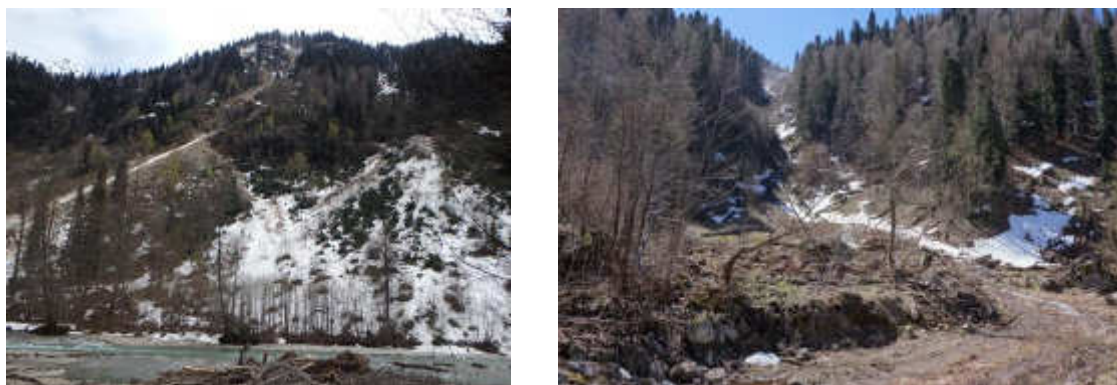
*Figure 11 – Bottom outlet inlet and outlet portals*

The Bottom Outlet's inlet and outlet portals are both situated in areas potentially affected by alluvial/debris fans with possible debris flow and avalanche activity. The inlet portal in particular is at risk of clogging due to floating debris (heavy rainfall, avalanches) and debris flow material. The design of the structures will take account of these possible hazards as the bottom outlet is a safety feature allowing the reservoir water level to be lowered if a safety issue arises, and blocking the bottom outlet would also stop the ecological flow leading (to environmental consequences).

The intake portal of the Bottom outlet tunnel is located at the foot of the snow-covered debris fan on the right of the photograph (left). The alluvial/debris fan with snow avalanche activity which points towards the area of the exit portal of the Bottom outlet tunnel (right).

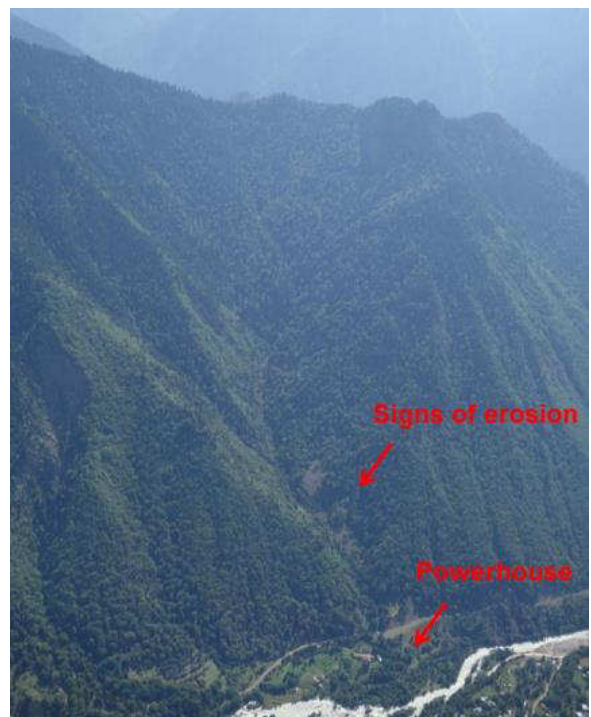
Figure 12 – Aerial view of the powerhouse area and smaller valley above

The powerhouse is located close to the exit of a smaller valley with a hydrographic basin of 1.9 square kilometres and maximum elevations around 1,750 metres asl (Figure 12).

A preliminary analysis of the geological, geomorphological and topographic situation shows that there may be possible sediment transport/debris flows during periods of heavy rainfall along the lateral torrent and at the exit of the upstream valley.

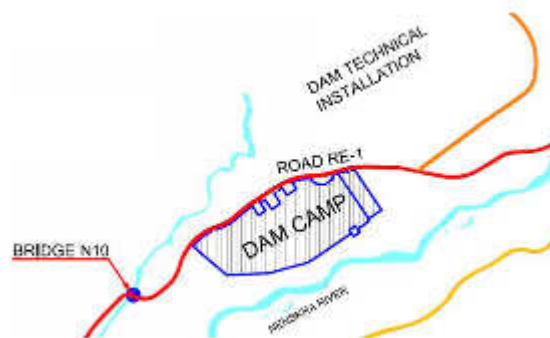
Figure 13 – Sketch of dam camp and technical installation layout

The layout of the dam camp and technical installation is illustrated in the sketch provide in Figure 13, and is situated approximately 2 kilometres downstream from the dam site.

The area where the camp is planned to be located is 1.5 kilometres downstream from the dam structure, it is located in a meadow where local people have constructed summer cabins. Local people report that in 1987 that the runout from an unusually large avalanche that occurred on the slopes above the meadow (on the right bank) extended across part of the meadow where the construction camp is planned to be located. Consequently, the risks for natural hazard events affecting the site are ranked as moderate and further studies will be undertaken to define the protection measures required. It should also be noted that the area earmarked for the construction camp is located 1.5 kilometres downstream from the area affected by the large avalanche that occurred in 1987 - near the dam site - and which blocked the valley which is very narrow at that point (see section 3.1.3.3A).

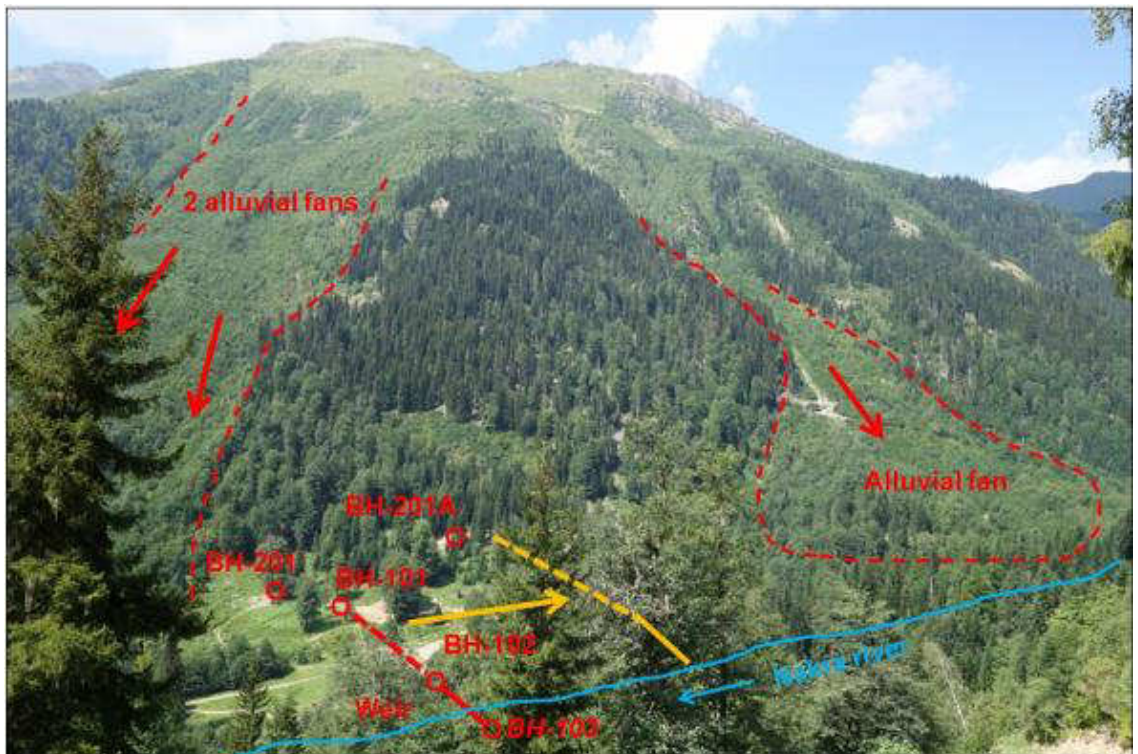
Figure 14 – Location of Nakra weir and transfer tunnel inlet portal

The structures are located at the foot of a steep valley slope, covered by older tree vegetation. On both sides, the area is delimited by alluvial fans, which show a younger tree population, indicating past geomorphological activity due to avalanches and debris flows.

During the basic engineering the structures were moved about 100 metres upstream from the position initially planned during the feasibility studies. This was in order for the structures to be located in an area less exposed to avalanche and debris flow hazards. Doing so, the weir and tunnel portal are located in the central part of the area, making them safe from avalanches or debris flows.

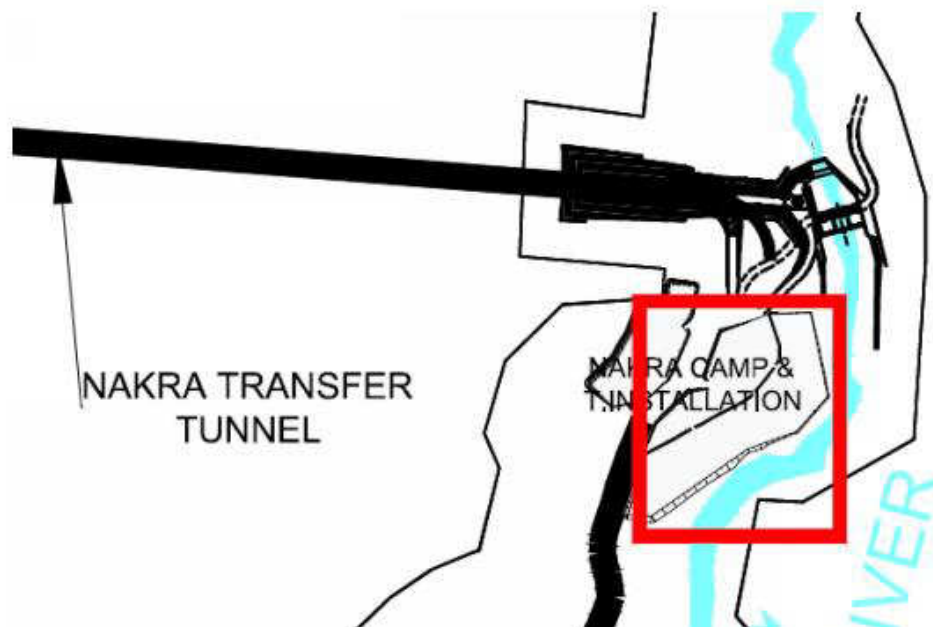
Figure 15 – Sketch of the Nakra camp and technical installation layout

The Nakra camp and the technical installation are located a few hundred meters downstream from the Nakra intake, on the right bank. The layout of the camp and technical installation is illustrated in the sketch provide in Figure 15

The slope above the site are moderately steep and occupied by a vegetation of relatively young trees, though this is thought to be by the result of logging activities, rather than avalanches and landslide activities.. However, avalanche and rockfall hazards will be assessed prior the start of the works in order to assess possibly localized problems and design protection measures, as captured by [SAF 3] Detailed natural hazard risk assessment for all construction camps and technical installations to be completed before camps and installations constructed.

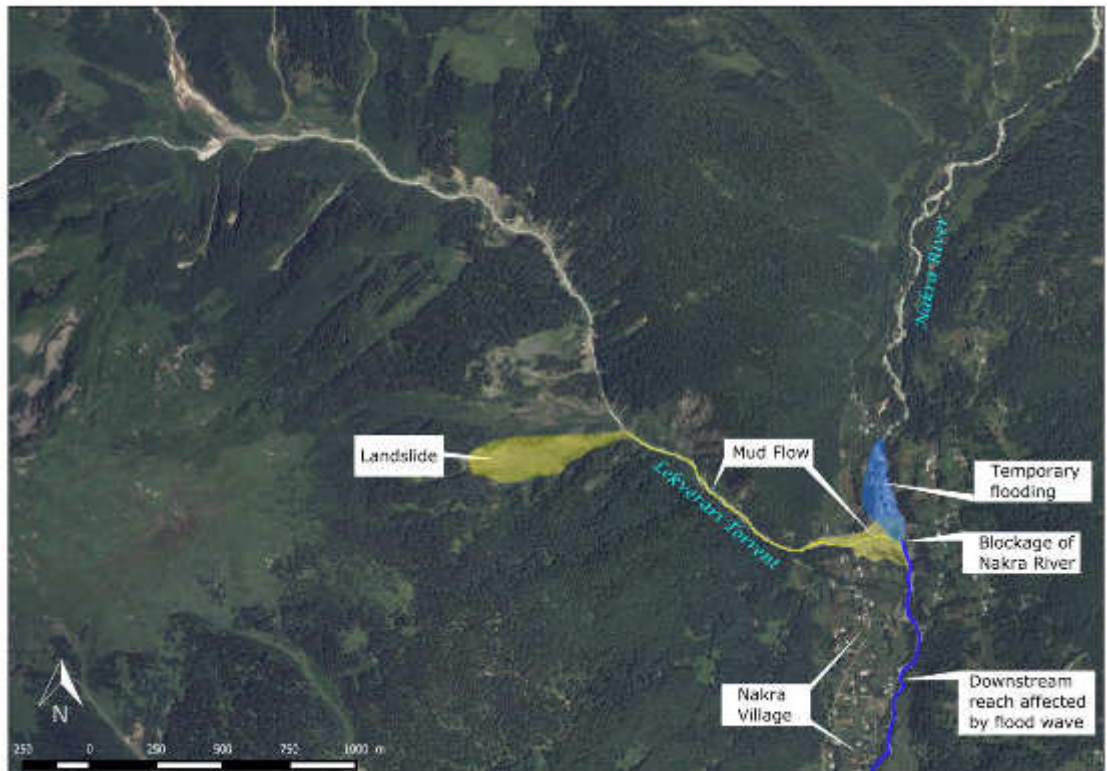
Figure 16 – Localisation of the Lekverari mudflow event, temporarily blocking the Nakra in 2011

Immediately upstream of the Nakra village, on right bank of the Nakra, is located the Lekverari torrent – a tributary of the Nakra River. In 2011, at the beginning of August, a particularly heavy rain storm triggered a landslide in the gorge through which flows the Lekverari flows. The Lekverari was in flood at the time and consequently transported a large amount of sediment from the landslide downstream to the confluence with the Nakra River, and blocked the Nakra by creating a natural dam. Within a few minutes flooding had occurred upstream extending some 800 metres. The location of the river blockage and temporarily flooded area is illustrated in Figure 16 below. Within about 5 minutes of the flooding, the force of the water flowing in the Nakra River – which was in flood – burst the blockage and caused a large wave of water to descended the river, though without causing any flooding. The natural flow of the Nakra River then progressively flushed away much of the remaining sediment.

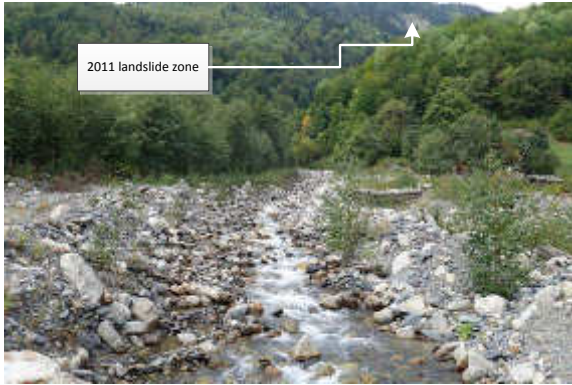
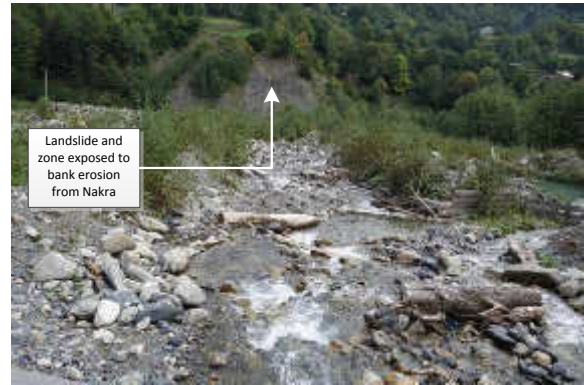
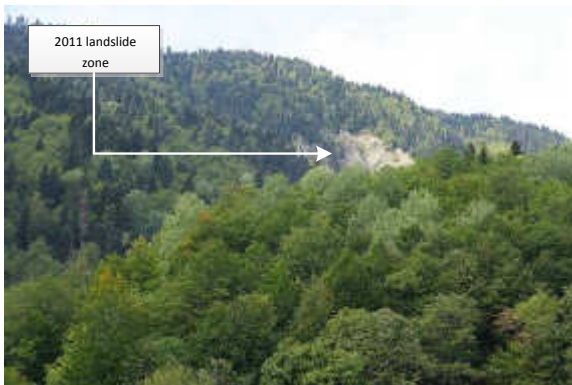
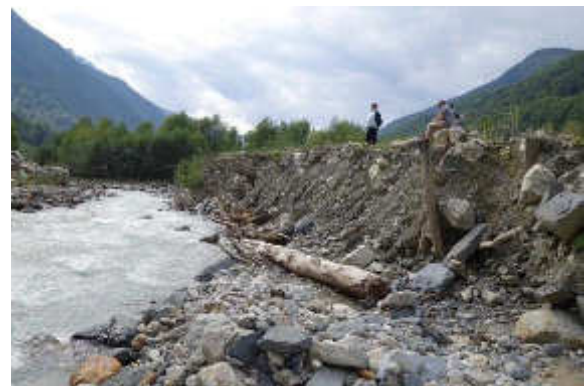
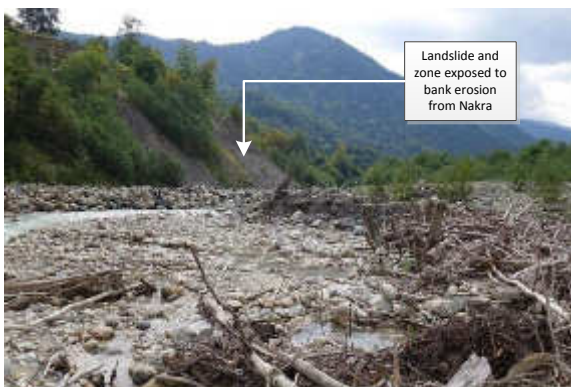
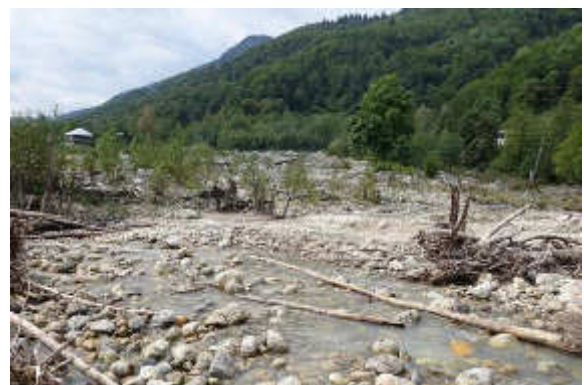
*Photo Sheet 1– Geomorphology features at the Lekverari – Nakra confluence*

2011 landslide zone

Lekverari torrent  
Photo taken from Nakra village.  
2011 landslide visible in upstream gorge

Landslide and zone exposed to bank erosion from Nakra

Lekverari torrent at Nakra village – looking downstream to the confluence with Nakra

Lekverari gorge - zone exposed to landslide risk

Nakra River – at Nakra village – remains of solid material transported by Lekverari torrent following landslide in 2011 – and which blocked the Nakra

Illustrates the depth of material that blocked the river

Lekverari torrent aluvial fan at confluence with Nakra River

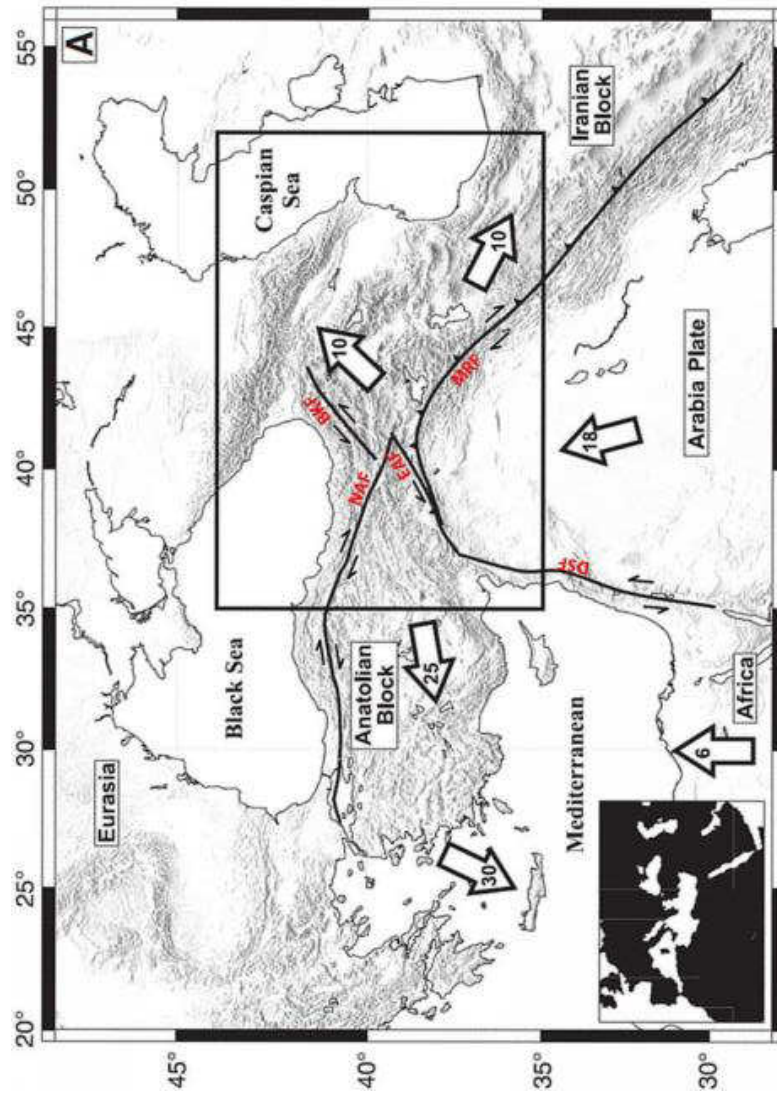
Figure A4-1: Relative plate motions in the eastern Mediterranean region

Source: Nenskra HPP Earthquake Hazard Assessment - originally in Tan & Taymaz, 2006

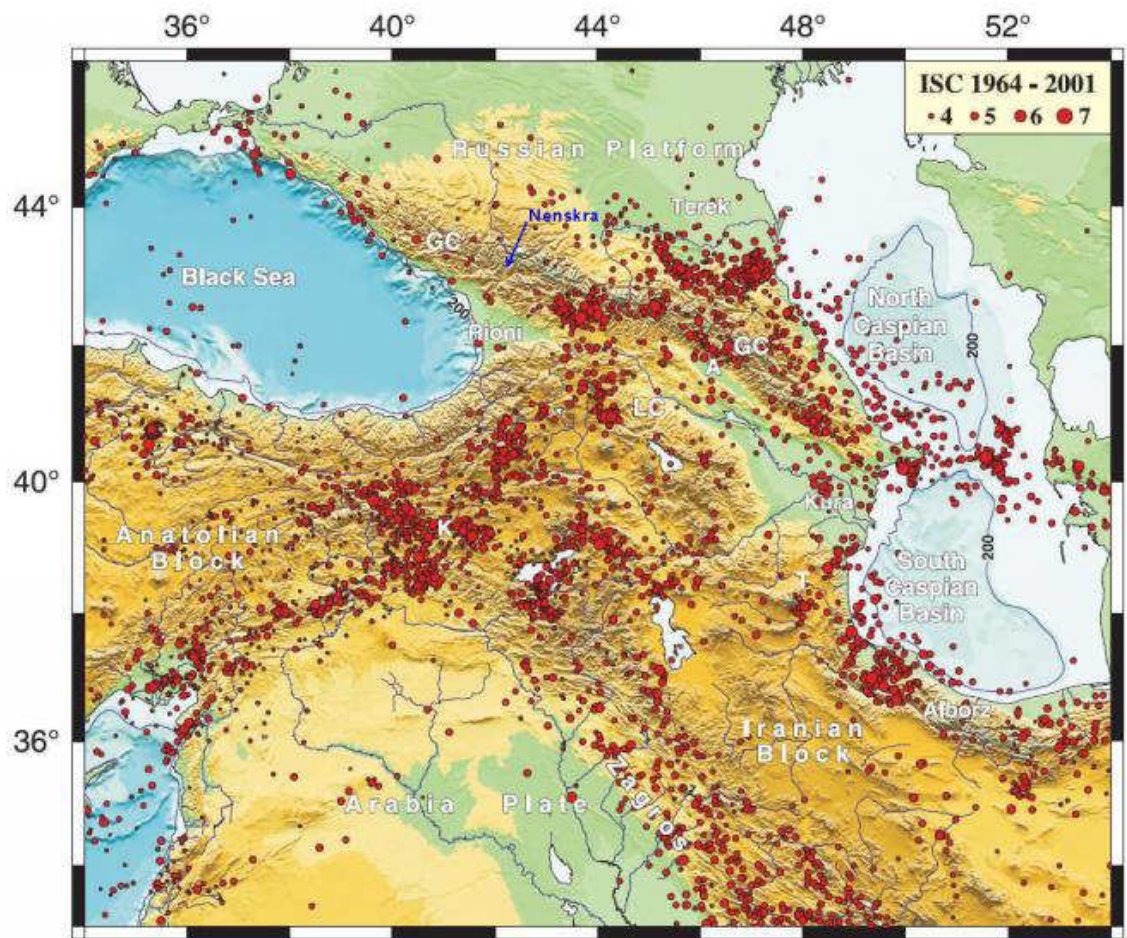
Figure A4-2: Seismicity of the Arabia-Eurasia collision zone

Source: Nenskra HPP Earthquake Hazard Assessment – originally in Tan & Taymaz, 2006

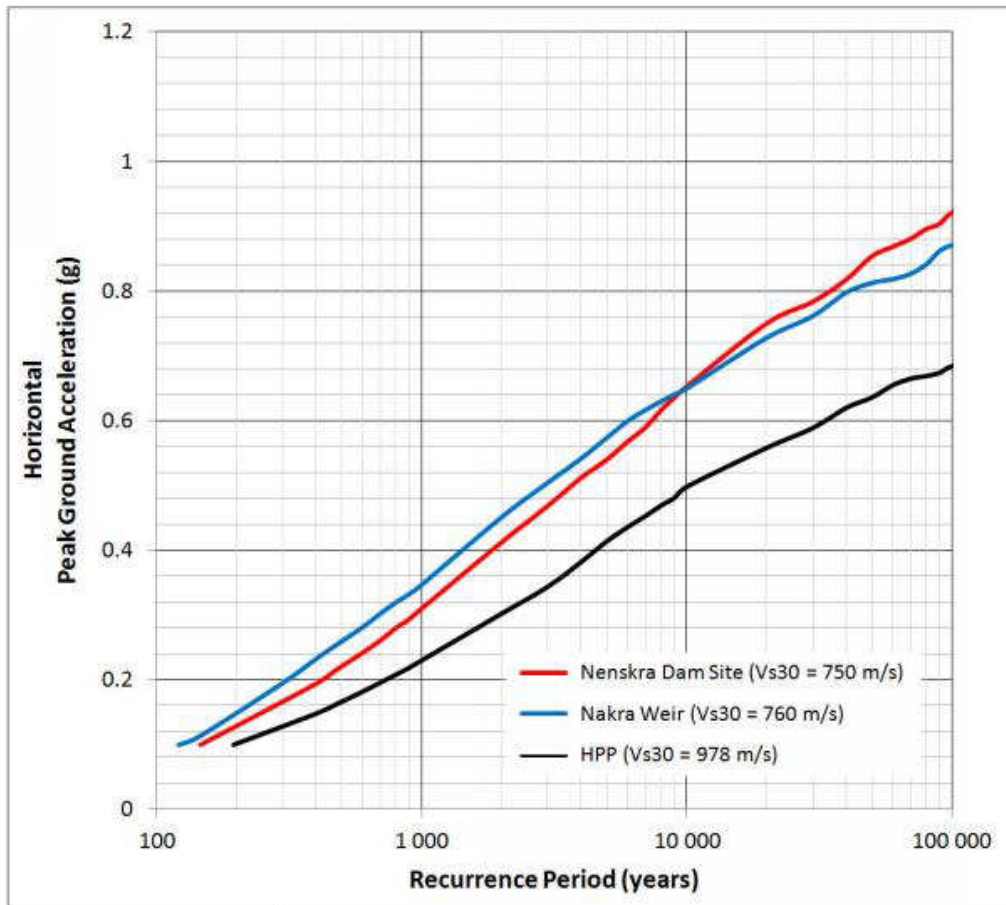
Recurrence Period (years)	Horizontal peak ground acceleration (g)		
	Nenskra Dam Site	Nakra Weir	HPP
145 (OBE2)	0.10	0.11	0.10
475 (OBE1)	0.22	0.25	0.16
1000	0.31	0.35	0.23
3000 (SEE)	0.47	0.50	0.34
5000	0.54	0.57	0.41
10000 (so-called MCE)	0.65	0.63	0.50
20000	0.75	0.73	0.56

A Monte-Carlo analysis was used to determine magnitude and frequency of ground motion at the Project site, assuming a maximum seismic event with a Moment magnitude ( $M_w$ ) of 7.5.

The hazard curves and the horizontal Peak Ground Accelerations (PGA) are presented in Figure A4-5.
