Environmental and Social Compliance Audit Report

TAJ: Golovnaya 240 Megawatt Hydropower Plant Rehabilitation Project

TAJ: Golovnaya 240 MW Hydropower Plant Rehabilitation Project¹ Environmental and Social Compliance Audit Report

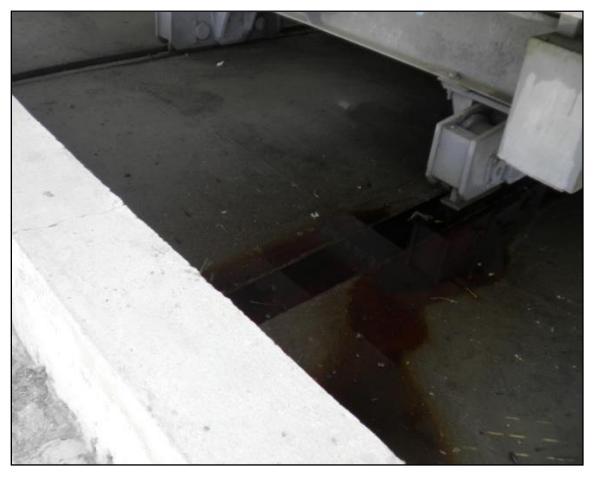
- <u>Oil leaks from power transformers</u> and lack of the oil containment facility and oil/water separators. Current relatively low level of leakage is managed/removed manually by the staff (using sand or wood particles), the leaks during rains are not prevented and end up in the river. In case of emergency larger spill, the manual oil removal is sufficient, and the oil will end up in the river too.

1. Leak of transformer oil; tailrace deck;

- 1. Powerhouse sumps should have oil/water separators.
- 2. Tailrace deck transformers should have oil containment equipment with oil-water separators.

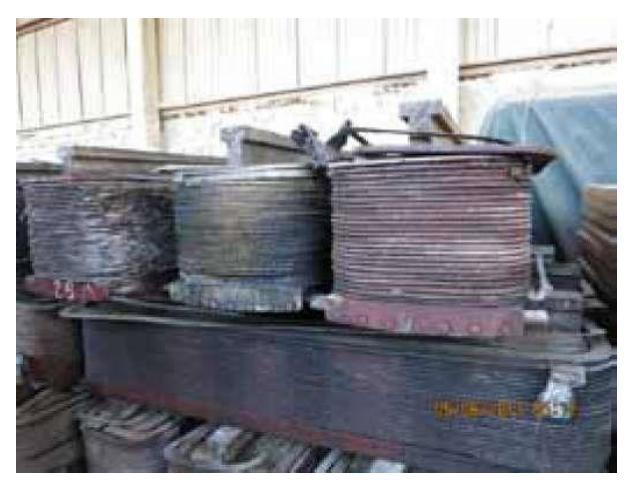
- <u>Asbestos paper</u> is used in between wiring of rotors. The paper layers were installed originally by the manufacturer and now during maintenance works, these paper layers, covered on both sides with lacquer are removed mechanically and new paper is installed. Asbestos emissions into the air and degree of protection of workers are not measured. Asbestos sheets (thicker paper) are also used (in a wet form) as fire prevention border during various welding works.

2. Asbestos paper used in between wiring of rotor

Current practice of the use of asbestos containing materials for the purpose of fire protection during welding should be changed in the future.

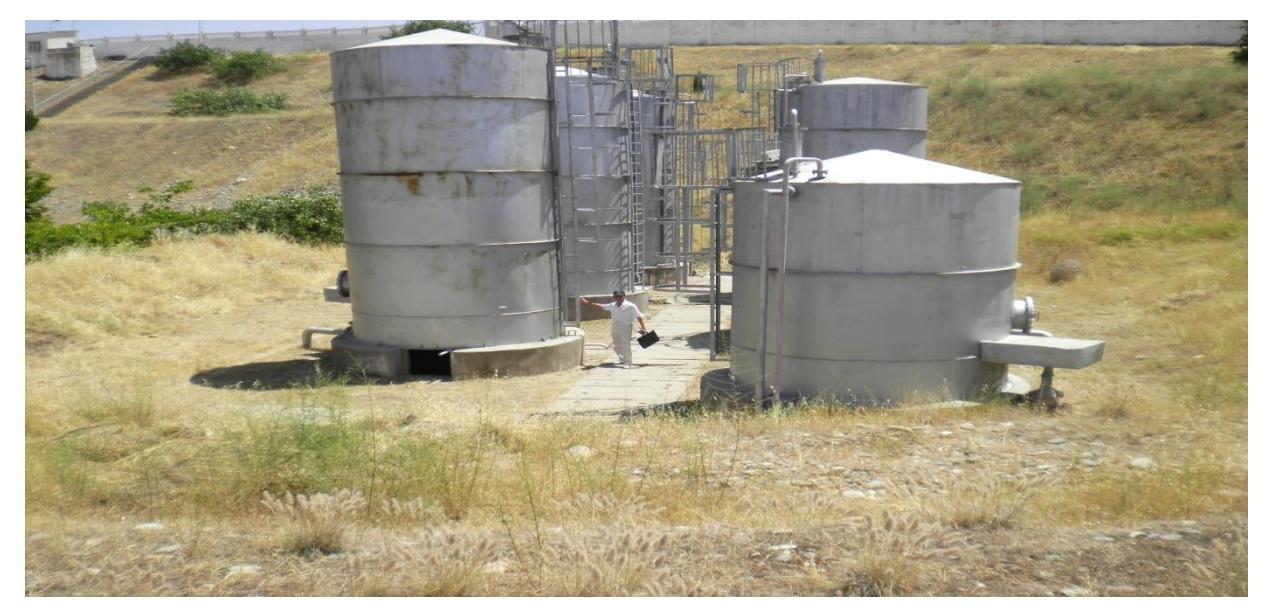
3. The storage tanks for hydraulic oil and transformer oil, located just south east of the control room, should have oil containment basins under the tanks and oil-water separators.

- 5. The storage tanks for hydraulic oil and transformer oil, located just south east of the control room, should have oil containment basins under the tanks and oil-water separators.

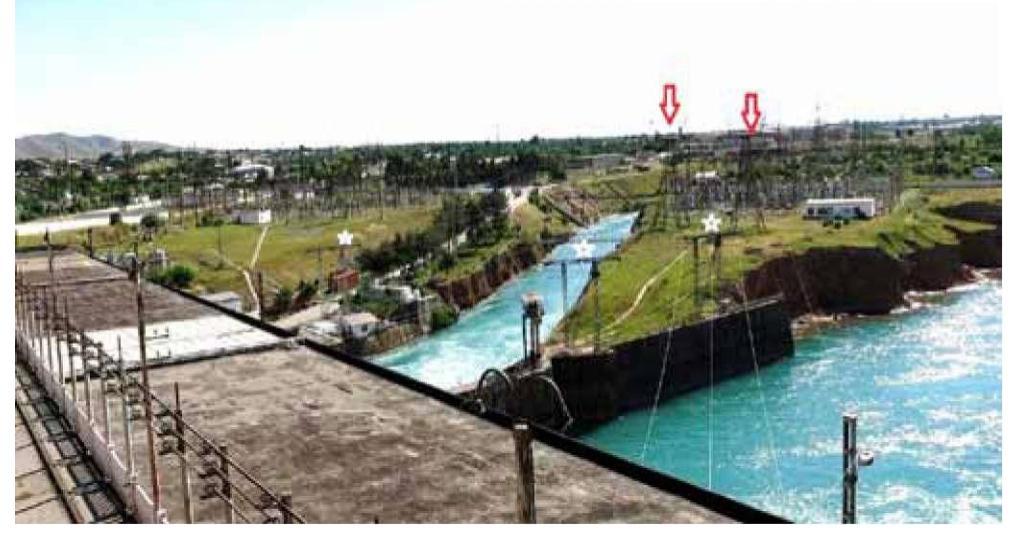
19 <u>Soil erosion</u> of the left river bank, close to the site of 220 kV switchyard, and to the smaller extent erosion of the right bank of the irrigation canal, also close to that switchyard site.

4. Left. Te highly eroded left river bank. There are no traces of the original embankment. The erosion is very close to the site of the 220kV switchyard, affecting its structural stability.

12 The scope of the proposed project covers the rehabilitation of the generation part of the plant: replacement of 3 generator units and rehabilitation of the remaining 2 old generator units, rehabilitation of the spillway and replacement of the 2 transformers. In addition, the project will finance the embankment of the eroded left river bank. Improvement of both switchyards is beyond the project.

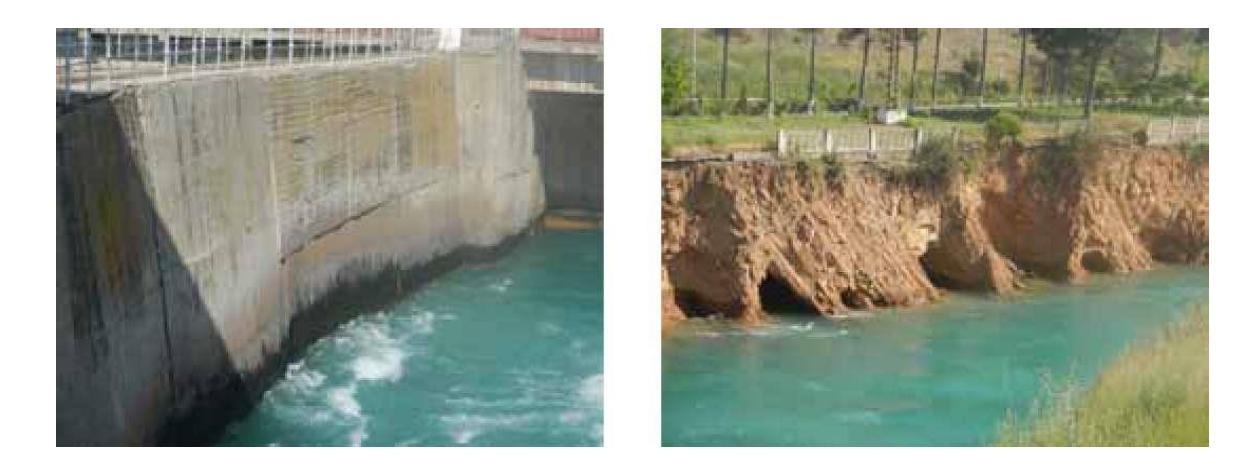
- <u>Soil erosion</u>: erosion of the left river bank, close to the site of 220 kV switchyard, and to the smaller extent erosion of the both banks of the irrigation canal, also close to that switchyard site.

5. Left: irrigation canal, right wall; right: irrigation canal: left bank - erosion;

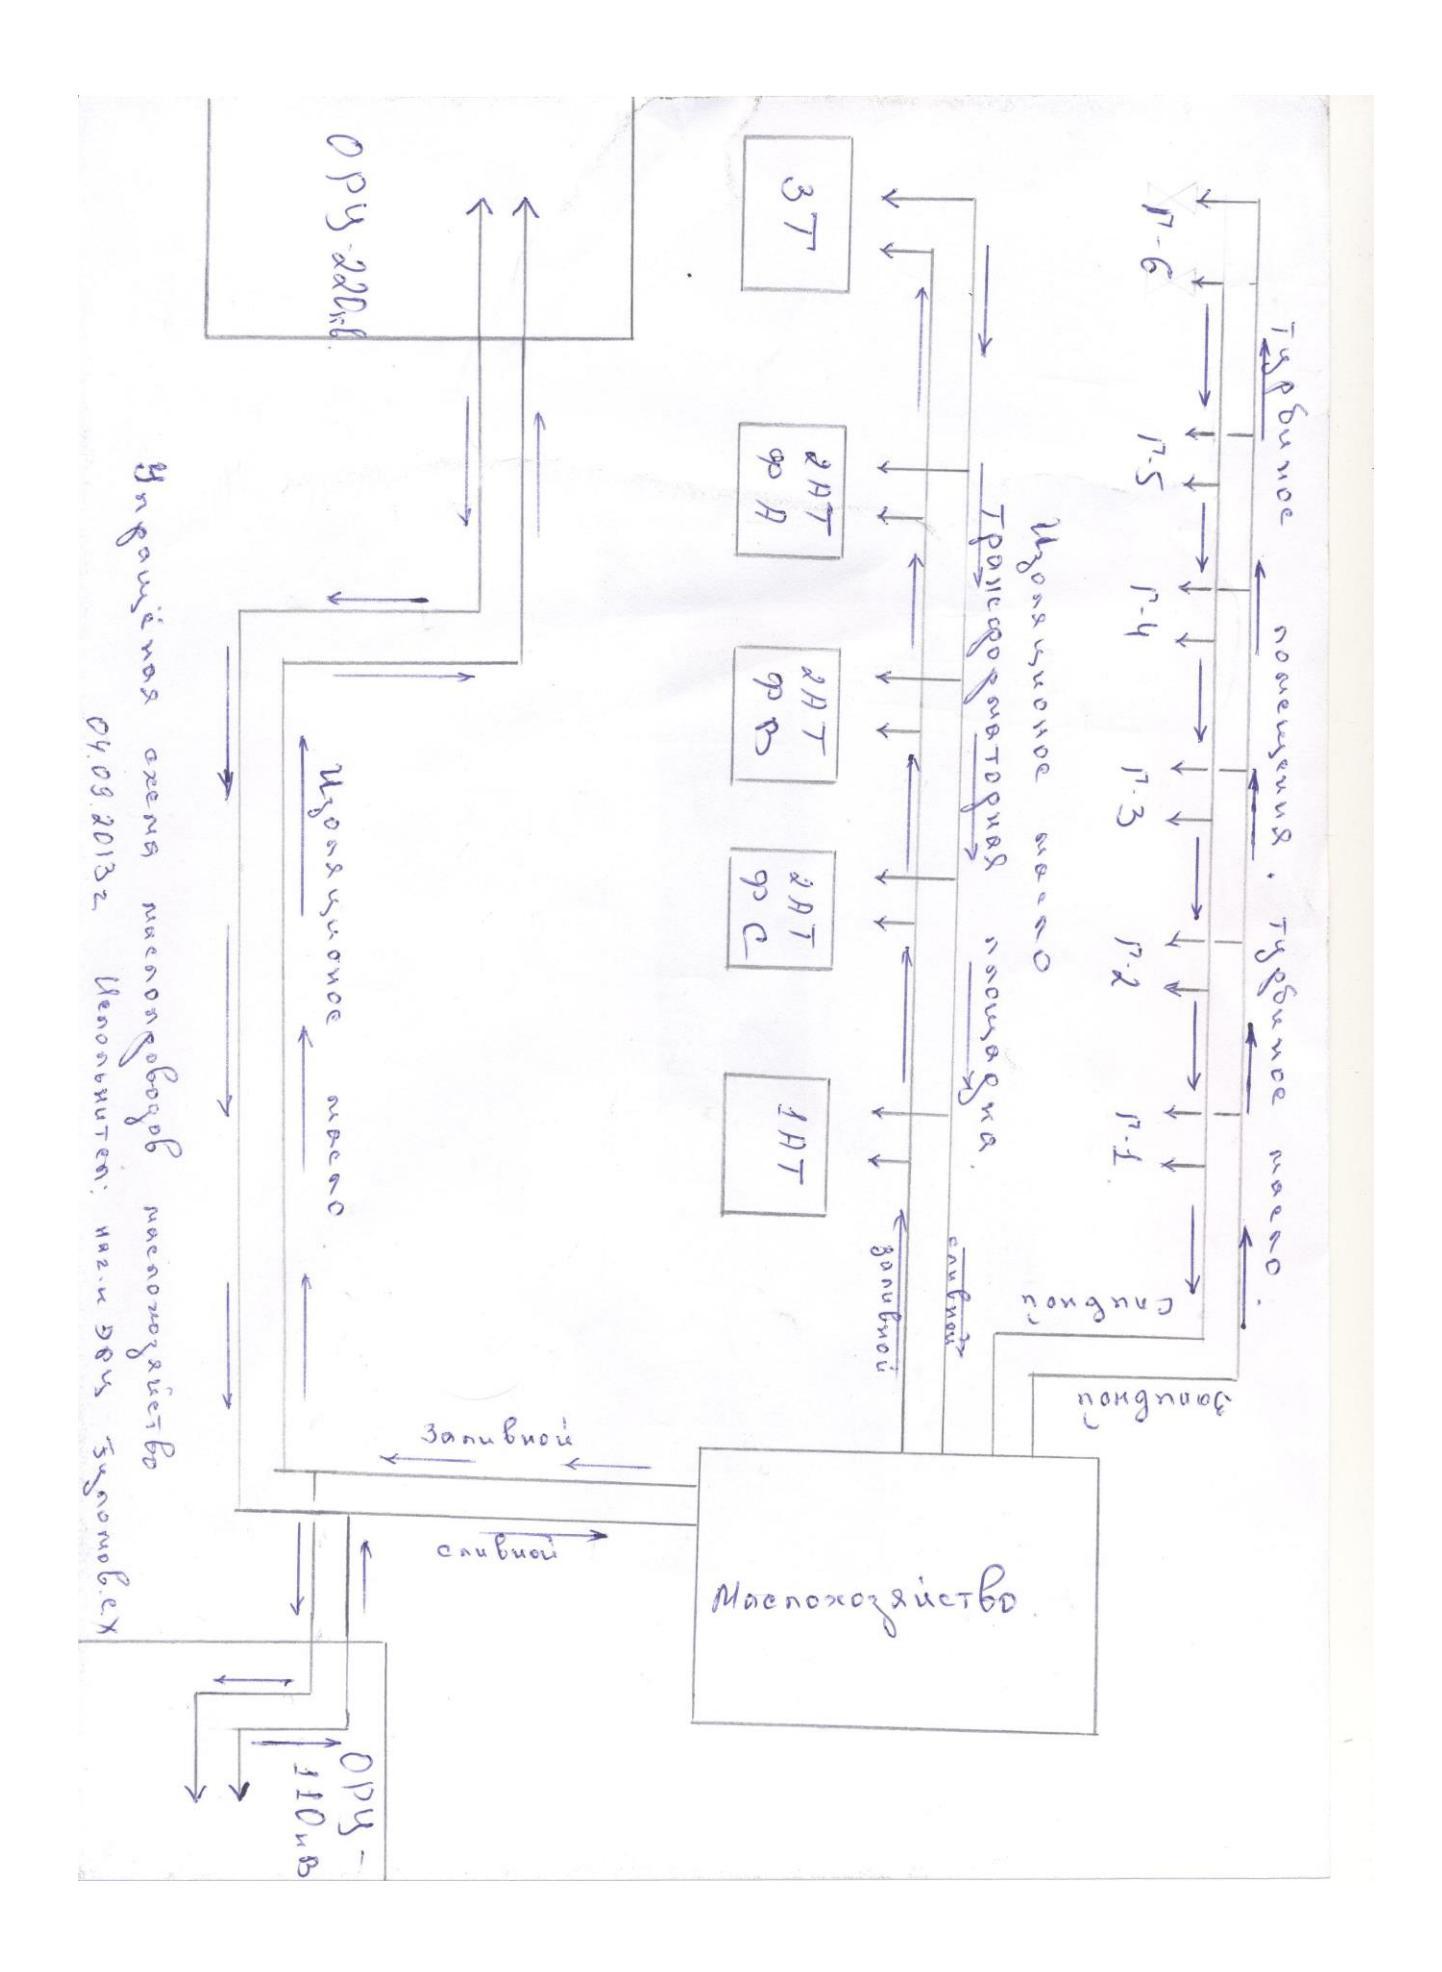
ANNEX 3. SCHEMATIC LAYOUT OF THE OIL TREATMENT INFRASTRUCTURE

- 6. Turbine and Transformer Oil Handling System. The common oil handling system for the governor, turbine-generator bearings, transformers and switchyards comprises steel tanks located in the open area, a pumping station, filtering station and piping system with flexible piping connections for connections to individual units. Although the turbine oil handling system is functional, the equipment is antiquated. Existing oil spills in the room housing the equipment are a hazard. With no adequate fire protection the present arrangement is a hazard for equipment and personnel. It is recommended that the oil handling system be replaced in the future with a modern system comprising a mobile cart with filter press, a portable system of drums and flexible piping. The equipment can be lowered to the turbine floor with an equipment cage using the powerhouse crane. There is no gases removal unit at the plant. When needed, the mobile unit is rented from other sites of BT, but this practice is ranked by Golovnaya as not efficient ad not sufficient for proper oil management
