MON: Western Regional Road Corridor Development Project – Phase I

ENVIRONMENTAL MONITORING REPORT

Bi-annual Report

April - June, 2014

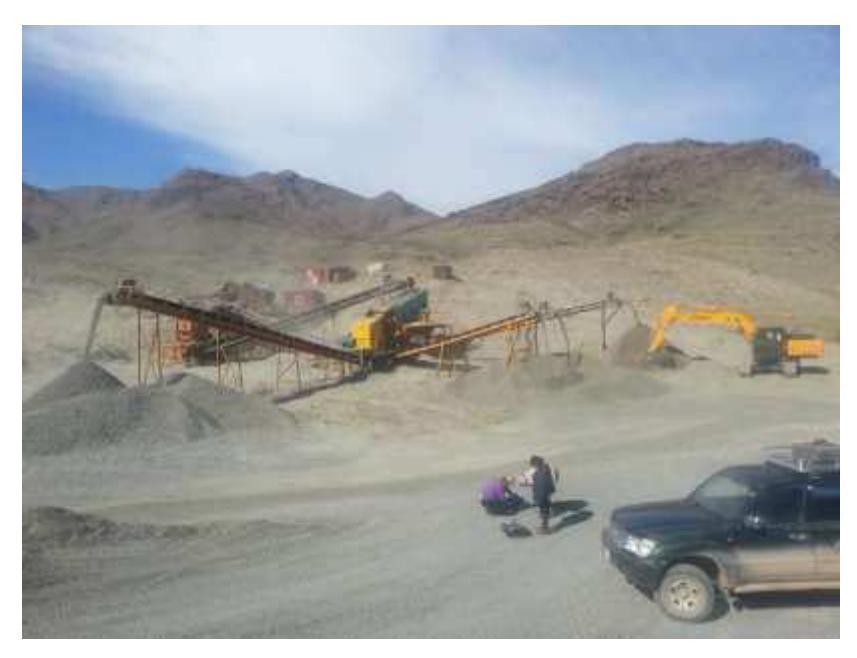
Figure 5: Quarry site, Package 1.

There are 3 quarries for producing aggregates for cement and asphalt concrete, graded crushed stone base course material located around STA.12 on the right 2 km away from Altay soum center, at STA.54 on right and STA.92 are under operation.

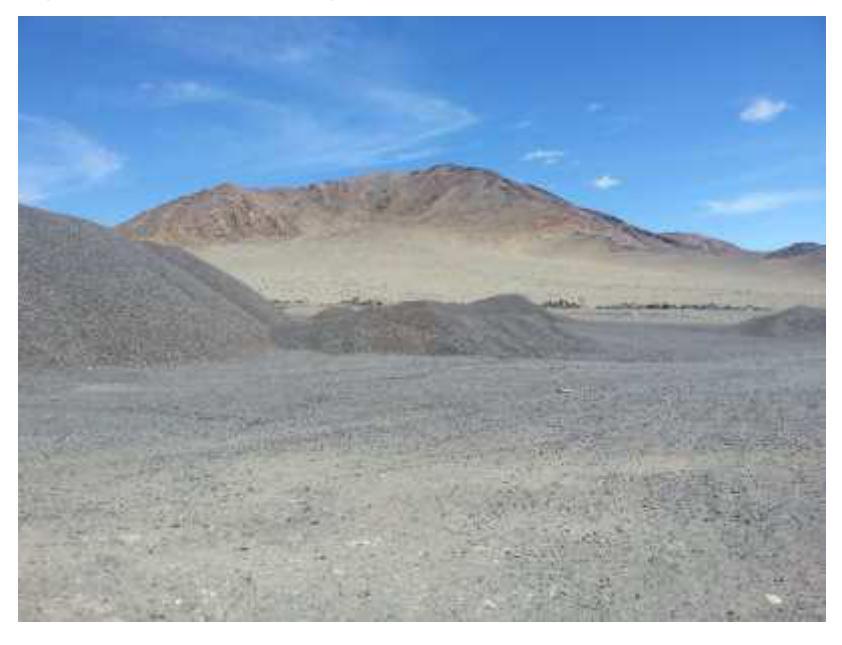
Figure 6: Quarry site, Package 2.

The quarry for production of aggregates for base course, cement and asphalt concrete located at STA.54 on the right 0.5 km away from the project road alignment is operating from beginning of April 2014.

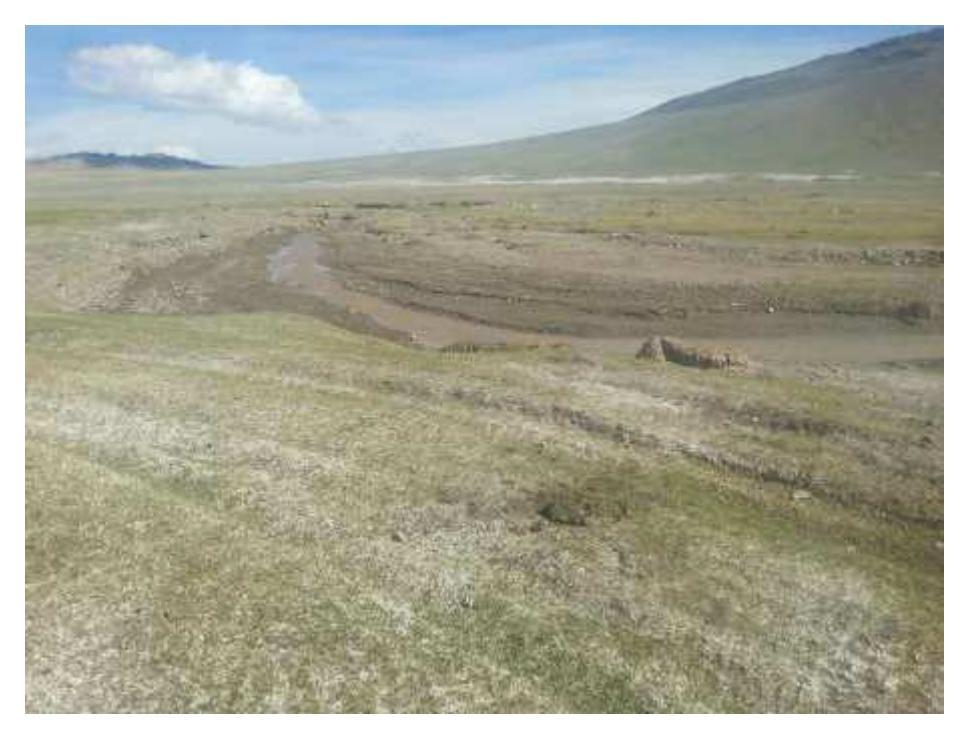
Figure 7: Tsahiriin River nearby the main camp of Package 2.

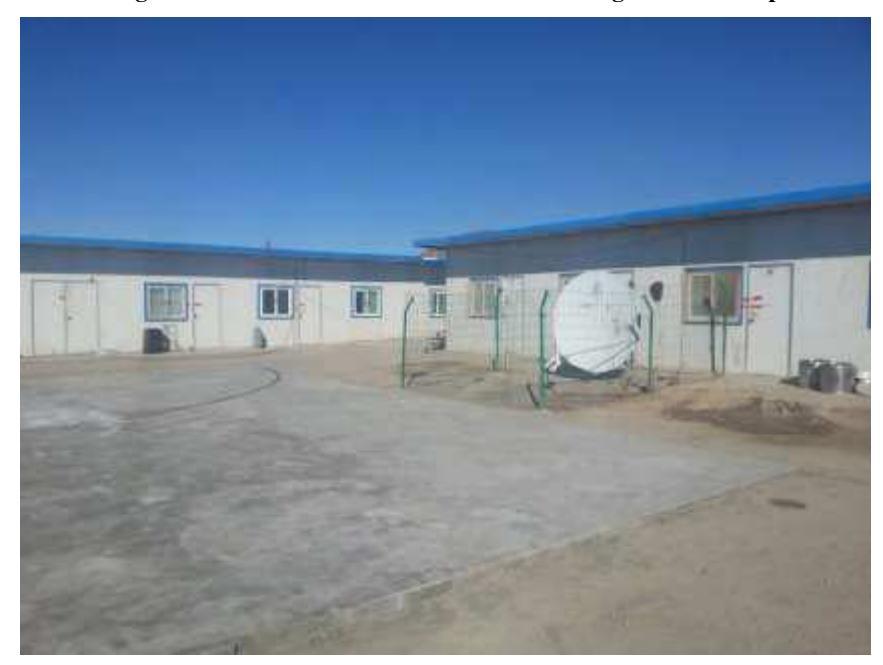
Figure 8: Workers' accomodation at the Package I Main camp.

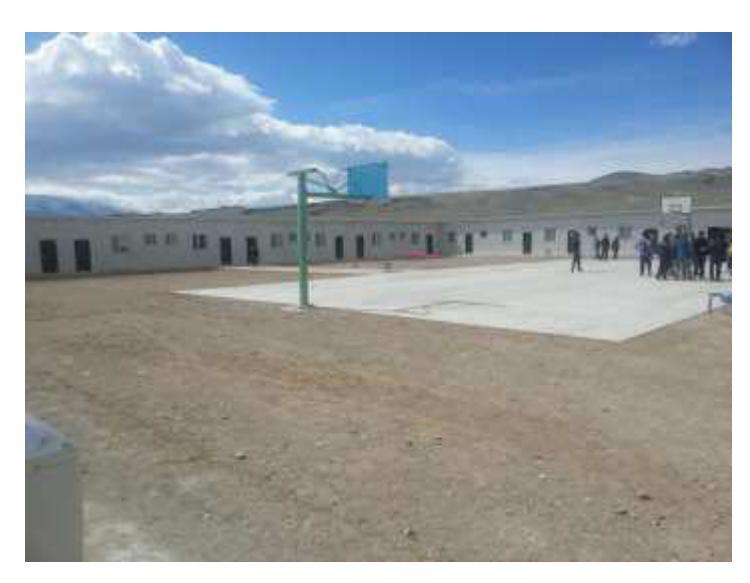
Figure 9: Package 2, Main camp

The campsite yard is covered with crushed stone together with concrete path, the access roads including drainage lines is kept neat and clean by spraying water regularly to control the dust.

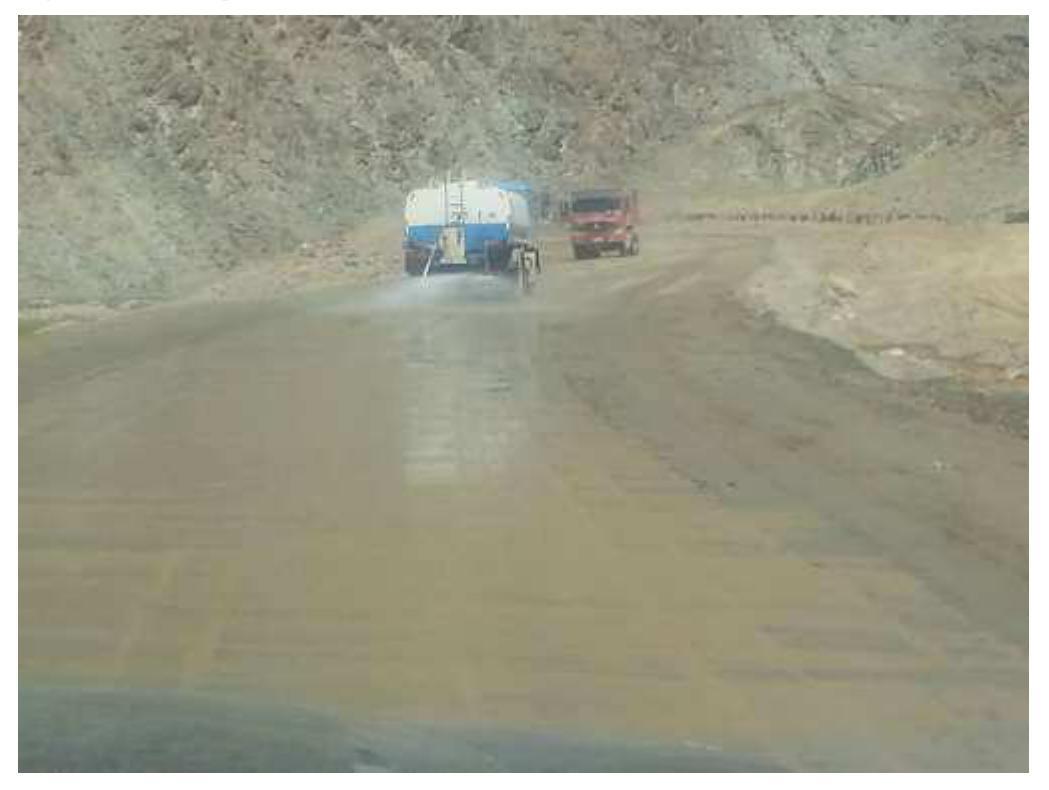
- Embankment sections spraying water by water truck regularly
- Around campsite spraying water by water truck regularly
- Traffic passage and access roads- Since it is very difficult practically for the Contractor to control the whole passage of traffic, the Contractor is able to send water spray trucks to the active operational sites only.
- Crushing plant Package 1: spraying water by nozzle connected to water tank while working. Package 2: Crushing plants are not erected yet.
- Asphalt plant to reduce smoke emission Package 1: Dust collector equipped to the plant is working properly. Package 2: not erected yet.

Figure 10: Water spray truck, Bodonch canyon

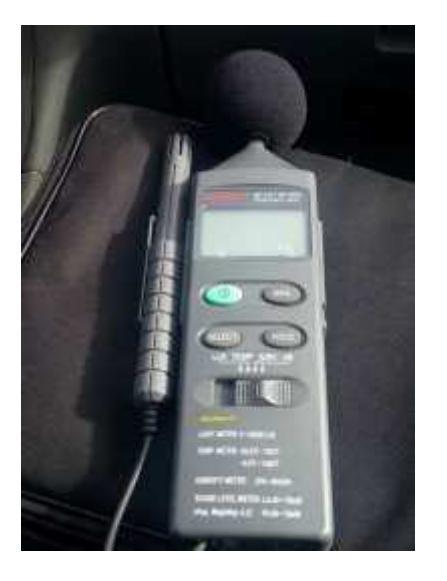
Figure 11: Noise measurement device used for monitoring

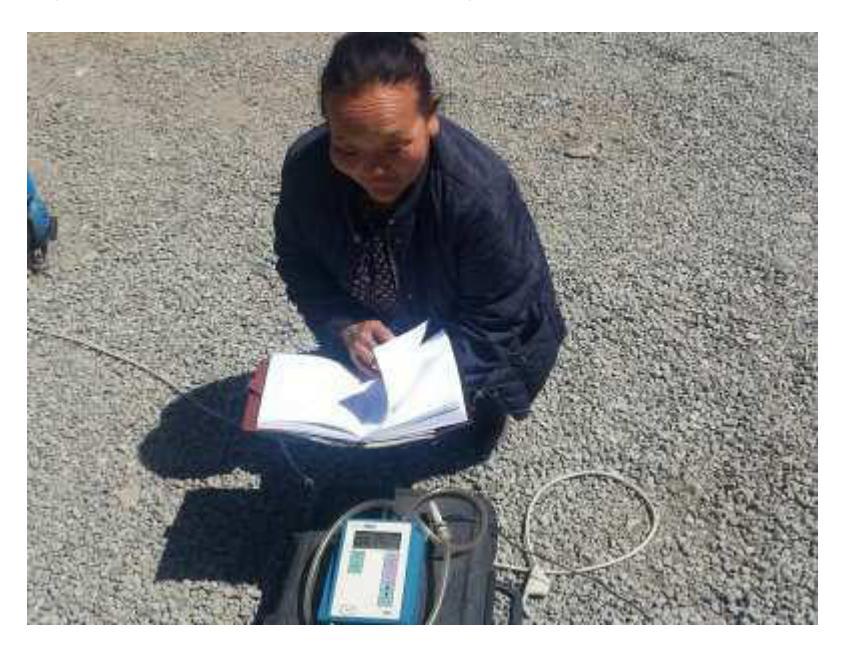
Figure 12: Dust Trak used for monitoring

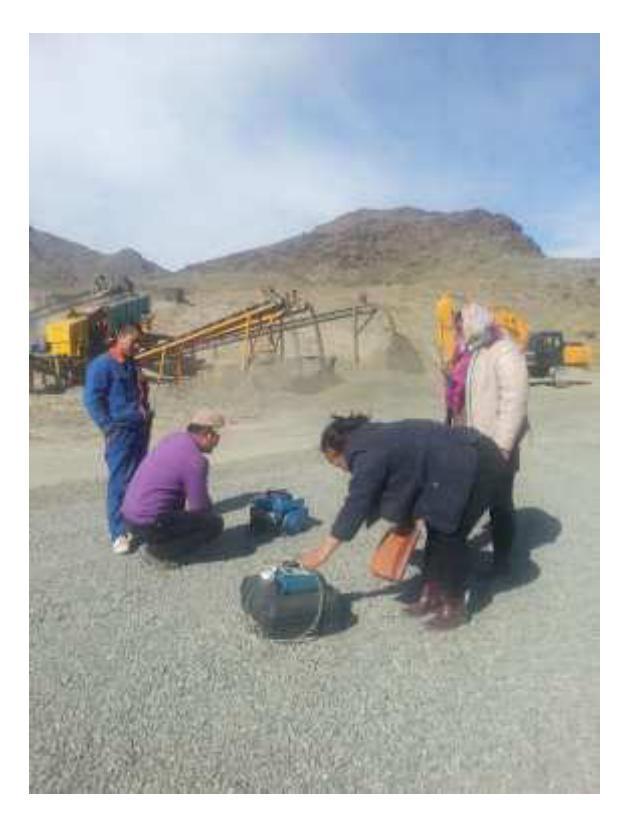
The monitoring team has chosen 11 points around construction camps, quarries, mixing plants and the most actively operating construction points where dust generation is relatively high. The maximum allowed level of dust concentration is 0.1 mg/m3 according Mongolian Standard on Ambient Air Quality. Measured dust concentration level was within the allowed level at 5 spots and very close to allowed level (slightly exceeding) at 3 other spots. Dust generation levels have exceeded the standard level significantly at Tsagduultiin am quarry, 5 Ovoo quarry and the Main camp of Package 1 during the active construction hours.

Figure 13: Specialists from the Institute of Meteorology of Khovd province measuring dust concentration level
