CIVIL AVIATION DEVELOPMENT INVESTMENT PROGRAM – TRANCHE 2

Environmental Monitoring Report

Reporting Period: July 2015 – December 2015 (2nd Semi-Annual)

PNG: Civil Aviation Development Investment Program – Tranche 2

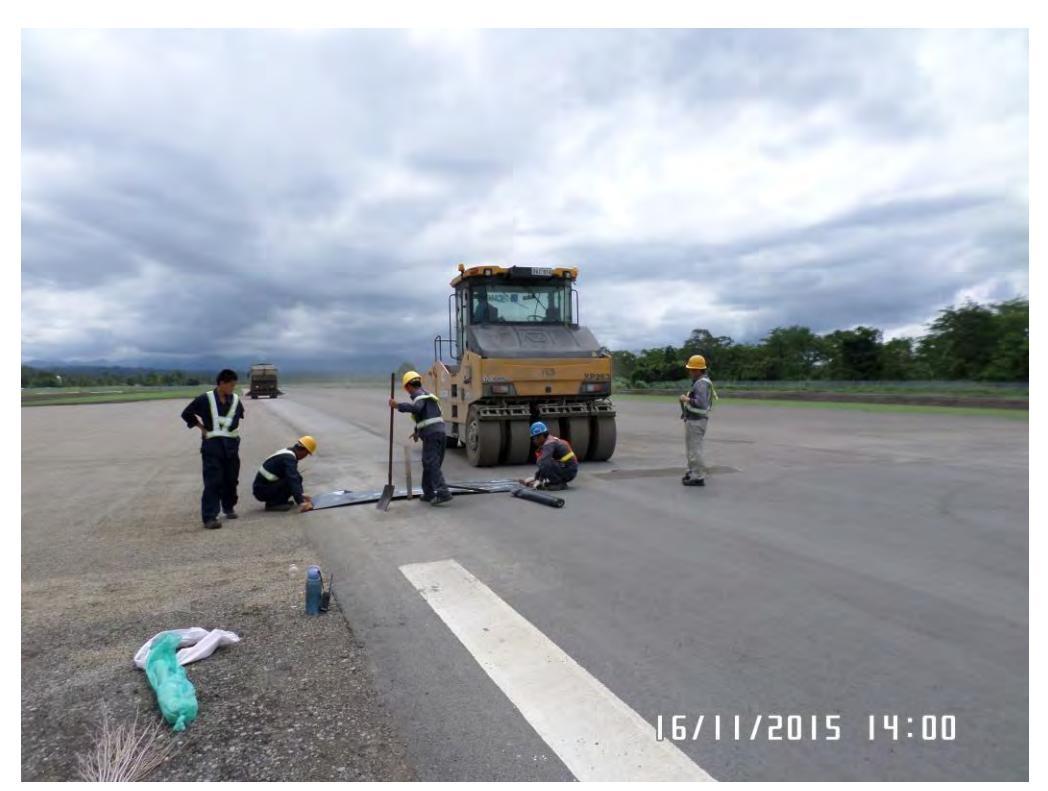
Picture 1: Gravel placement and compaction on the main runway

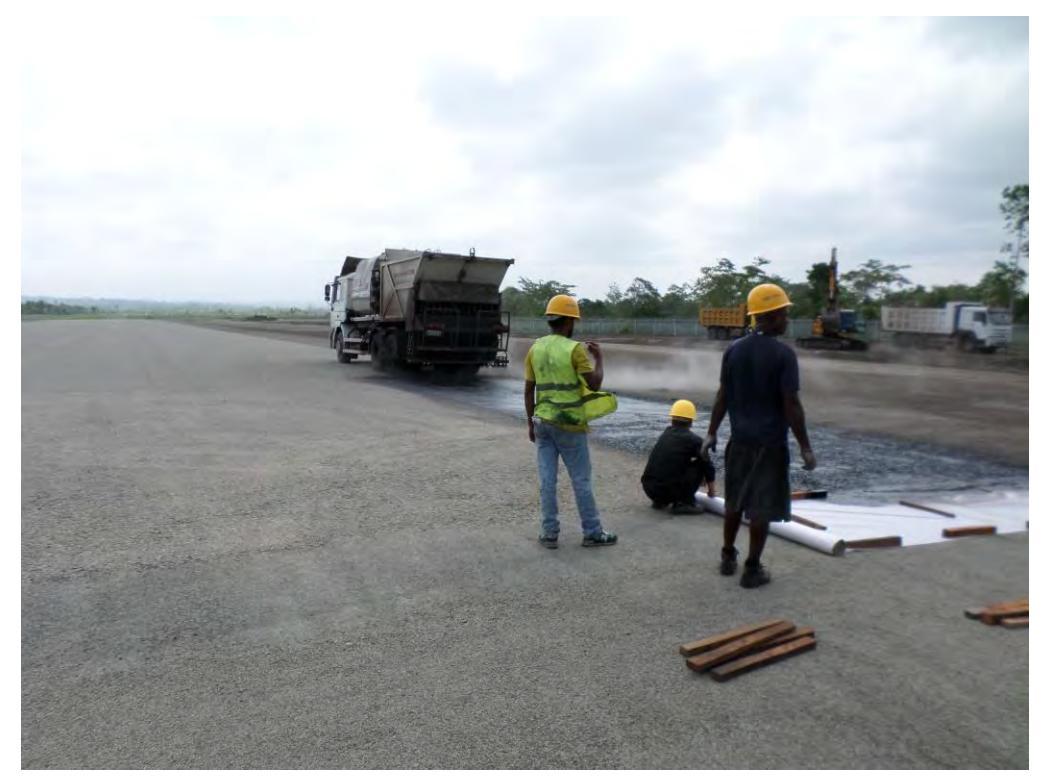
Picture 2: Gravel priming and lay down of bitumen at finish level.

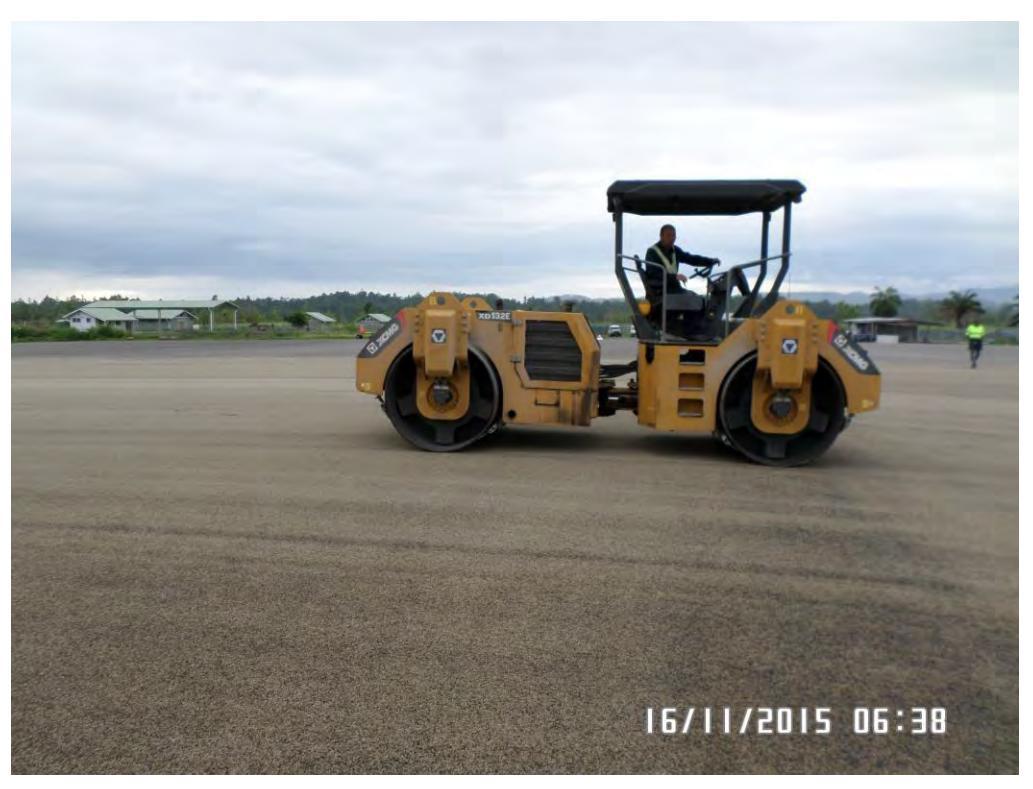
Picture 3: Bitumen compaction is done soon after priming to avoid seepage and air pollution exposure.

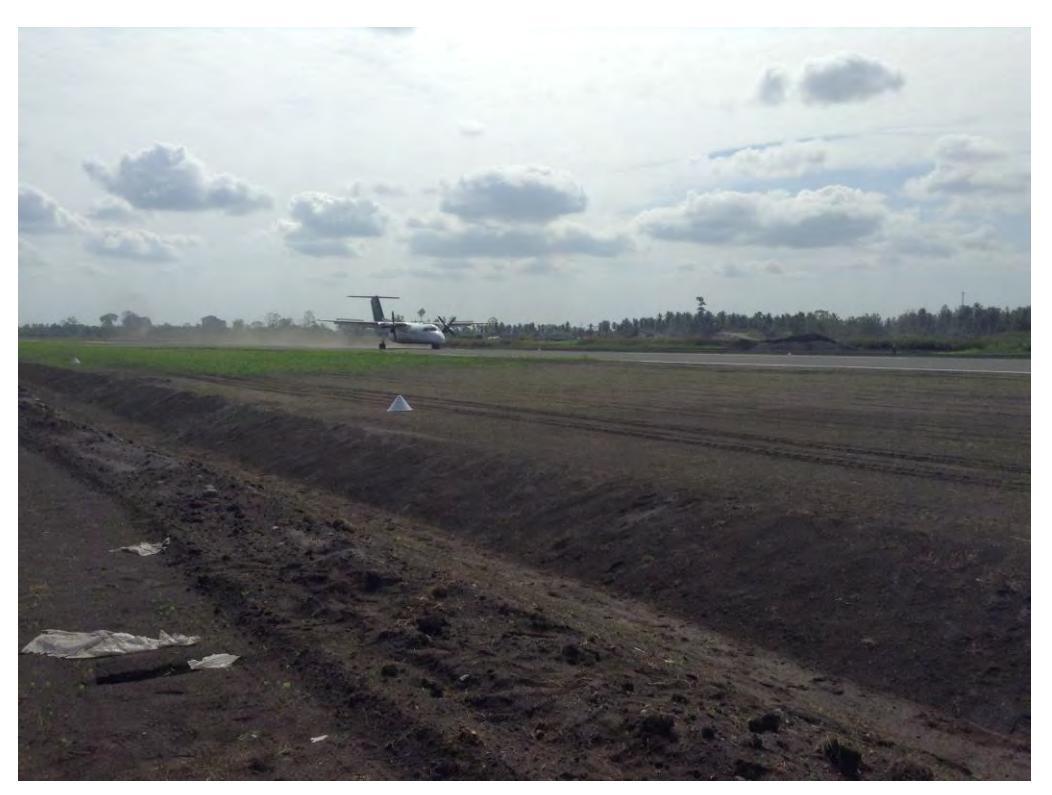
Picture 4: Completed construction of open unlined drain to a required dimension and slope to contain highest rainfall from surface runoffs. Notice the Dash 8 aircraft landing from the new runway end with minimal dust emission generated from the pavement. The flight strip are and the drain is left stable for grass growth.

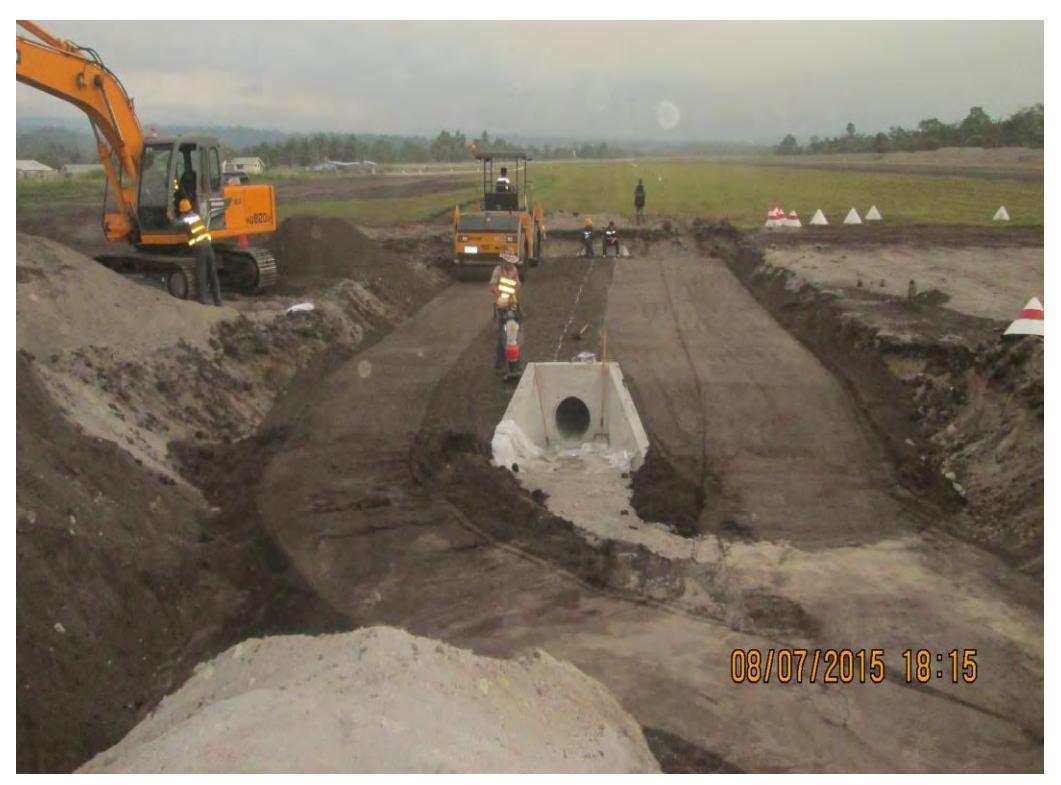
Picture 5: Construction of storm water drainage for proper drainage.

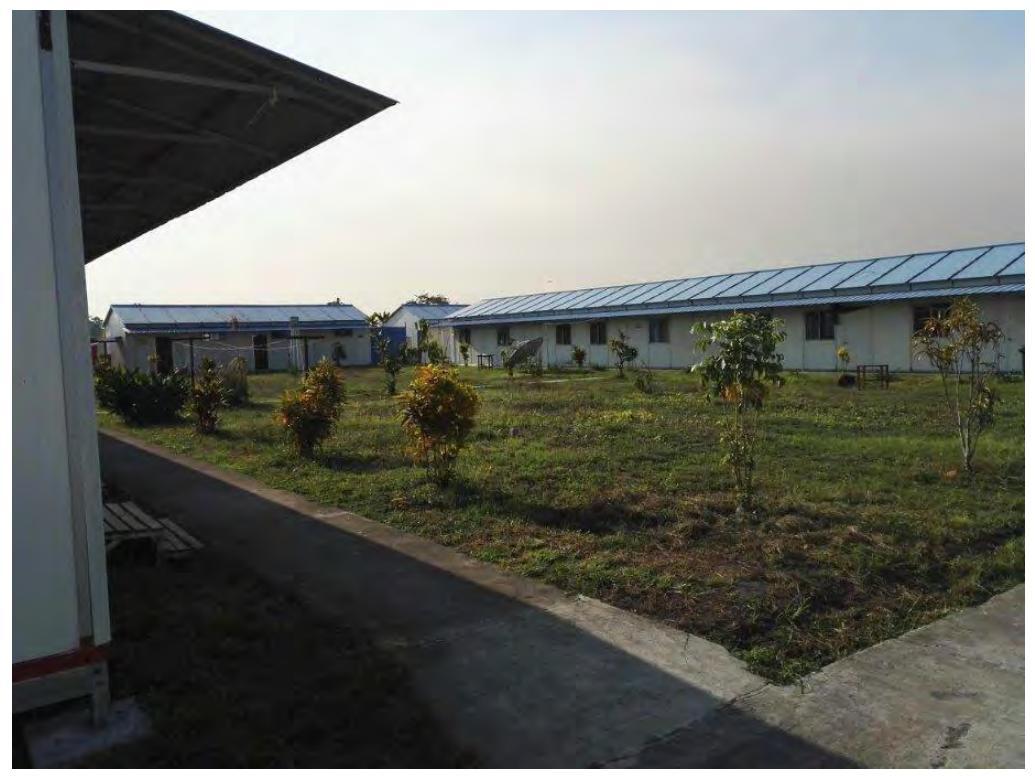
Picture 6: Maintaining cleanliness at the camp site. Soil expose areas are planted with grass and flowers for beatification and control of dust during sunny days, mud forming during rain.

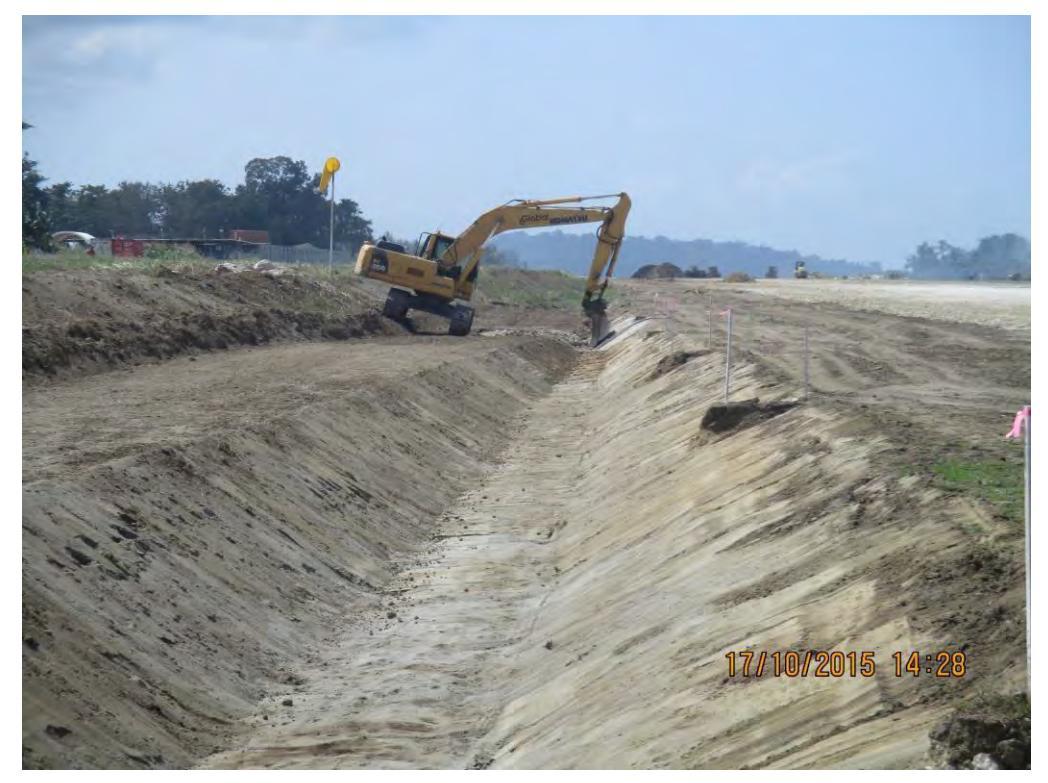
Picture 7: Grubbing and scrubbing; top soiling and proper stockpiling. Constructing of open unlined drain (OUD) with proper dimension and slop design. Spoils are later used for top soiling and re-grassing.

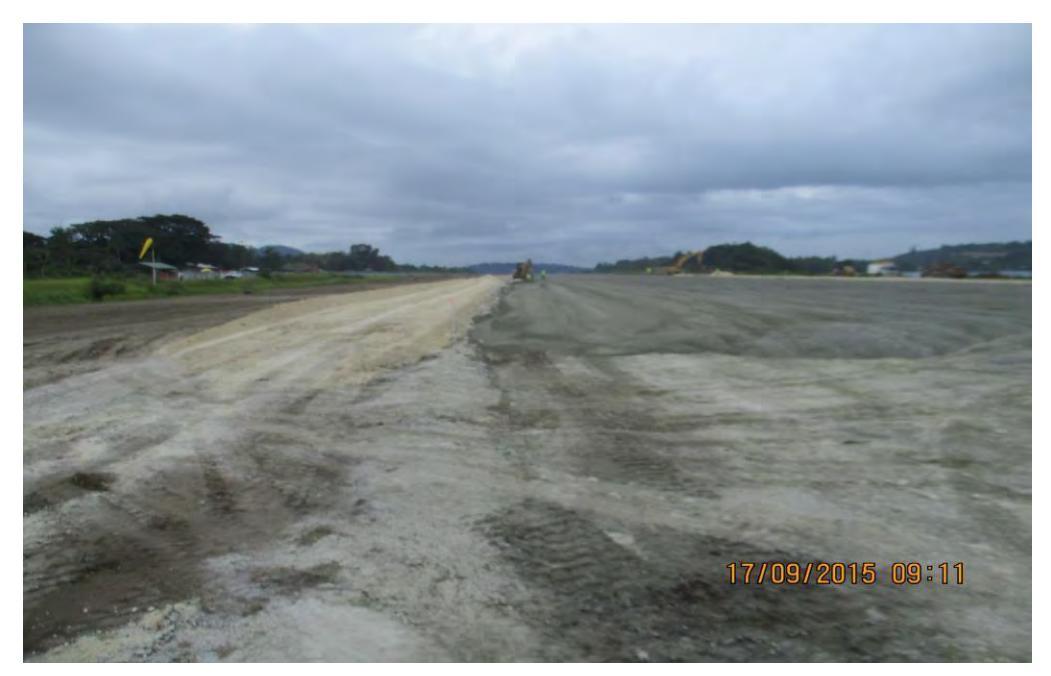
Picture 8: Base course placement and compaction on the main runway. Notice moisture content of the base course to control excessive dust emission.

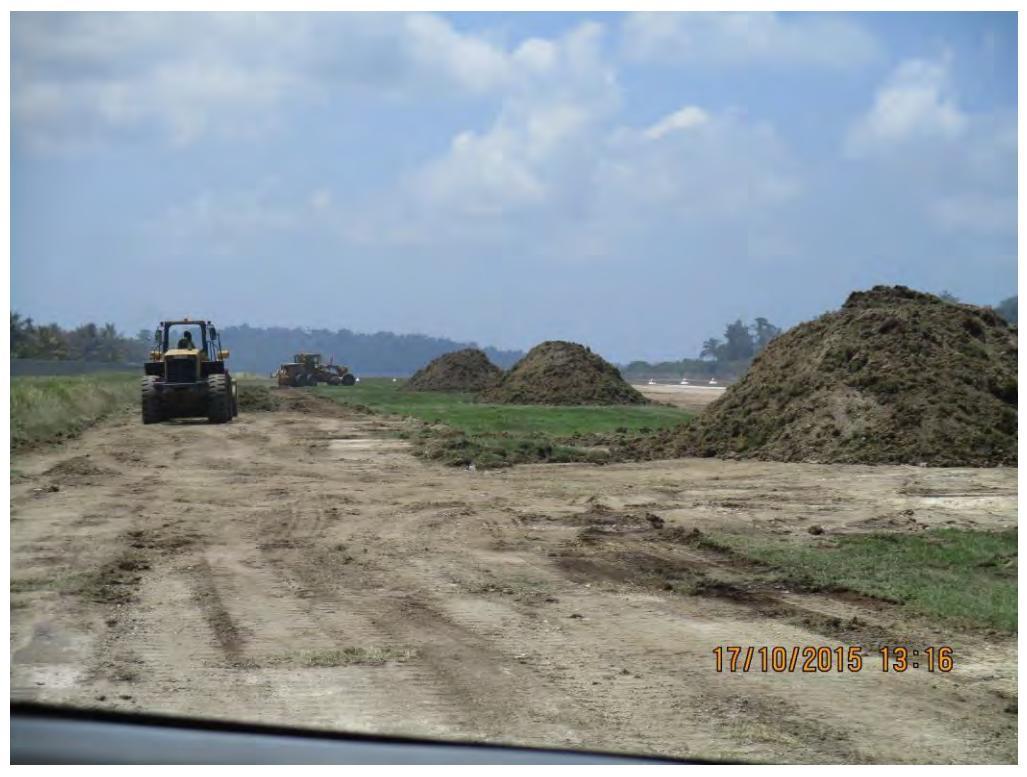
Picture 9: Grubbing and scrubbing works on flight strip. Topsoil; stockpiled appropriately and away from drains and water bodies.

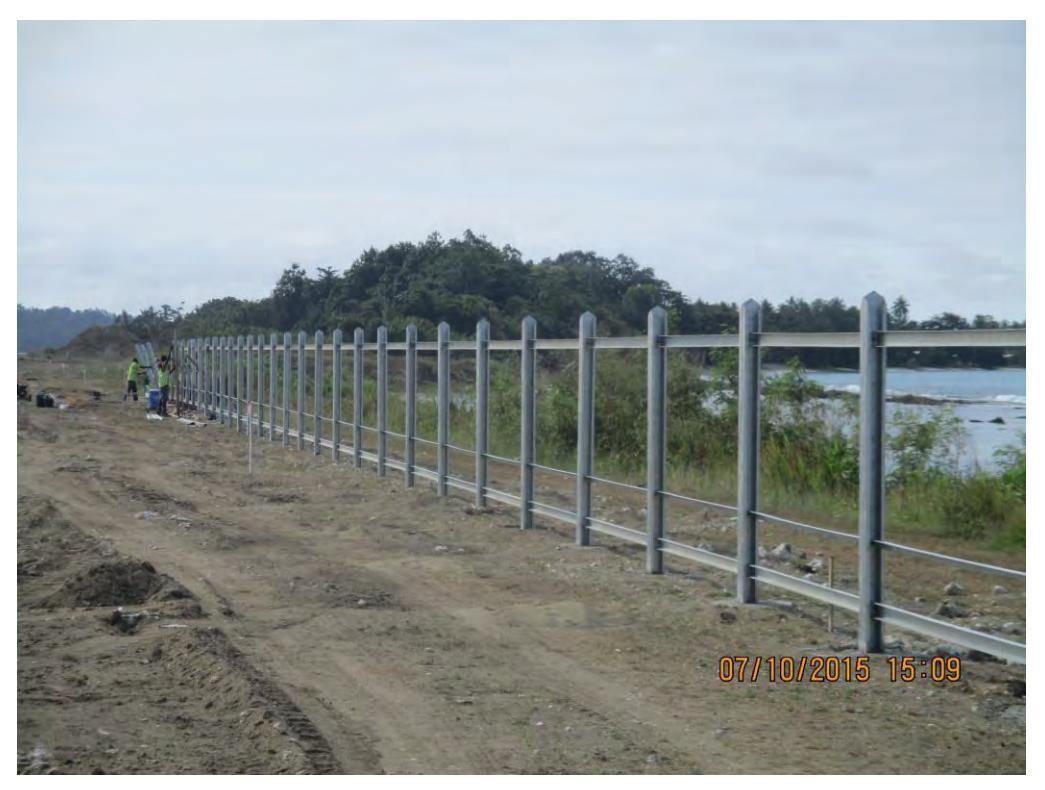
Picture 9: New Palisade fencing installation works. Spoils are removed and cleared from working area. Top soiling is done later on embankment flanks to allow grass regrowth.

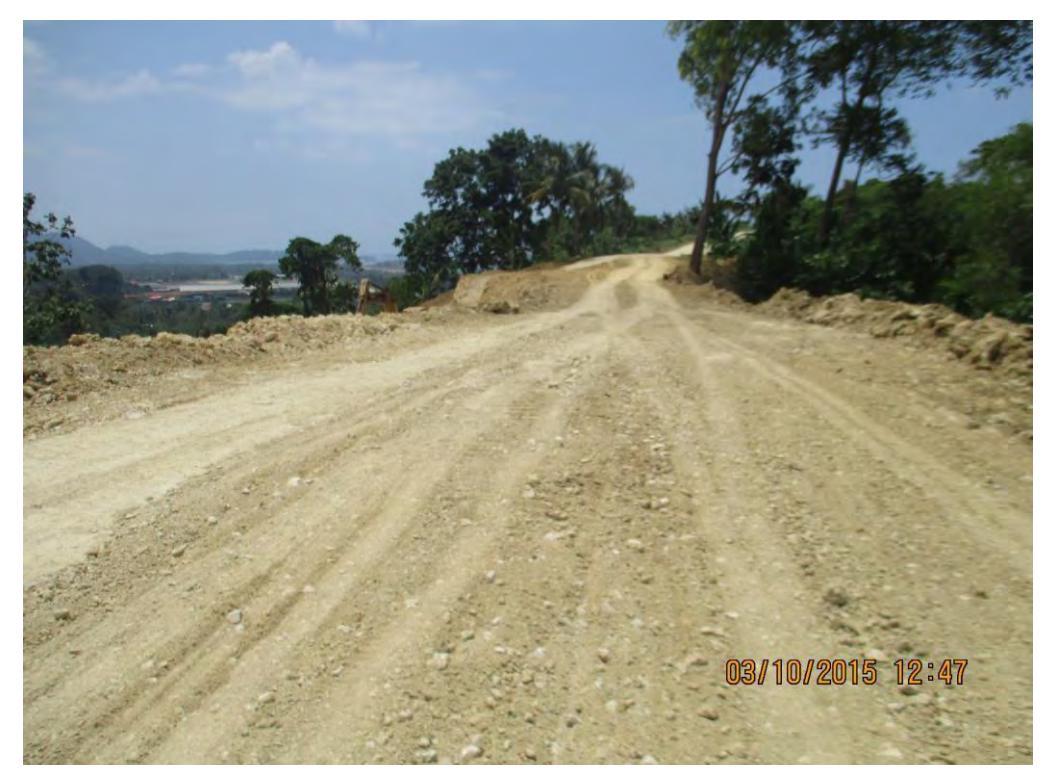
Picture 12: The once narrow access road is improves to allow easy passage for truck load of coronus base course materials from the extraction site to the construction site. This road is now easily accessible by locals who live along the road. Dust is minimized using water truck

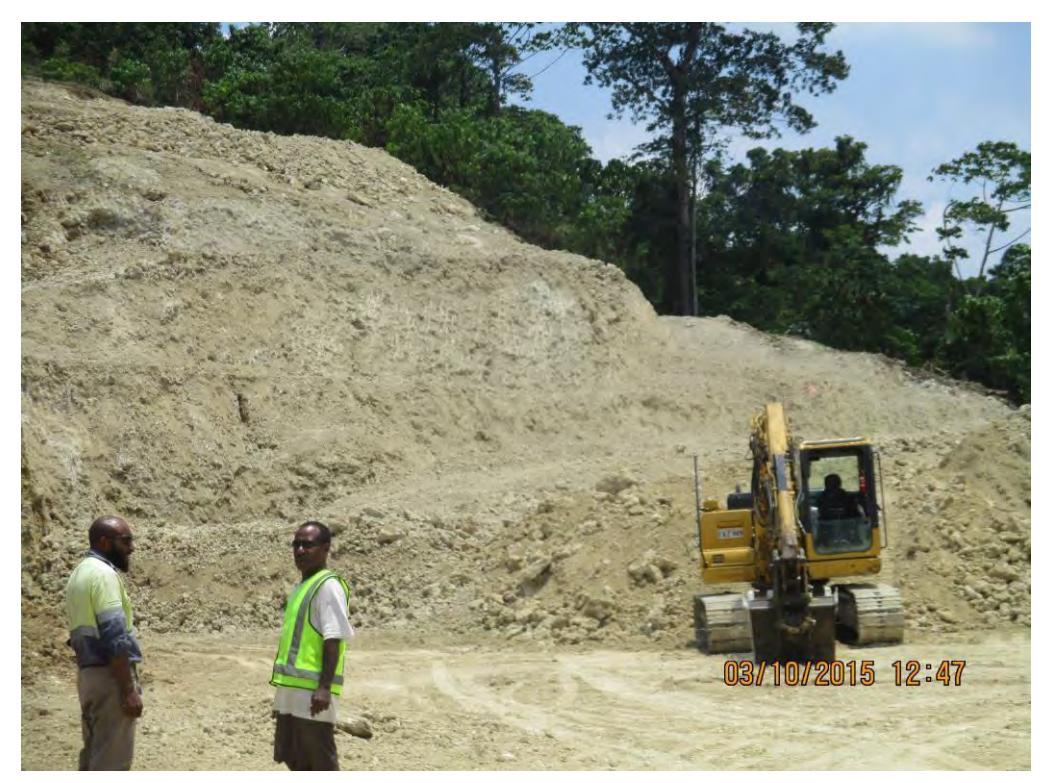
Picture 13: Gravel extraction site. Activities here are monitored to ensure no excessive dust, noise, or sedimentation occurs to nearby residents, communities, gardens and waterbodies.

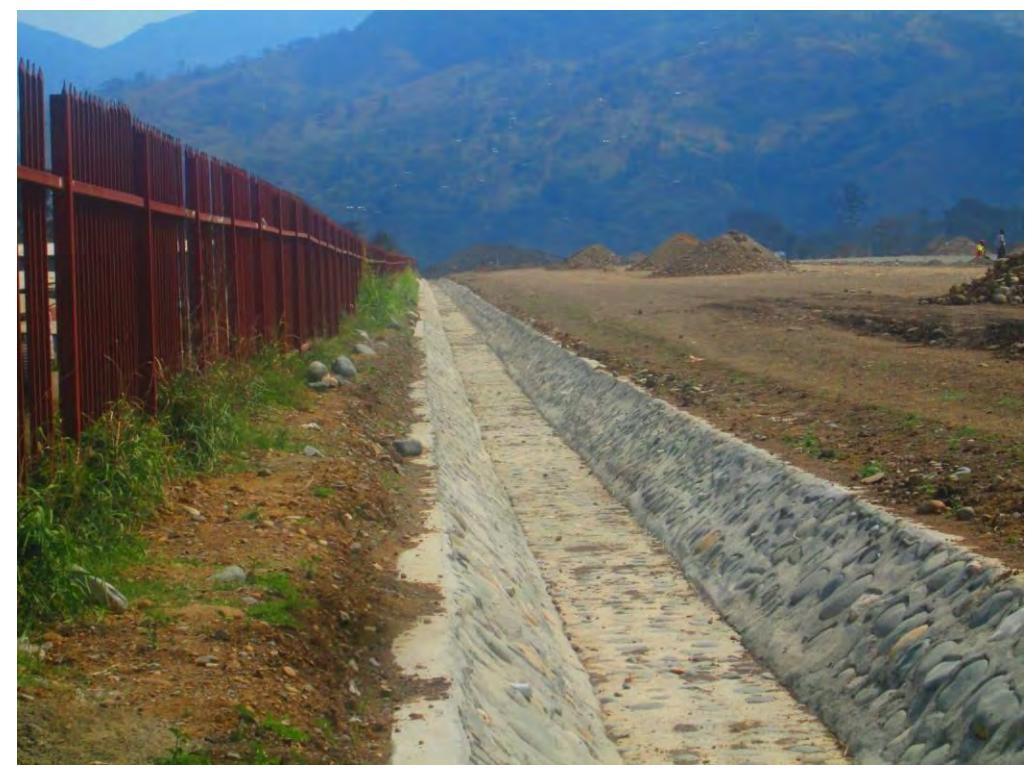
Picture 14: lines drains with proper dimension and slope design to allow flow of surface runoffs. Grubbing and scrubbing of topsoil and stockpiling away from the drain.

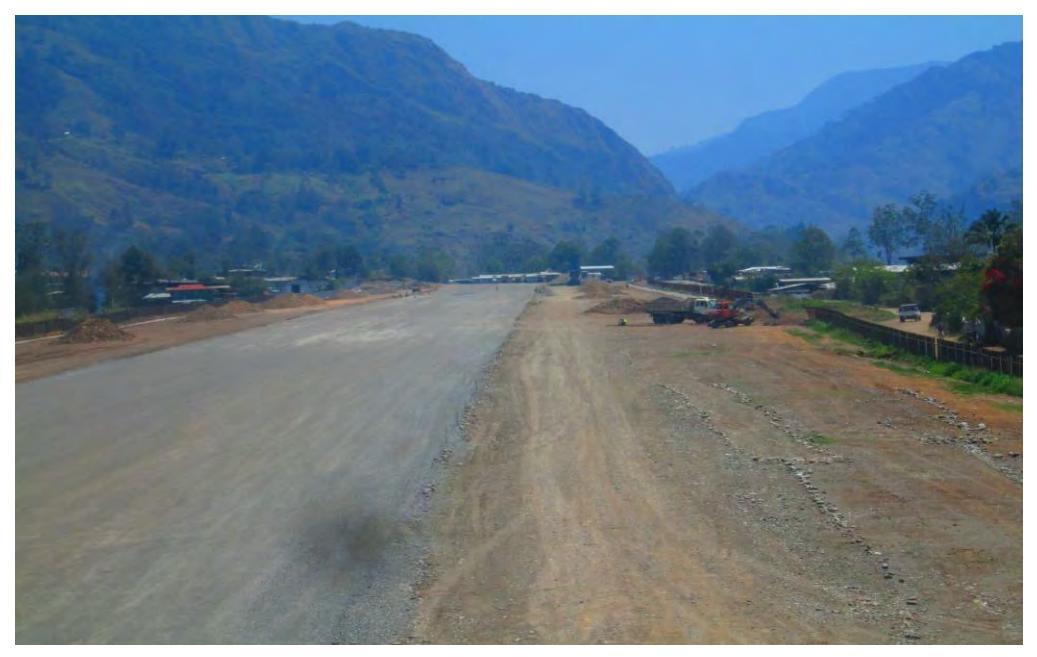
Picture 15: topsoil clearing of flight strip and improving of the runway pavement. Notice the removal of the old picket fence around the airport. New fencing will be installed.

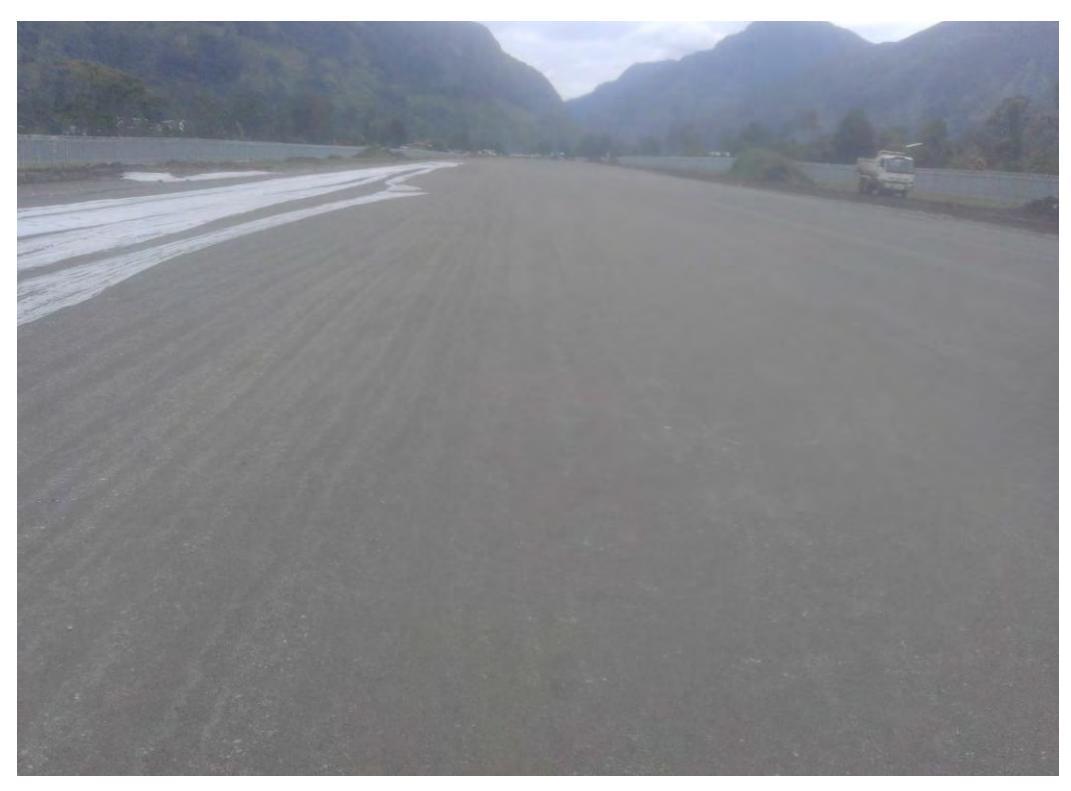
Picture 16: Use of white coloured geotextile to cover recently placed basecourse on the runway and allowing for grass regrowth on the topsoil stockpiles minimize the impact of sedimentation into the drains.

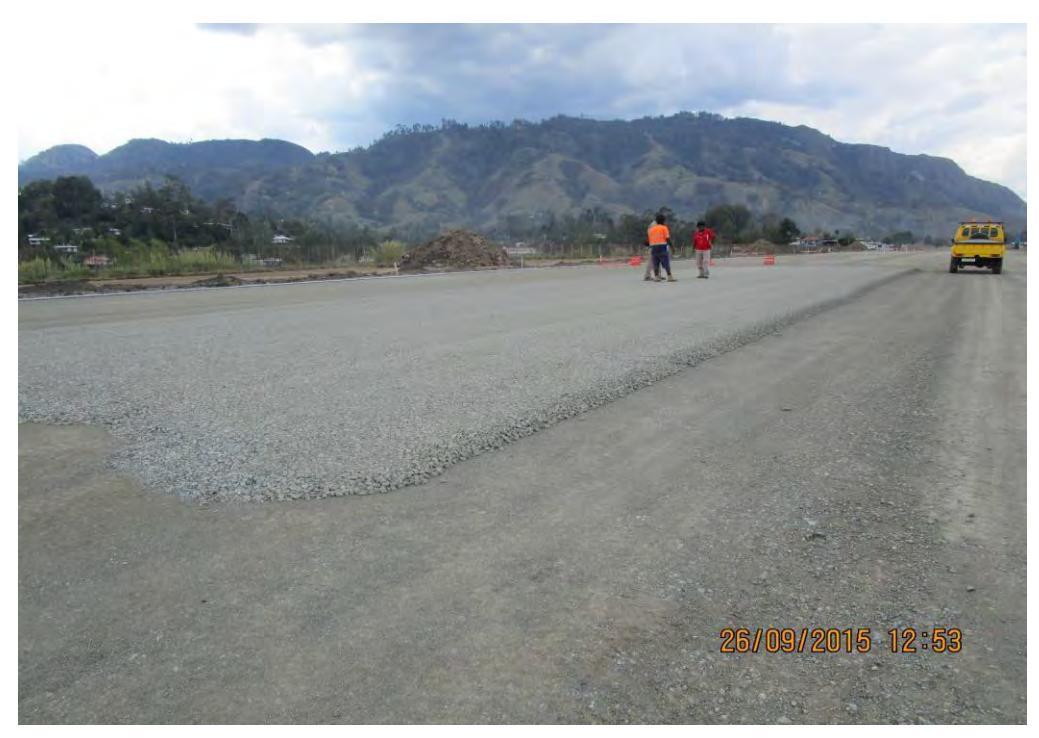
Picture 17: Placing and compacting of basecourse at the runway. The basecourse is mixed with water and cement when crushed which does not emit dust when placed on compacted.

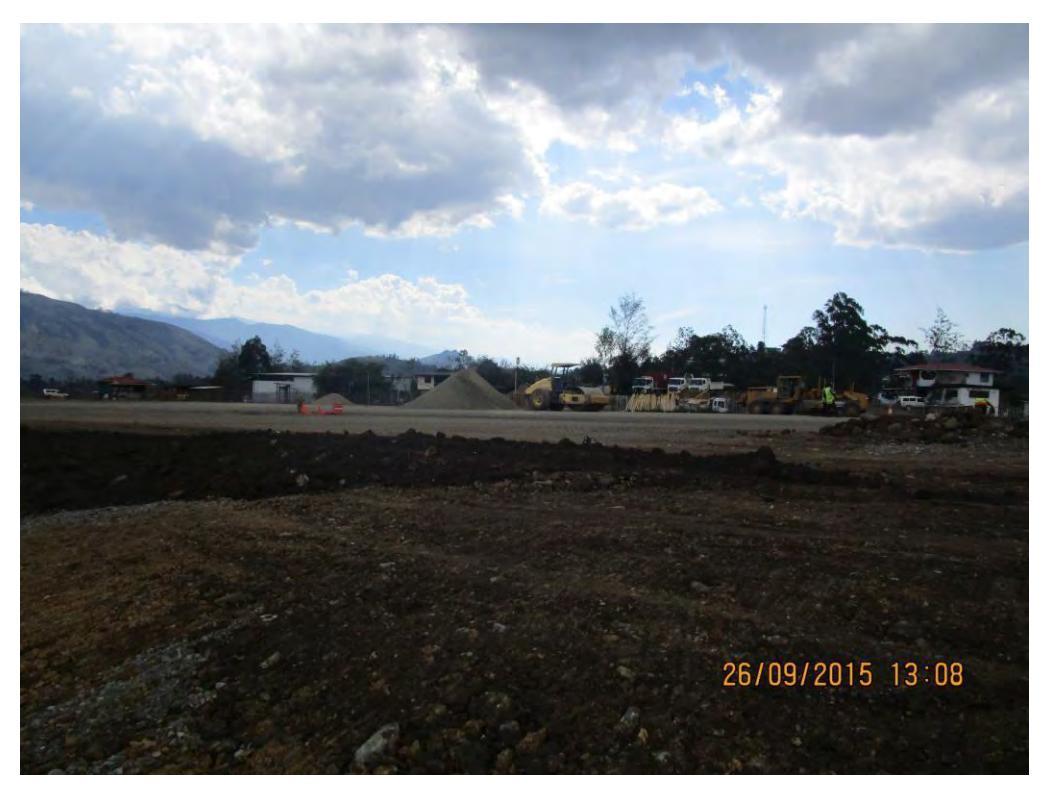
Picture 18: Placing and spreading of topsoil stockpiles on the flight strip areas for re-grassing.

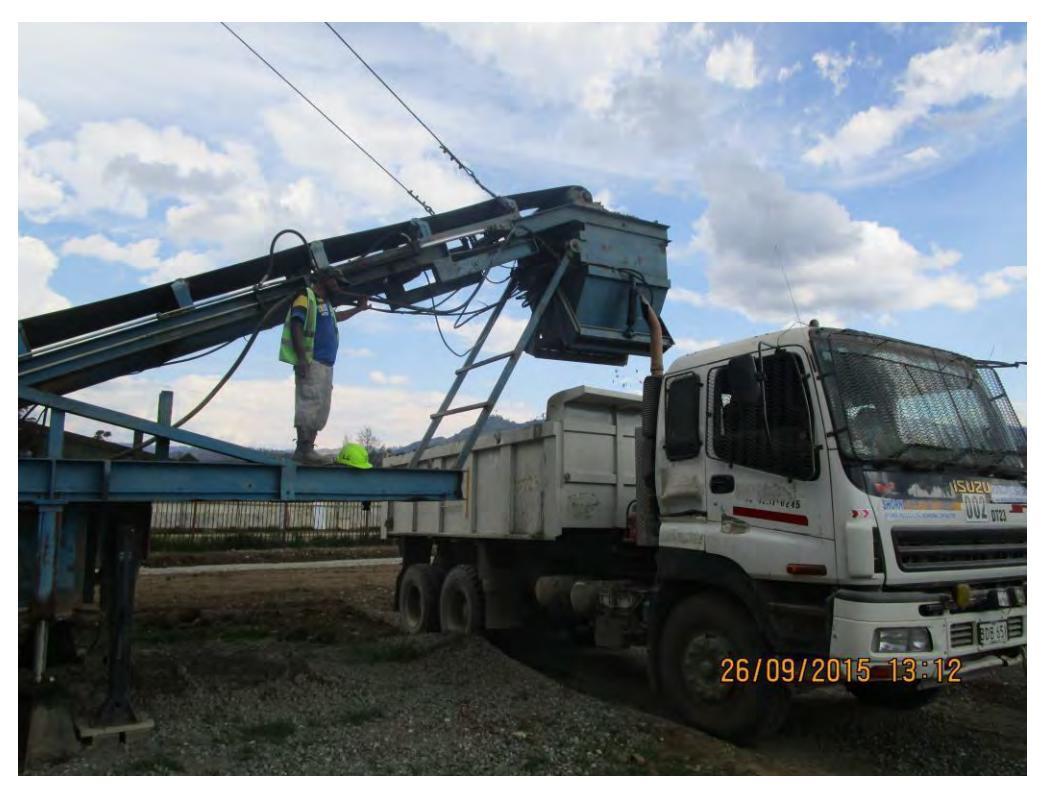
Picture 19: Crusher plant on-site is maintained and kept clean. Operations are strictly during daytime hours and not night-time to avoid noise causing nuisance to nearby residents.

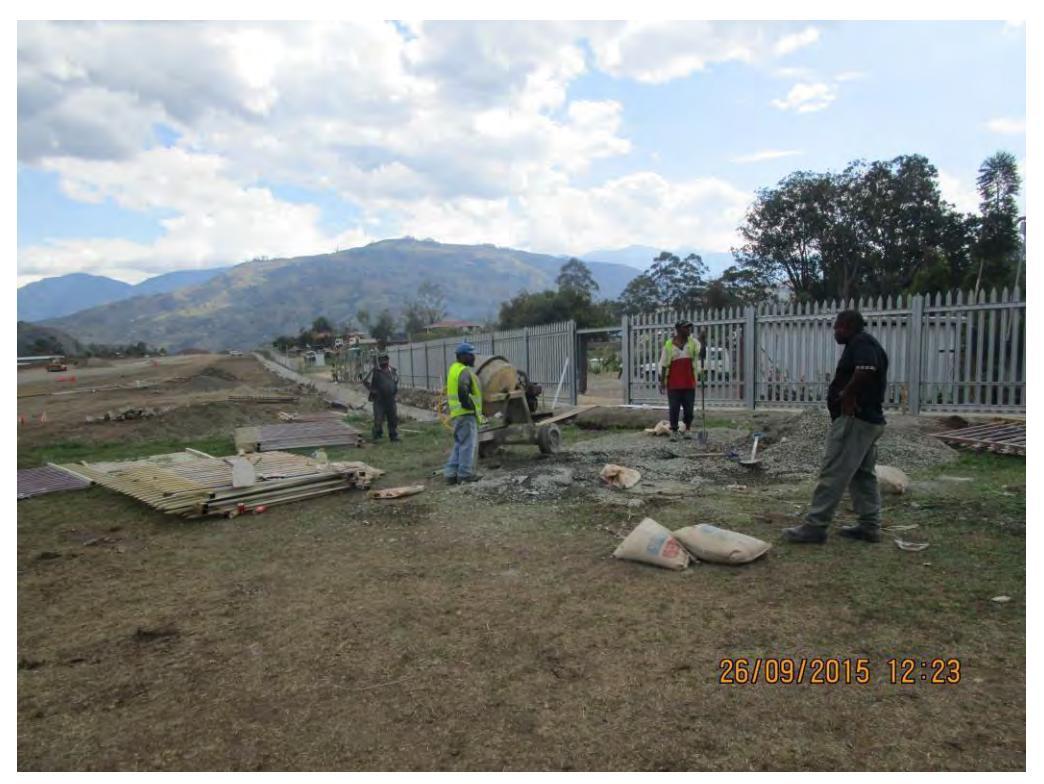
Picture 20: Installation of new palisade fencing materials around the airport boundary. This work is done mostly by the locals.

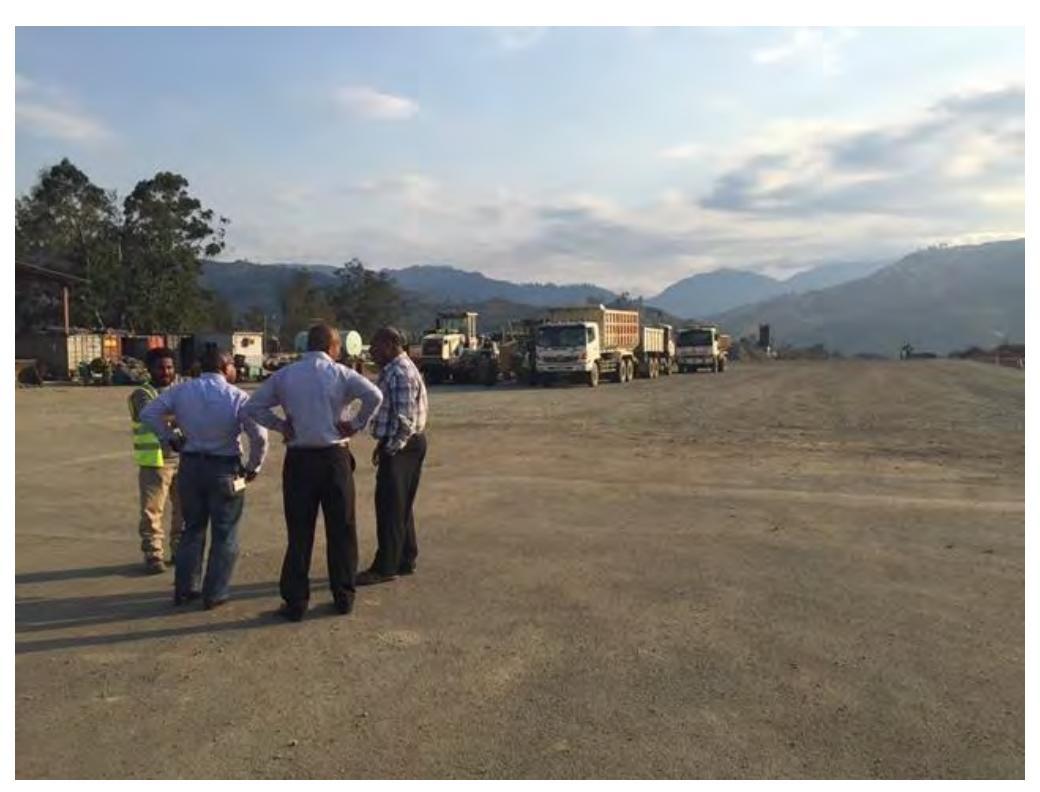
Picture 21: Laydown area is kept clean at all times. Cars, trucks, equipment are located in their appropriate areas next to the workshop ready to be maintained.

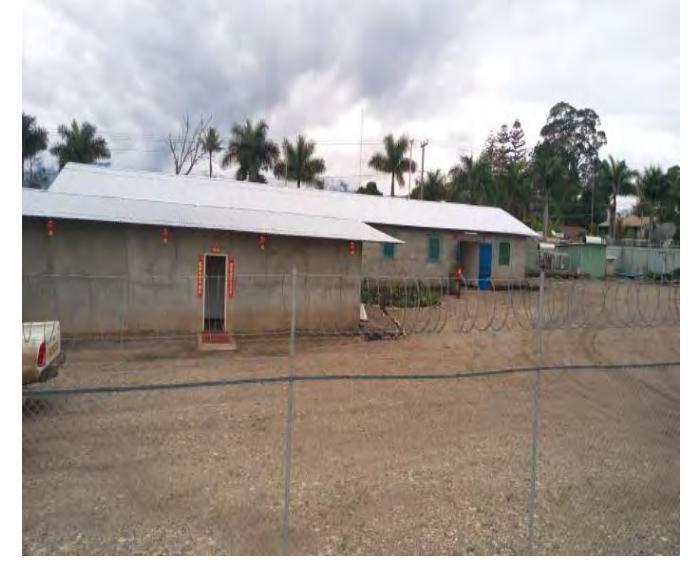
Picture 22: Establishment of contractors' office, personnel accommodation and dining area inside the project site. The area is kept clean at all times.

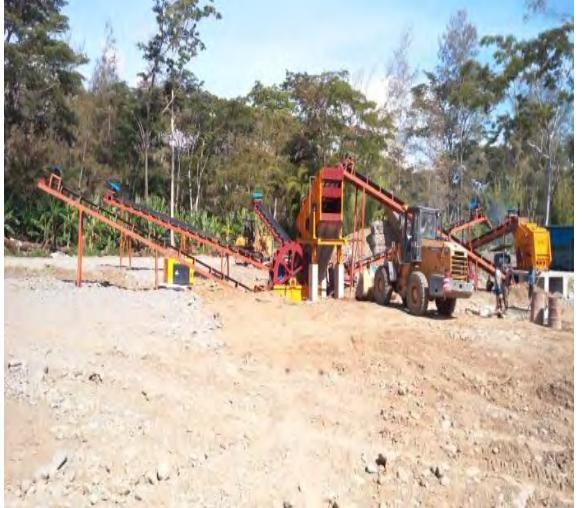
Picture 23: Establishment of contractors' crusher plant at Kamaliki River. The site has been used by other contractors in the past.

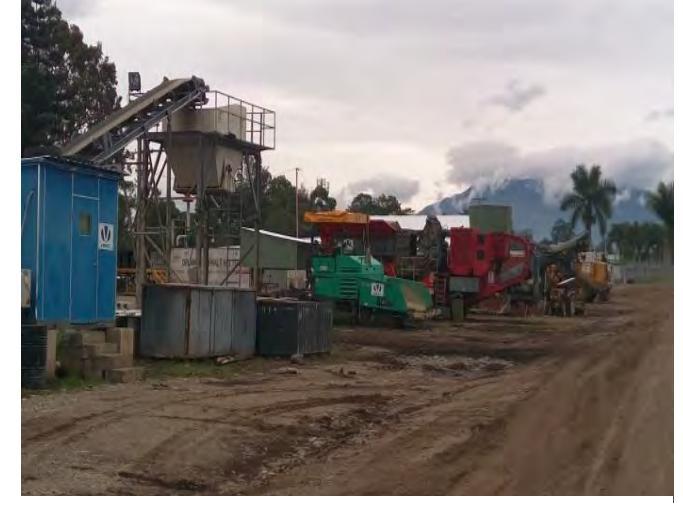
Picture 24: Establishment of contractors' batching plant at the project site. Drums are installed to collect concrete waste.

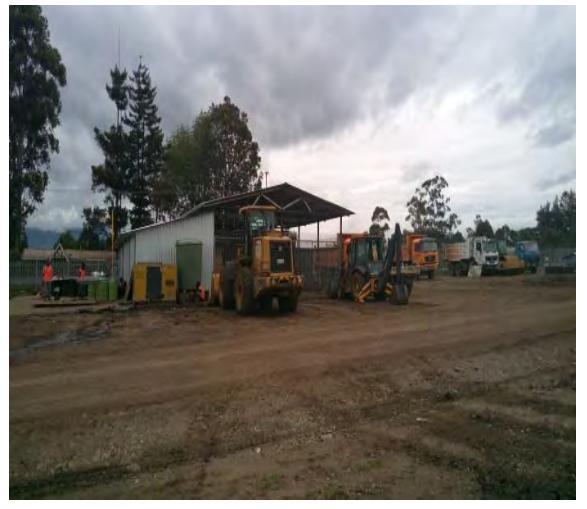
Picture 25: Establishment of contractors' workshop and storage area at the project site.

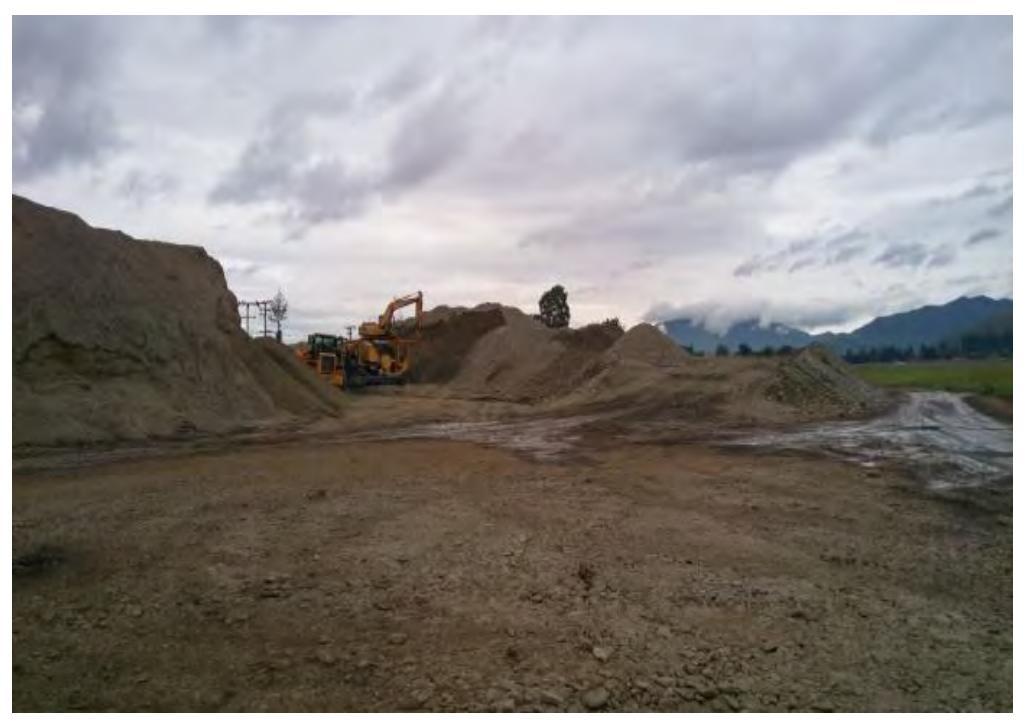
Picture 26: Gravel stockpile area at the project site. Notice the moist content of the gravels ensure minimal dust emission during stockpiling works.
