# Environmental and Social Monitoring Report

Fifth Quarterly Report  
June 2016

## IND: Jaipur Metro Rail Line 1-Phase B Project

Prepared by Jaipur Metro Rail Corporation Limited for the Asian Development Bank.

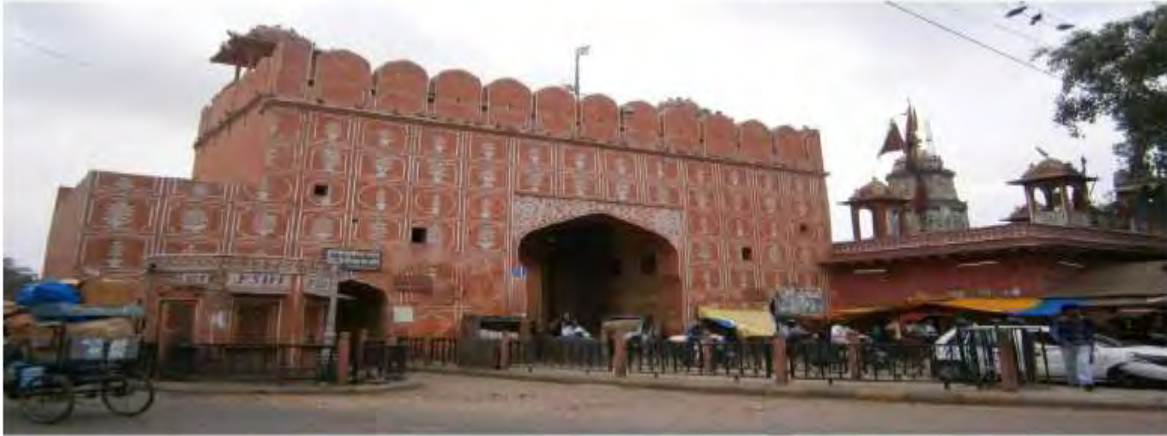
#### Chandpole Gate Tunnel Underpass Scheme

18. Chandpole Gate is coming right in the center of alignment, attracting maximum settlement, but original drawings relating to its foundation were not available. Therefore, the foundation of Chandpole Gate has been physically examined by a team of engineers, by making several trial pits around the gate.

19. For the determination of the structure's foundation, special survey was carried out by CEC and nine trial pits were executed in certain locations near the gate.

20. The foundation of Chandpole Gate has been found to be in a sound condition which can sustain the impact of tunnel-making underneath.

26. Now both TBMs have crossed underneath Chandpole Gate. The gate sustained no damage during the tunneling process.

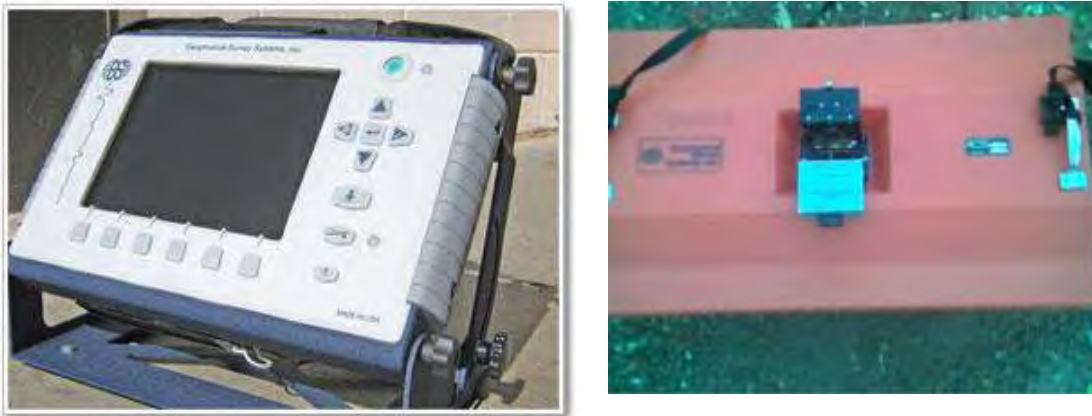
**Figure 2: Equipments used for GPR survey**

31. The equipment used for the scanning includes SIR-3000 (GPR) of Geophysical Survey Systems Inc. (GSSI), USA, 100 MHz paired antenna with other peripherals as shown in the Figure 2.

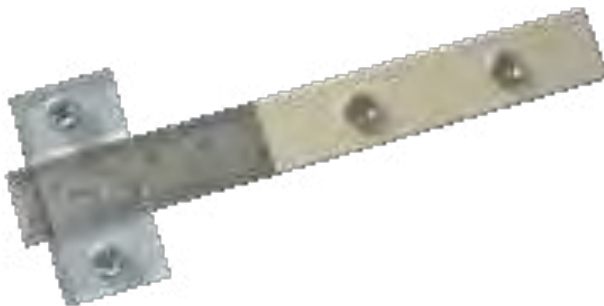
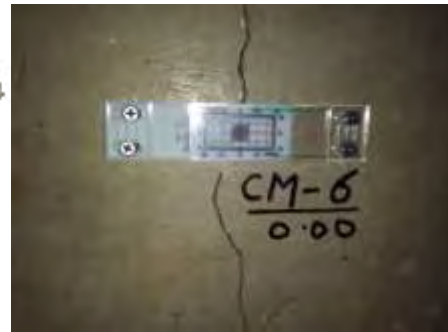
46. **Crack meter- Model AIM-100SC or equivalent:**The crack meter is suitable for measuring structured cracks ranging from 0.5 to 100 mm with a hairline cursory mark in two directions i.e. vertical and horizontal. The advantages of this instrument are: reliable and accurate, simple to install, simple to operation and low cost. This is very simple and accurate instrument to monitor the hair crack. The mechanical crack meter is made of polycarbonate transparent sheet with graduated marks. The both sheets will be assembled on crack with the help of fasteners.

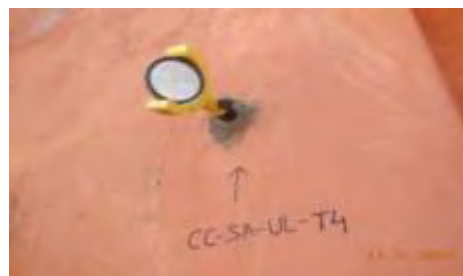
47. **Bi- Reflex Target:**

48. The bi-reflex target is one of the surveying equipment to measure deformations and settlements of the structures surrounding the construction site. It is rugged precise and low cost with an accuracy of +/- 0.1mm.

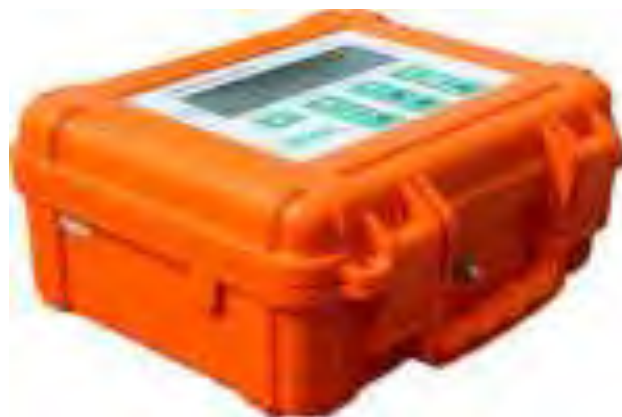
54. The equipment consists of Geophones and Kelunji Echo Seismic Recorder which is able to monitor the effect of vibration on all three planes. It is equipped with three geophones, capable of picking up signals in all the three planes described above. It is able to perform full field analysis of the event to evaluate the peak pulse velocity, peak frequency, peak acceleration and peak displacement.

55. The Echo is simple to use, easy to install and maintain, and light and robust enough to enable use of single equipment for monitoring different locations of the same structure or different structures. Ethernet based communications such as VSAT, ADSL, and some radios allows easy configuration of networks for data telemetry. GSM, GPRS, CDMA & PSTN are also supported.

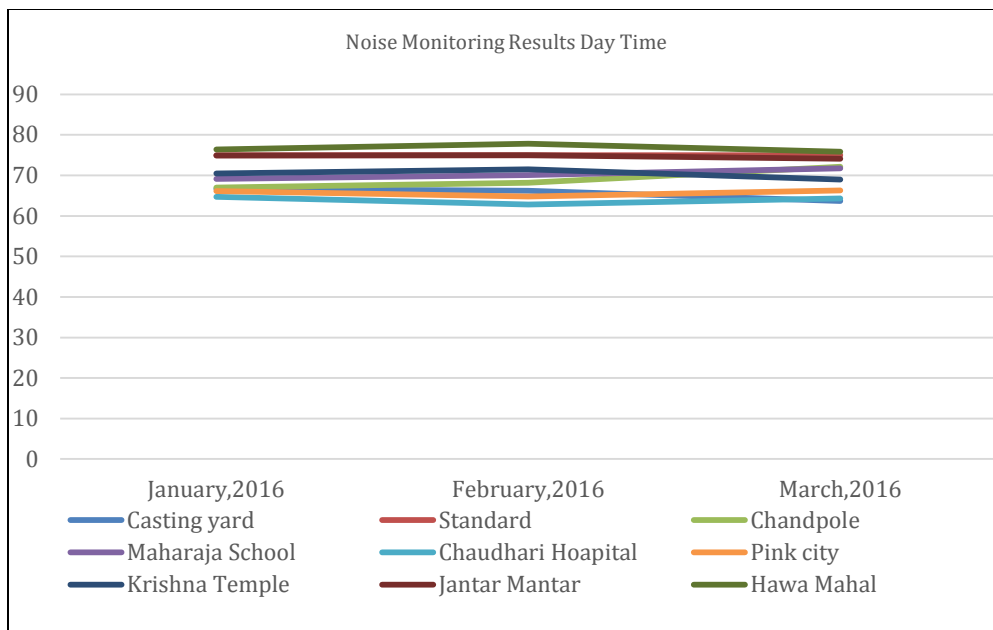
**Table 8: Noise Monitoring Results (Day time)**

Date	Leq Day dB(A)							
	Location							
	Casting Yard	Chand pole	Maharaja School	Chaudhri hospital	Pinkcity Hospital	Krishna Temple	Jantar Mantar	Hawa Mahal
21.01.2016 to 25.03.2016	67.7	67.0	69.1	64.7	66.1	70.5	74.9	76.4
18.02.2016 to 20.02.2016	66.2	68.2	70.1	62.8	64.8	71.5	75.0	77.8
15.03.2016 to 20.03.2016	63.7	72.1	71.7	64.3	66.3	69.0	74.1	75.8

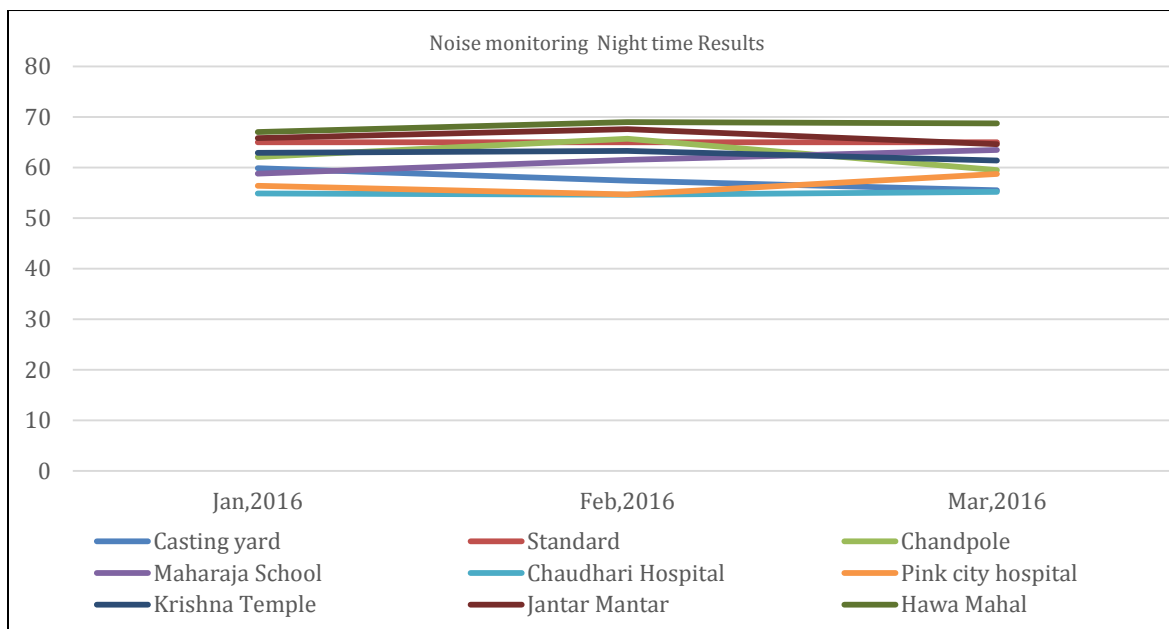
**Table 9: Noise Monitoring Results (Night time)**

Date	Leq Night dB(A)							
	Location							
	Casting Yard	Chand pole	Maharaja School	Chaudhri hospital	Pinkcity Hospital	Krishna Temple	Jantar Mantar	Hawa Mahal
21.01.2016 to 25.01.2016	59.9	62.1	58.8	54.9	56.4	62.9	65.8	67.0
18.02.2016 to 20.02.2016	57.4	65.7	61.5	54.6	54.7	63.3	67.6	69.0
15.03.2016 to 20.03.2016	55.5	59.5	63.5	55.2	58.7	61.4	64.6	68.7
