Initial Environmental Examination

Project Number 48484-004

TUV: Outer Island Maritime Infrastructure Project Additional Financing

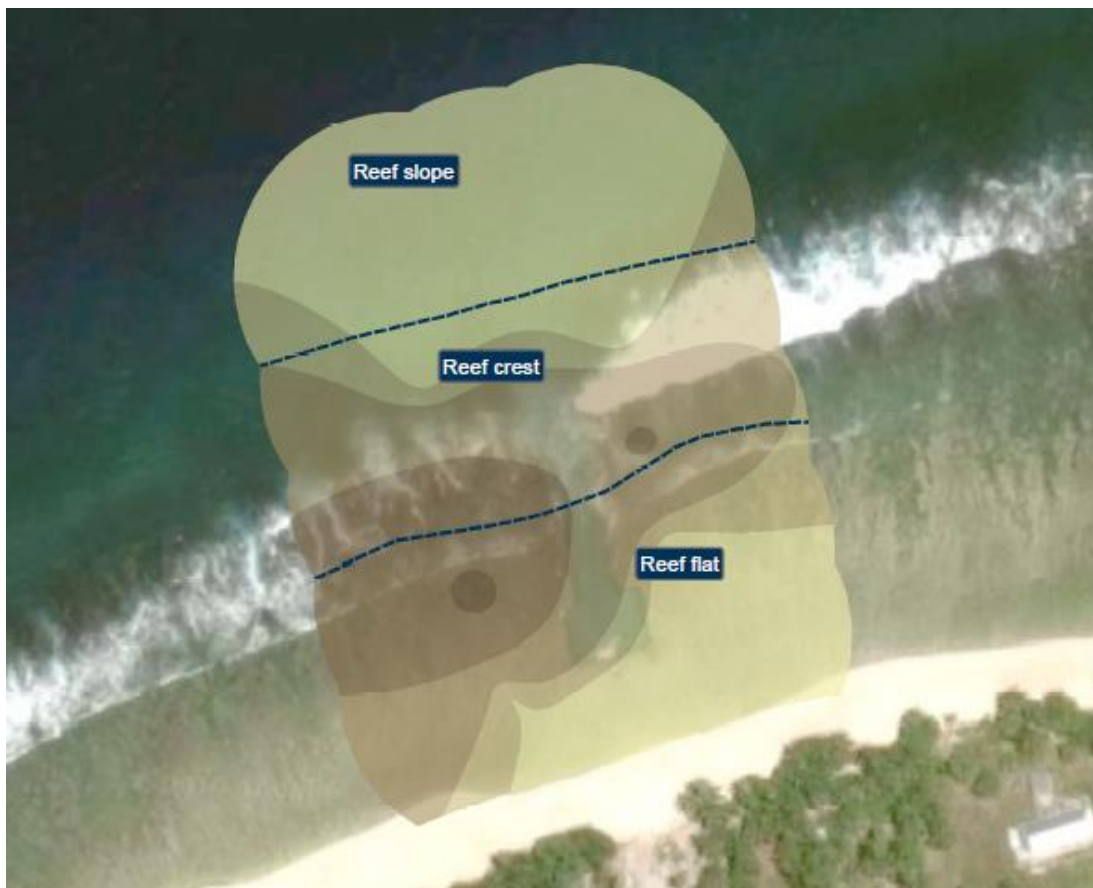
Figure 4.2: Reef Zones at Proposed Harbor Location

92. Figure 4.2 shows the proposed harbor location divided into reef zones including the slope (farthest from shore), crest and flat (nearest to shore).

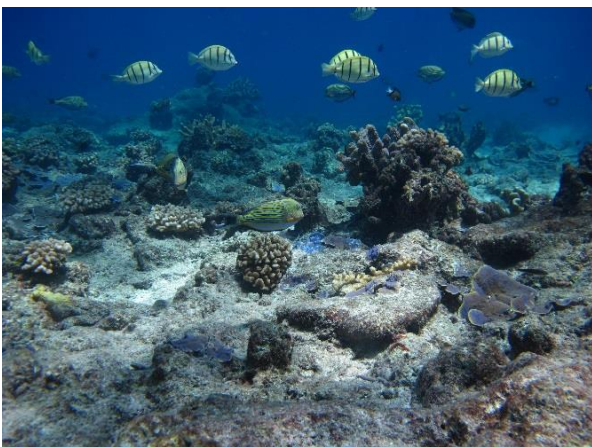
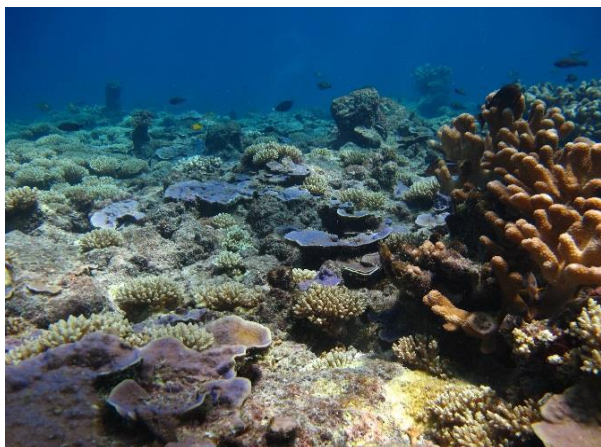
Plates 4.2 a & b: Reef slope at proposed workboat harbor location

95. Plates 4.2 show the reef slope at proposed harbor location, Plate 4.2a includes school of convict surgeon fishes (*Acanthurus triostegus*) and blue-lined surgeonfish (*Acanthurus lineatus*).

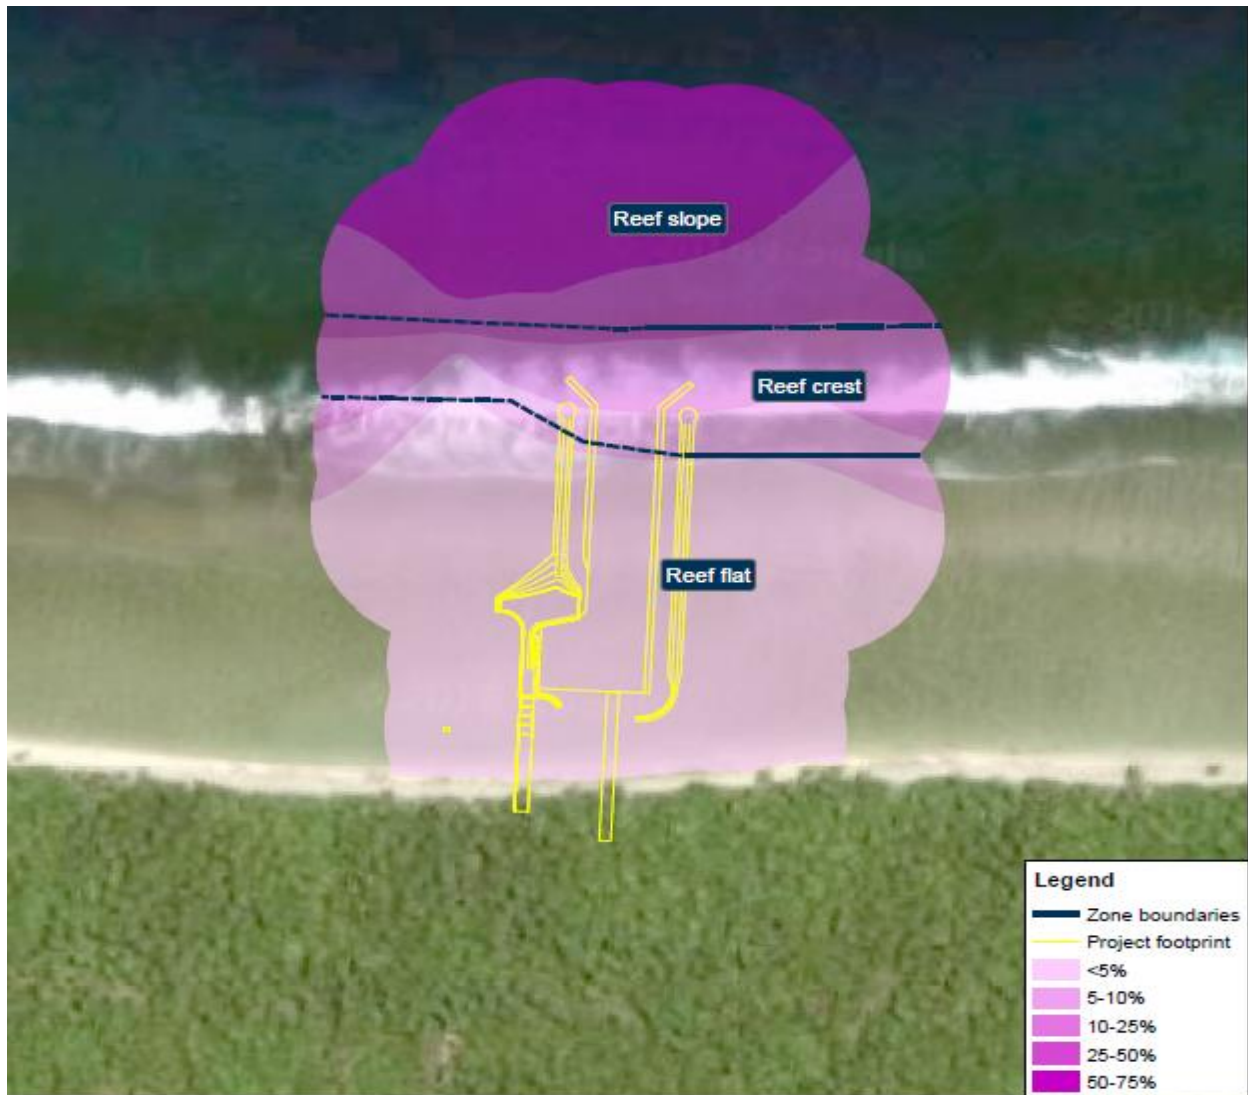
Figure 4.3: Proportion of Coral Cover

94. At the proposed harbor location, a smaller proportion of coral cover was observed at the reef crest ($11.4\% \pm 2.5$) and none on the reef flat (Figure 4.3). The proportion of cover of live coral at the existing boat ramp at Niutao was very low, ranging between $3.0\% \pm 1.2$ on the reef slope to $0.2\% \pm 0.2$ on the reef flat, with most habitat consisting of coral rock covered with turfing and encrusting algae. A veneer of fine sediment was also observed on the coral bedrock at the existing boat ramp location. Families of corals recorded at Niutao included *Acroporidae*, *Pocilloporidae*, *Montiporidae* and *Poritidae* (see Plates 4.1 a and b). Several genera that were recorded for each of these families, however, genera of the family *Acroporidae* was the most abundant family, forming extensive pavements across the seafloor.

93. **Habitats and sessile assemblages.** As shown in Table 4.1, the proportion of live coral cover is greatest on the reef slope at each the three areas surveyed and greater at the proposed harbor location compared with the existing boat ramp. The reference survey stations (to the north of the proposed workboat harbor) recorded significantly greater proportion of live coral cover.

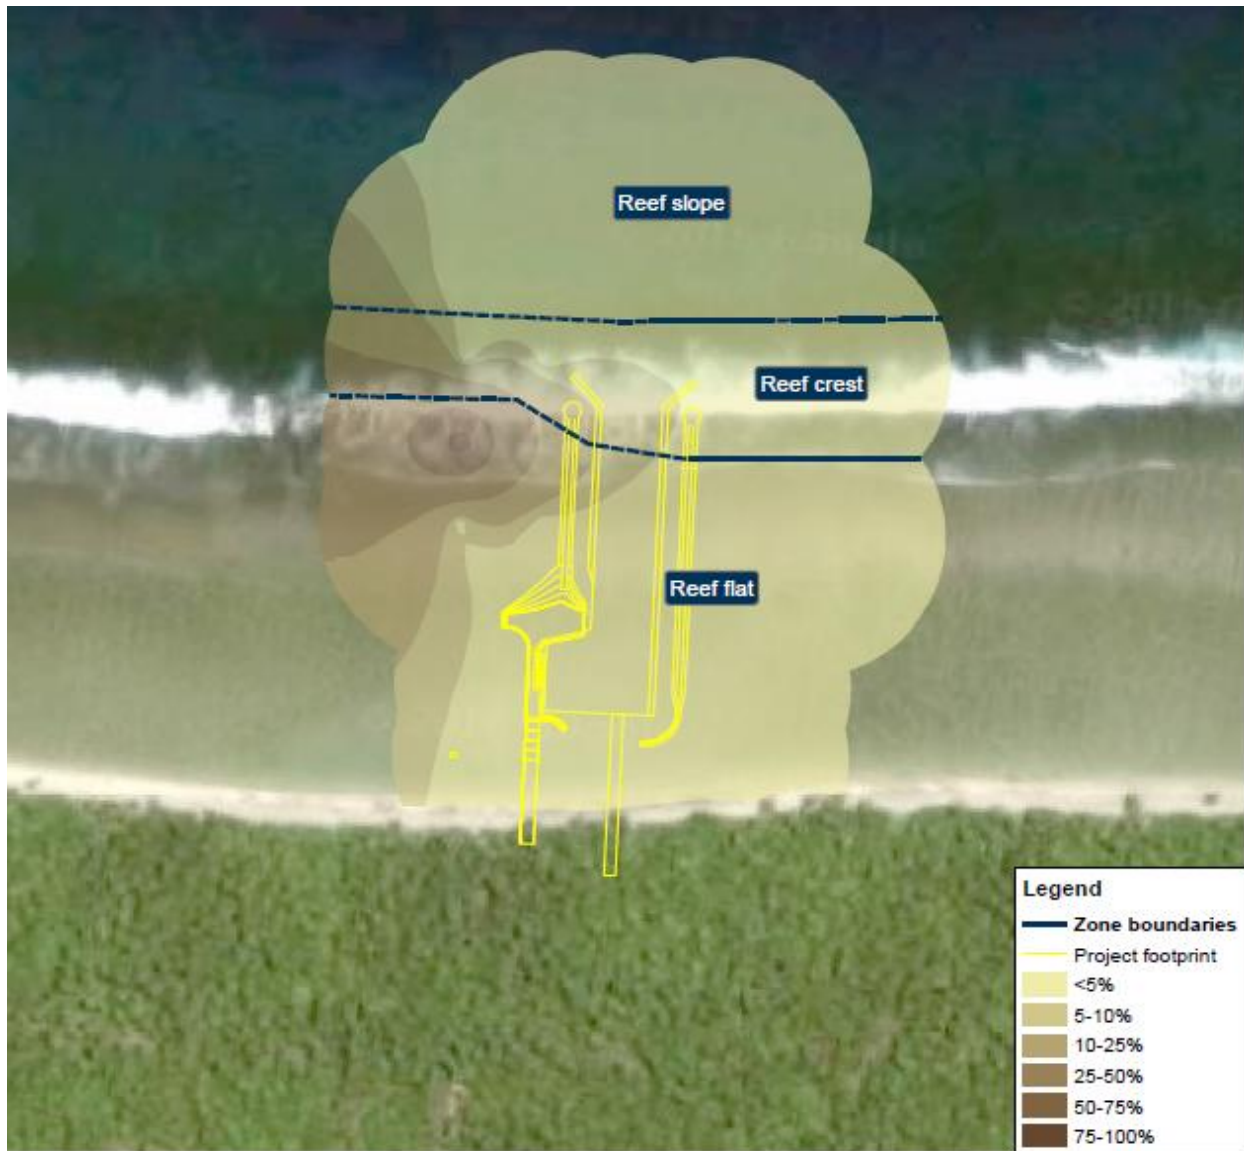
Figure 4.4: Proportion of Micro-algae Cover

96. The proportion of macro-algae cover was greater at the existing boat ramp location than at the proposed harbor location and no macro-algae was recorded at the reference location. The mean percent cover at both these locations was, however, greatest within the reef crest zone and to a lesser extent, the reef flat, particularly at the existing boat ramp (Figure 4.4), *Caulerpa racemosa* and brown filamentous algae were the most common types of algae recorded on both the reef crest and flat.

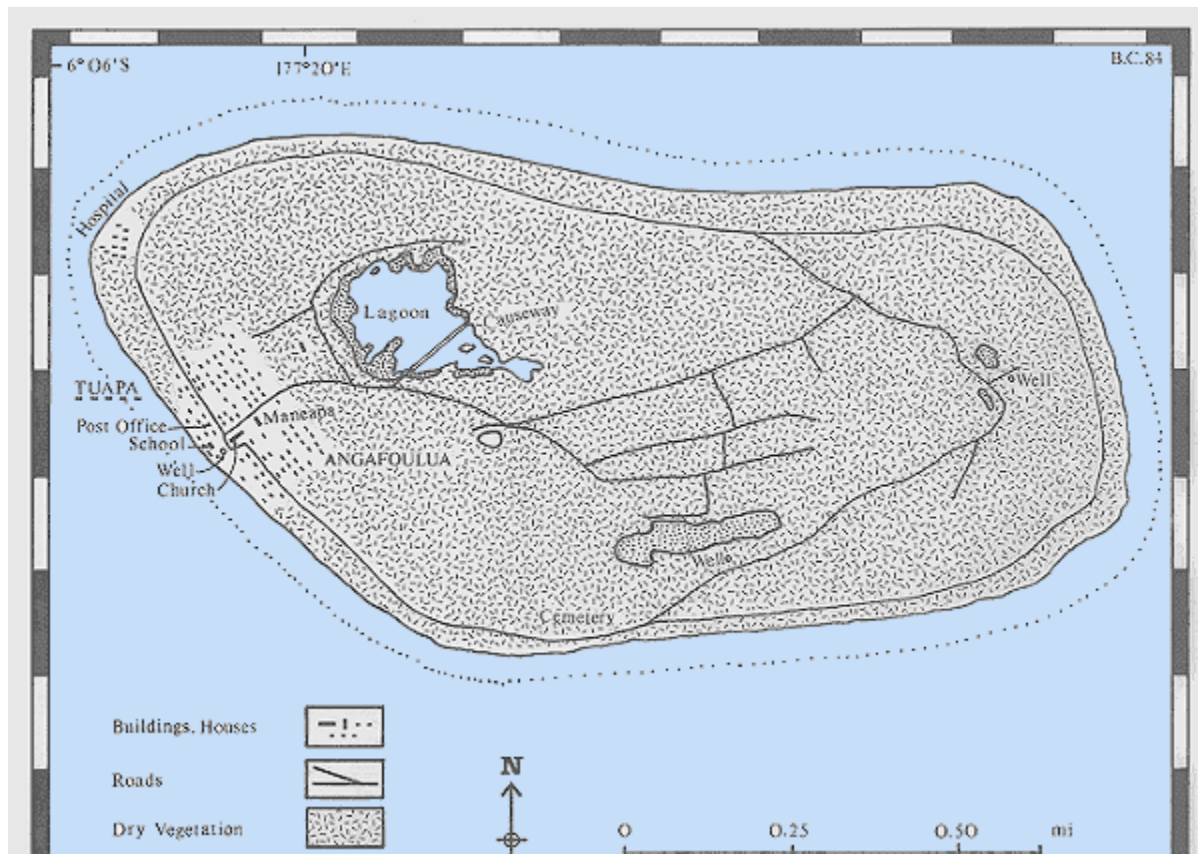
Figure 4.5: General Land Use on Niutao

124. The island comprises two villages, Kulia and Teava (which used to constitute one village called Tuapa), both on the western side of the island. The area or district of the two villages is Angafoulua. As noted above, there is an unpaved road around the island (Figure 4.5).
