Environmental Due Diligence Report

Document stage: Draft for Consultation
Project Number: 49107-013
August 2022

INDIA: Integrated Urban Flood Management of the
Chennai-Kosasthalaiyar Basin Project – Additional
Financing

Infection Prevention and Control of COVID-19 and
Other Communicable Diseases through WASH
Services for the Urban Poor (JFPR Grant)

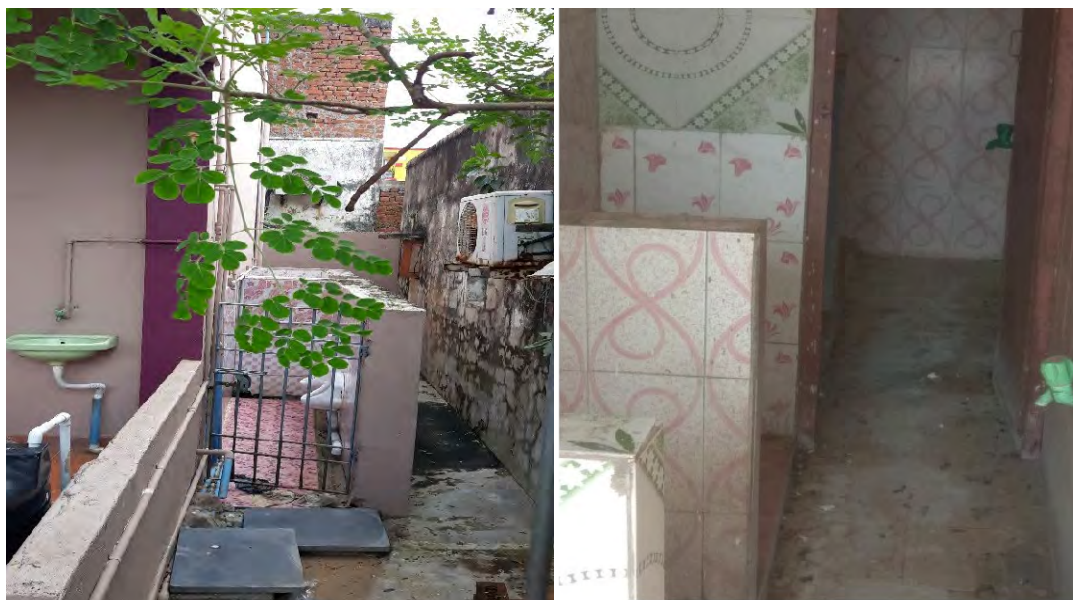
16. **Toilet Facilities.** Around 40 to 60% of school toilets are having accessibility, functionality, privacy and cleanliness standards in line with the National WaSH Standards. Some schools are provided with new toilet facilities with the help of the NGOs. 4 schools with disabled children but not having disabled friendly toilets have been identified. Around 30% of the schools do not have area for construction of additional toilet blocks. The toilets use septic tanks / soak pit arrangements in areas where the sewage lines are not directly connected to the system.

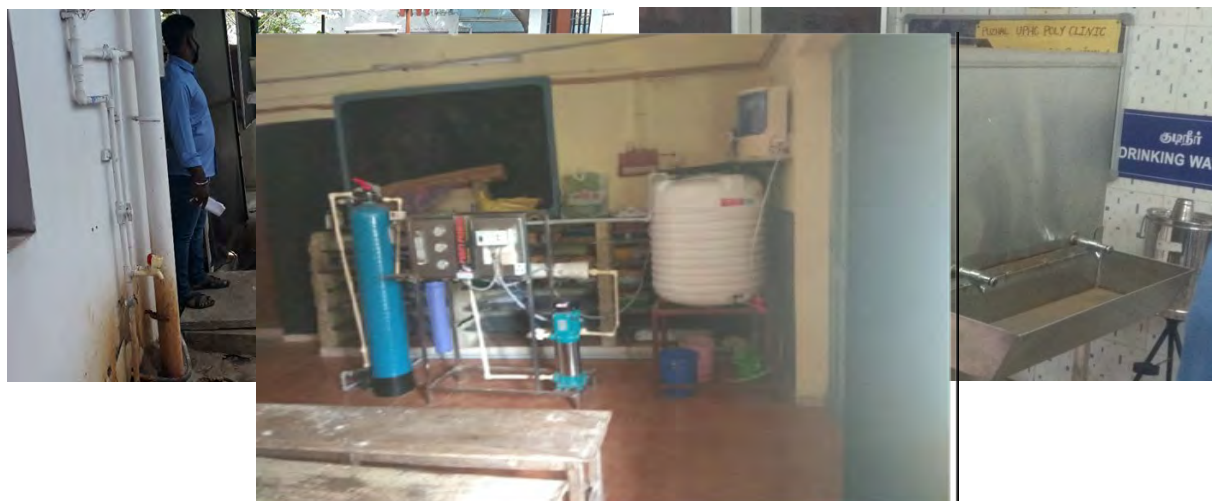
18. **Drinking water Facility.** Around 90% of the schools are having RO system for treating the water, which is supplied either by the Chennai metro water or individual bore well. However, it was observed that nearly 30 to 40% of the RO system is not functioning.

Drinking water	<ul style="list-style-type: none"> • RO water treatment system has to be repaired for filters, motors and pipelines. • Water dispensing station made of stainless should be provided with proper tap and drain. • In addition to the hand operated piped drinking water dispensing facility foot operated drinking water dispensing facility also to be provided to accommodate the COVID19 requirements.

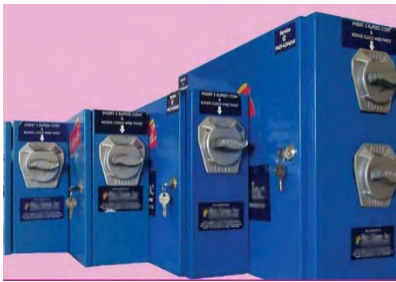
<p>(Representative image) Incinerator</p>

Output	Components	Design Considerations for the Proposed Interventions
	Menstrual hygiene management (MHM)	<ul style="list-style-type: none"> A separate privacy room for menstrual hygiene management should be provided for all the 30 schools having classes from class 6 (grade 5). The privacy room shall be provided with an incinerator with exhaust, hand wash basin with proper water inlet and proper outlet with closed drainage and a menstrual pad dispenser The wall and floor shall be tiled and should be designed for easy maintenance. Incinerators for sanitary pad disposal to be provided Incinerators' capacity will be from five to 10 napkin pads per cycle with a minimum of 200 pads per day. Incinerators, having a length of 2.5 meters, also come with thermally insulated front door. Emission outlets of the incinerators include a metal pipe exhaust on top and flexible steel hose of a minimum length of two meter with clamp provision. Complete burning of napkins only less than 1 g ash per napkin is generated. The exhaust gas meets the solid waste management rules 2016/CPCB guidelines. Ash collection with easily openable and ash disposable

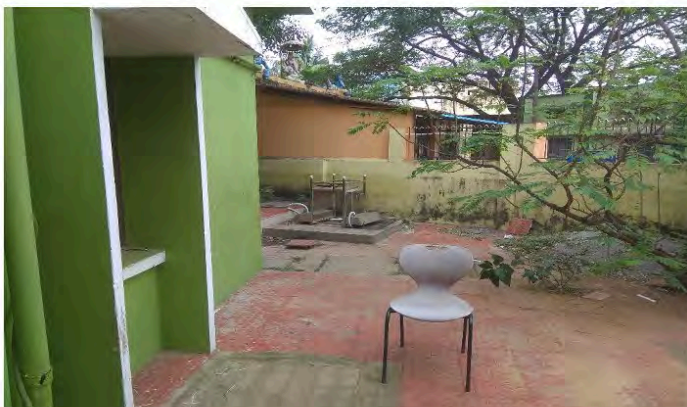
Zone	03 - Madhavaram
Division	26
School Name	UPHC
Location	Swamy Nagar, Madhavaram

Handwash (Totally neglected condition)

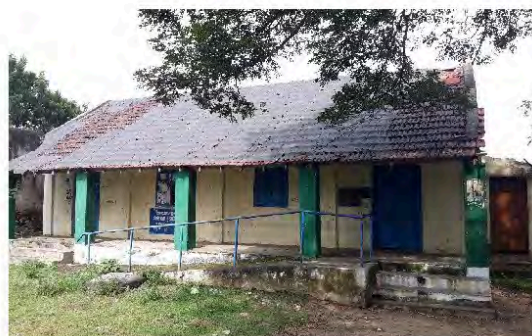
Zone	02 - Manali
Division	15
School Name	CPS
Location	New Nappalayam, Edayanchavadi Rd., Manali

Very poor building condition with huge roof leak
