Draft Environmental Impact Assessment

India: Karnataka Integrated and Sustainable Water Resources Management Investment Program – Project 2

Vijayanagara Channels

**VIJAYANAGARA CHANNELS
FEASIBILITY STUDY REPORT**

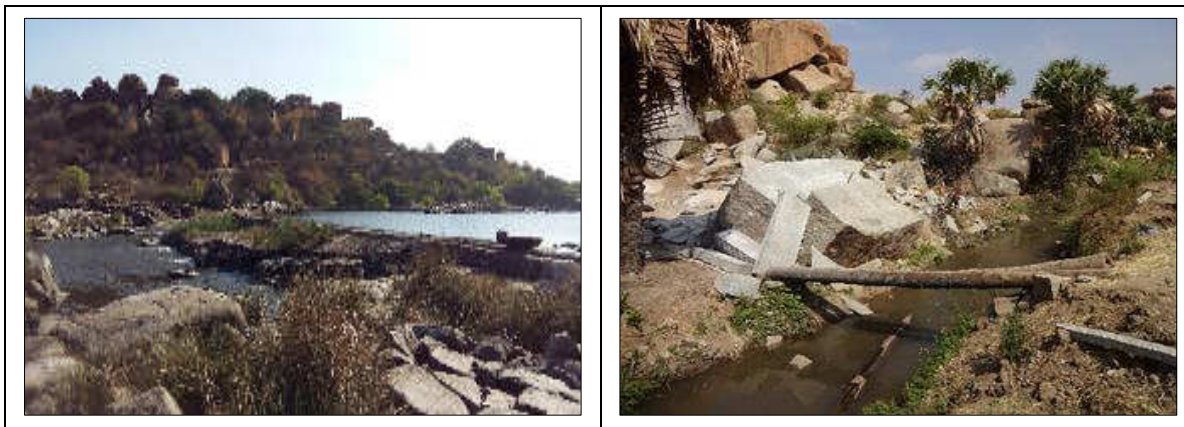
Plate 1: Deteriorating anicuts and other structures requiring immediate rehabilitation

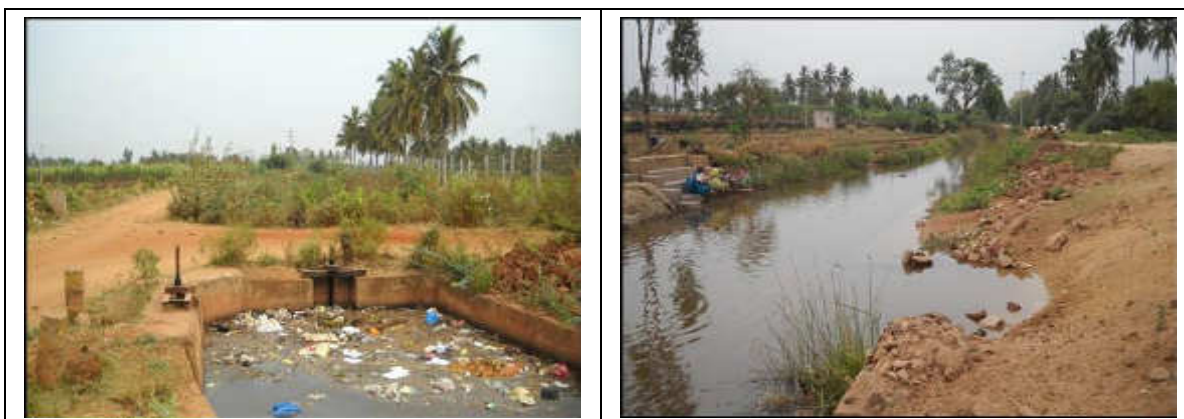
Plate 2: Photos showing untidy channels

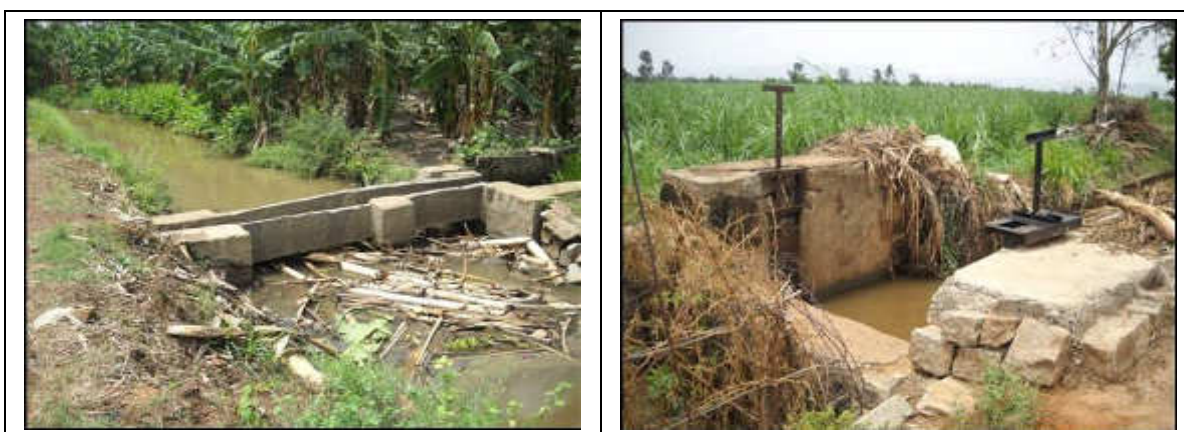
Plate 3: Channel used as a disposal point

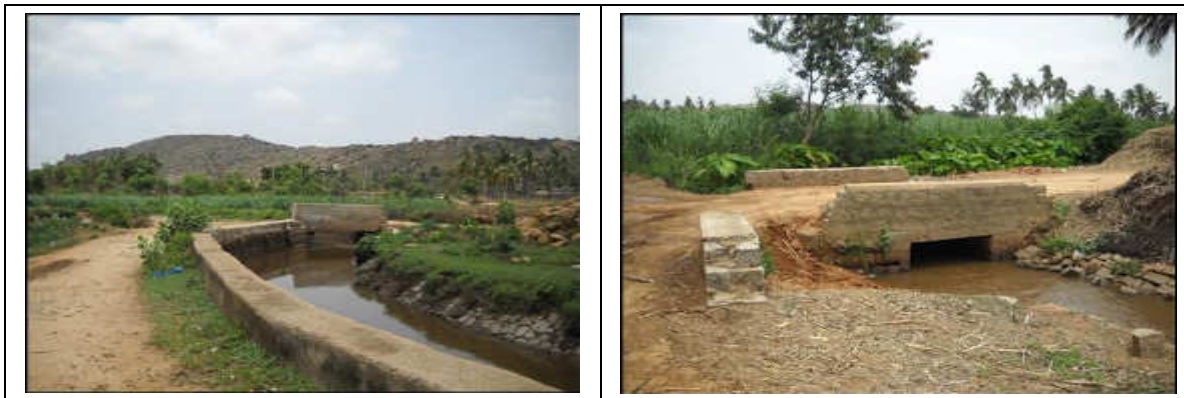
Plate 4: Channel reaches with size stone masonry lining

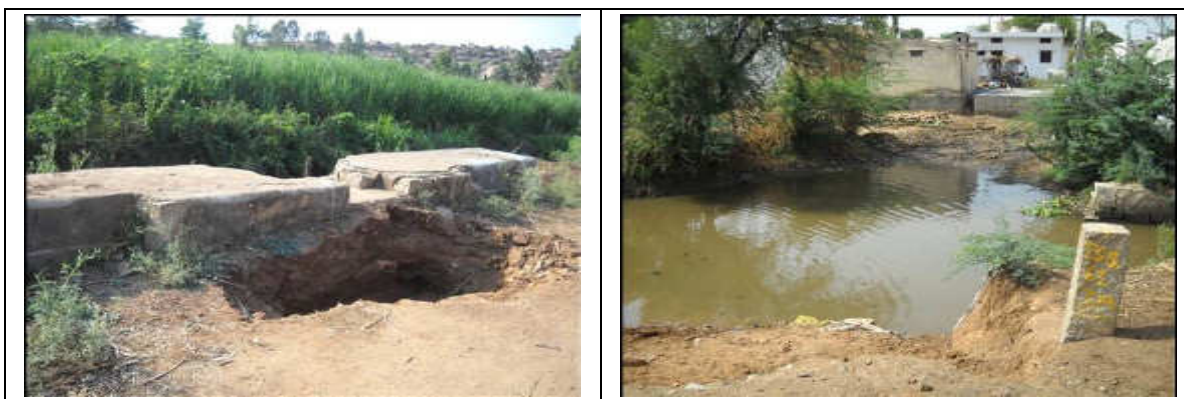
Plate 5: Damage due to seepage and poor maintenance

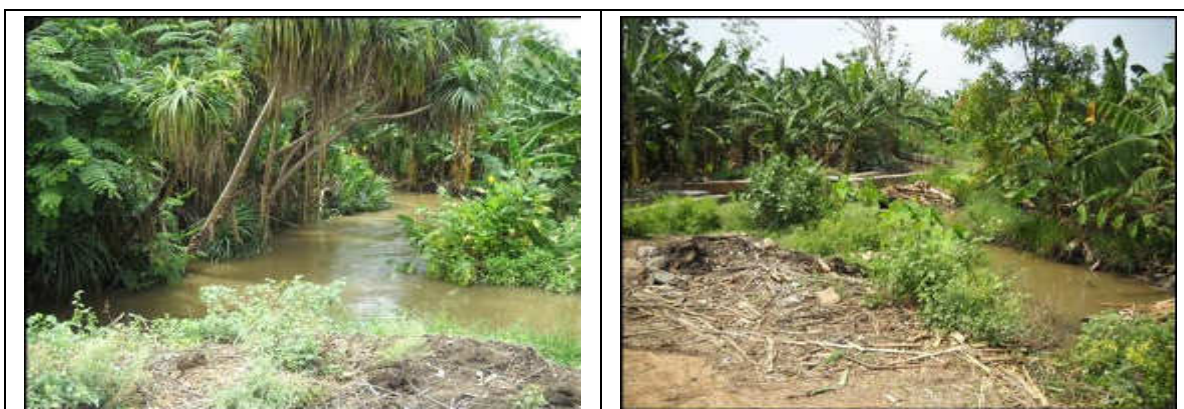
Plate 6: Thick vegetation around channels

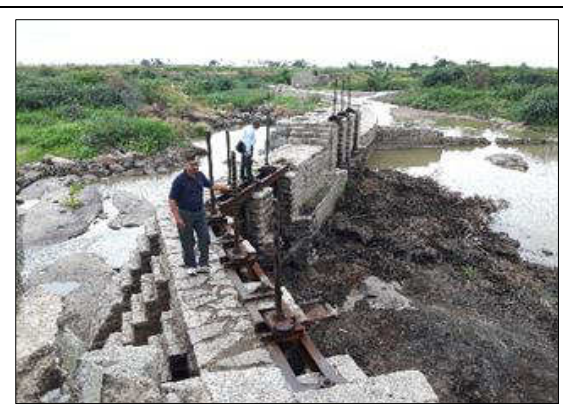
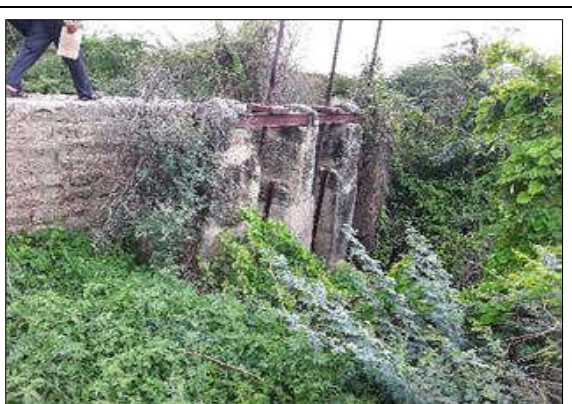
Plate 13 : Debris around Head Regulator

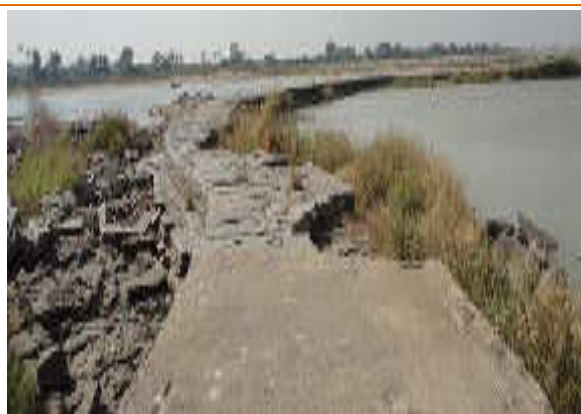
A typical damaged VNC anicut

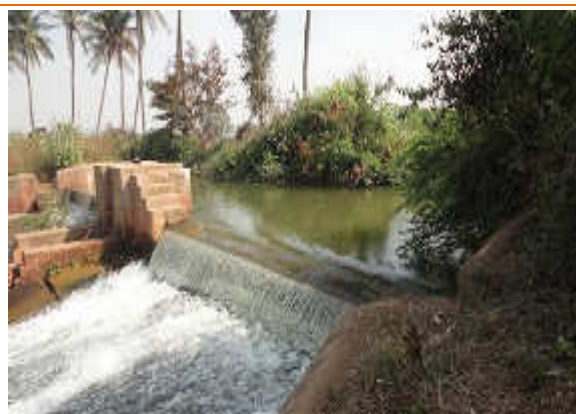
A structure on Raya Channel in need of rehabilitation

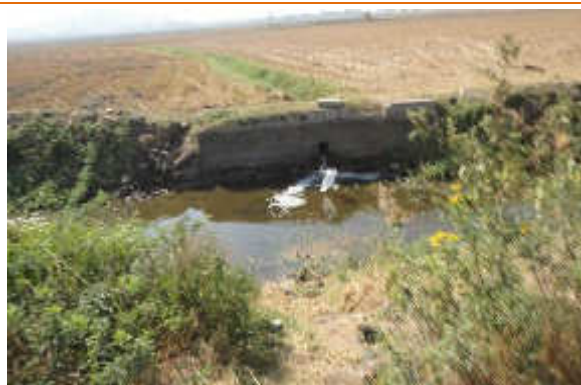
Degraded banks of the Siruguppa Channel

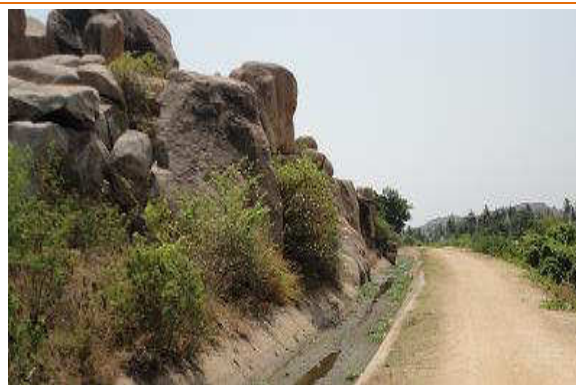
Silting in Anegundi Channel

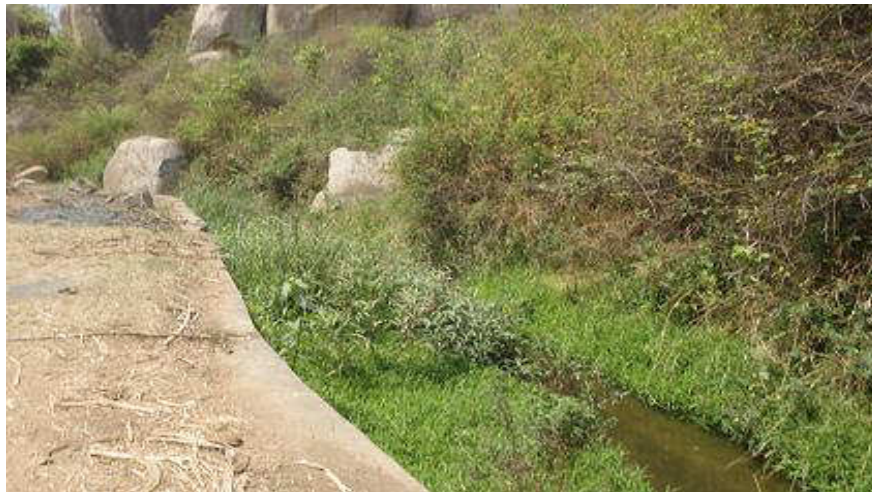
Thick vegetative growth in Anegundi Channel hampering flow of water

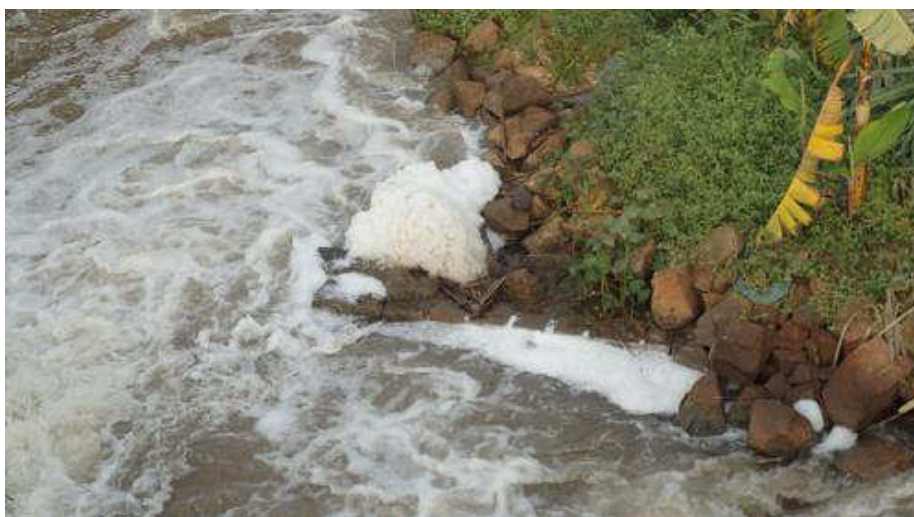
Foam in the Kalaghatta Canal due to industrial effluents let into the canal

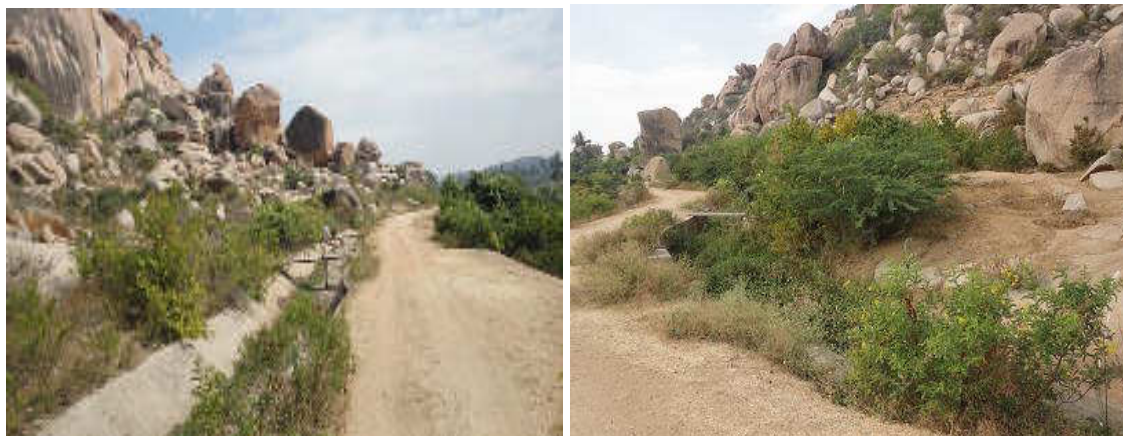
Figure 17: Location along Anegundi Canal where the stormwater runoff directly enters the canals

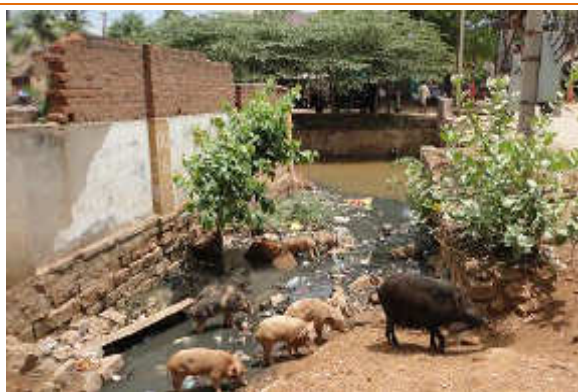
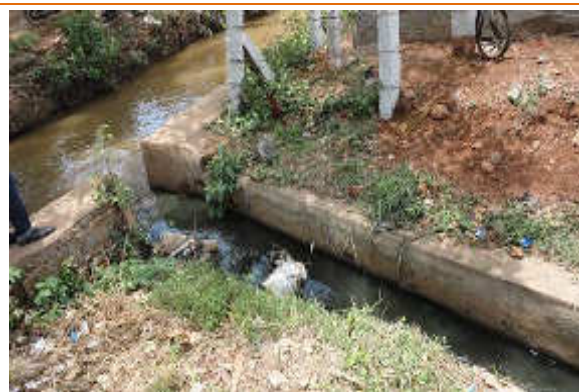
Sewage Entry into Basavanna Canal Stretches within Hospet Town limits

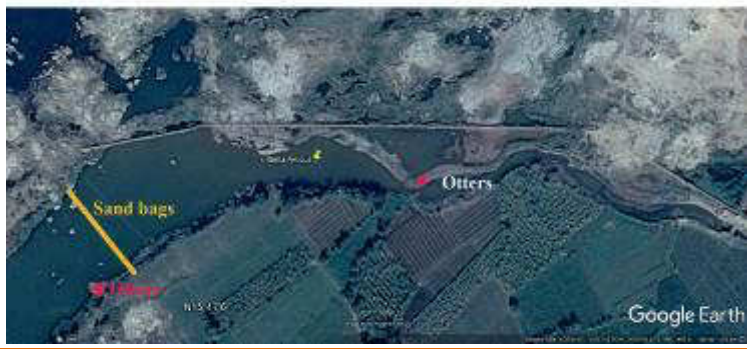
<p>The image shows a river area with a dam structure. Yellow arrows point to 'Sand bags' and a red arrow points to 'Otters'. The text 'Google Earth' is visible in the bottom right corner.</p>	<p>Bella anicut:</p> <ol style="list-style-type: none"> 1. Otters and crocodiles are active in this anicut. 2. An appropriate secondary ring bund shall be built across the river in the upstream of the anicut.
2	<p>Fig-21 Interventions- Turtha anicut</p>

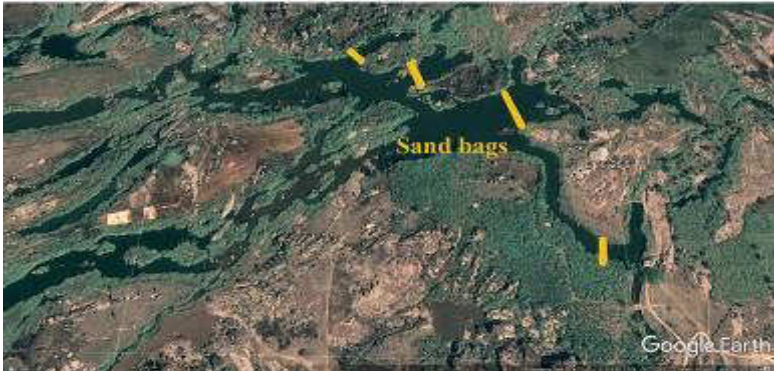
<p>The image shows a river area with a dam structure. Yellow arrows point to 'Sand bags'. The text 'Google Earth' is visible in the bottom right corner.</p>	<p>Turtha Anicut:</p> <ol style="list-style-type: none"> 1. Complex of 5 and more anicuts. 2. Excessive weed grown and choked with excessive sedimentation. 3. Suitable secondary ring bund to be built based on condition of the anicut

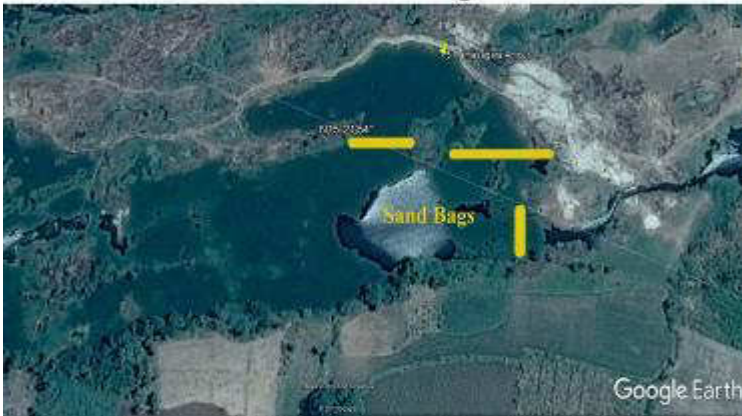
<p>The image shows a river area with a dam structure. Yellow arrows point to 'Sand Bags'. The text 'Google Earth' is visible in the bottom right corner.</p>	<p>Ramasagara Anicut</p> <ol style="list-style-type: none"> 1. It is a very long anicut. 2. Otters and crocodiles are in good numbers in this anicut area. 3. The existing islands shall not be destroyed. 4. Secondary Ring bunds shall be planned meticulously based on the condition and water level in the anicut area.

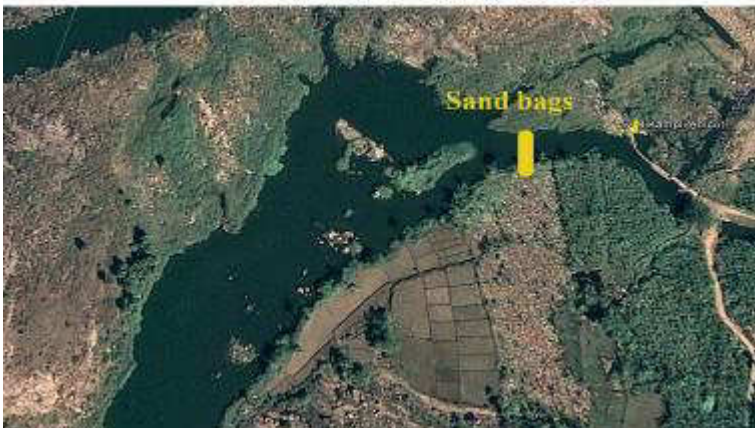
<p>Kampli Anicut</p> <ol style="list-style-type: none"> 1. Otters are in good number in the anicut area. 2. A suitable secondary ring bund shall be built based on the condition of the site and season.
5	<p>Fig -15 Interventions: Hulagi anicut</p>

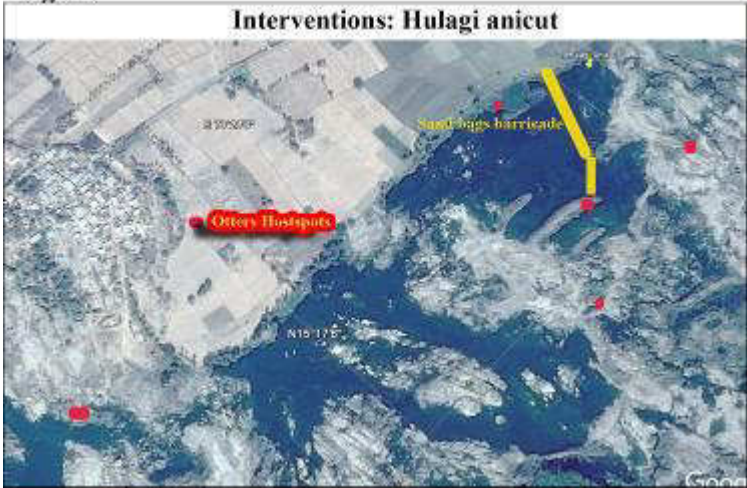
<p>Hulagi Anicut</p> <ol style="list-style-type: none"> 1. It is a very broad anicut. 2. Otters and crocodiles are in good number in this anicut. 3. The Otter use the long "finger shaped" islands for resting and mass defecation. 4. They also breed in side of the rocky island around anicut. 5. Construction of secondary ring bund shall be planned meticulously based on the condition of the anicut and season.
6	<p>Fig-16 Interventions - Shivapura anicut</p>

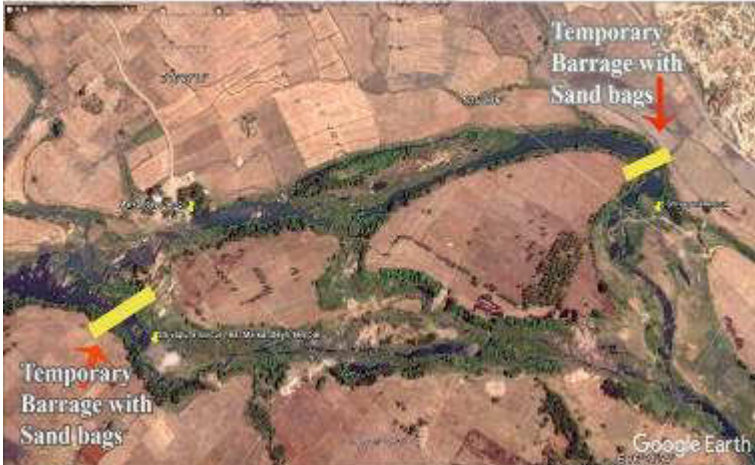
<p>Shivapura Anicut</p> <ol style="list-style-type: none"> 1. Otters and crocodiles are in good number in the upstream of the anicut. 2. Construction of Secondary ring bund shall be planned based on the condition.

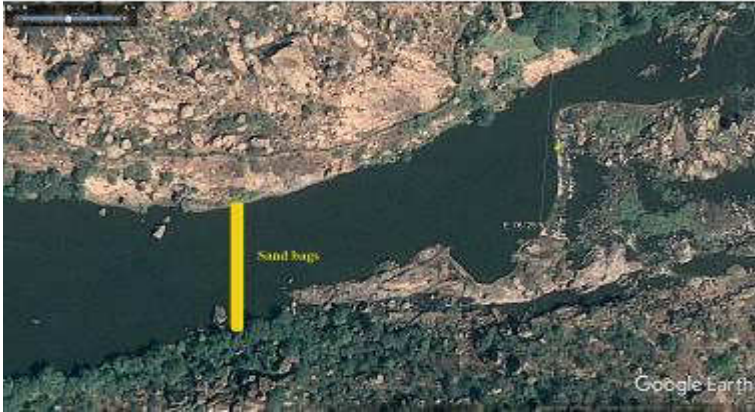
<p>Sanapura Anicut</p> <ol style="list-style-type: none"> 1. Otters use the anicut as corridor. 2. The Secondary ring bund shall be built across the narrow part of the river.
8	<p>Fig-18 Interventions - Upper Gangavathi</p>

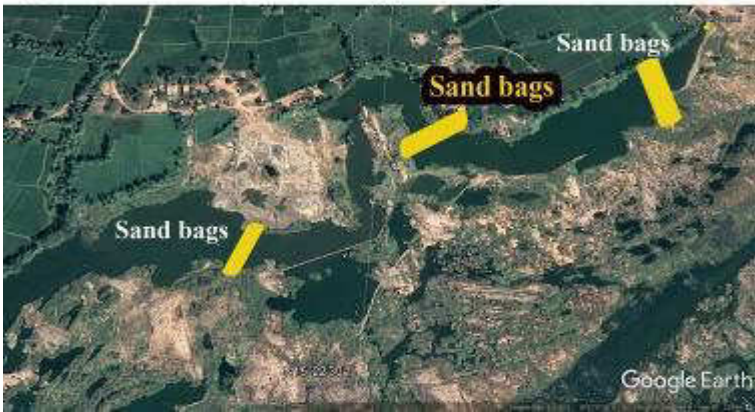
<p>Upper Gangavathi Anicut</p> <ol style="list-style-type: none"> 1. It is a very long anicut. 2. Most of the portion of the anicut area is over silted. 3. The secondary ring bund shall be built based on the condition of the location.
9	<p>Fig-19 Interventions - Lower Gangavathi anicut</p>

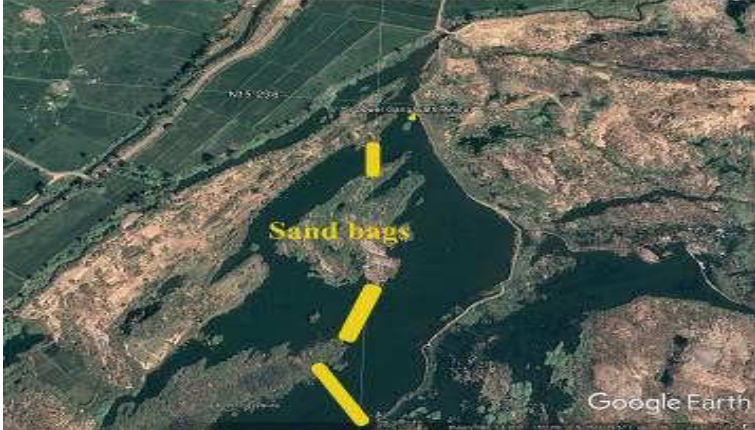
<p>Lower Gangavathi Anicut</p> <ol style="list-style-type: none"> 1. It is a very long anicut. 2. Secondary Ring bunds shall be constructed based on the condition of the anicut.

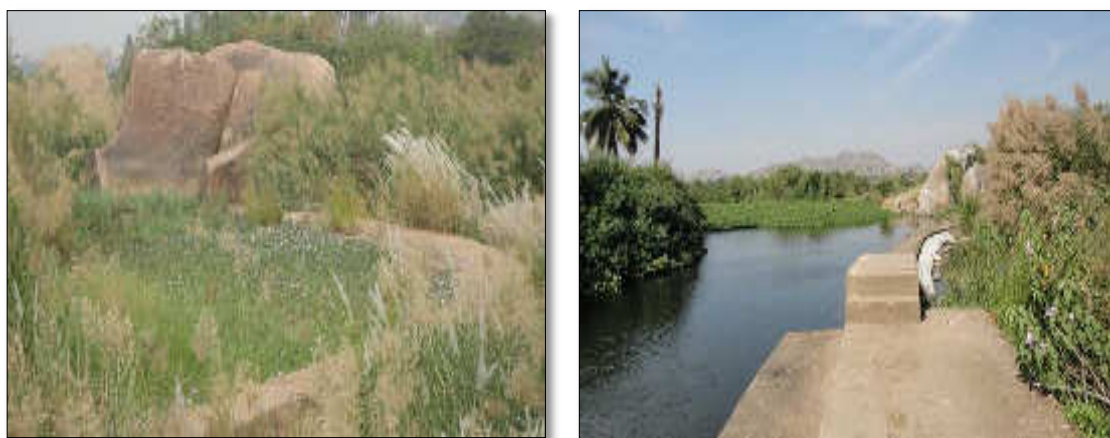
Figure 19: Typical work area within the OCR: Need for Desilting and Deweeding

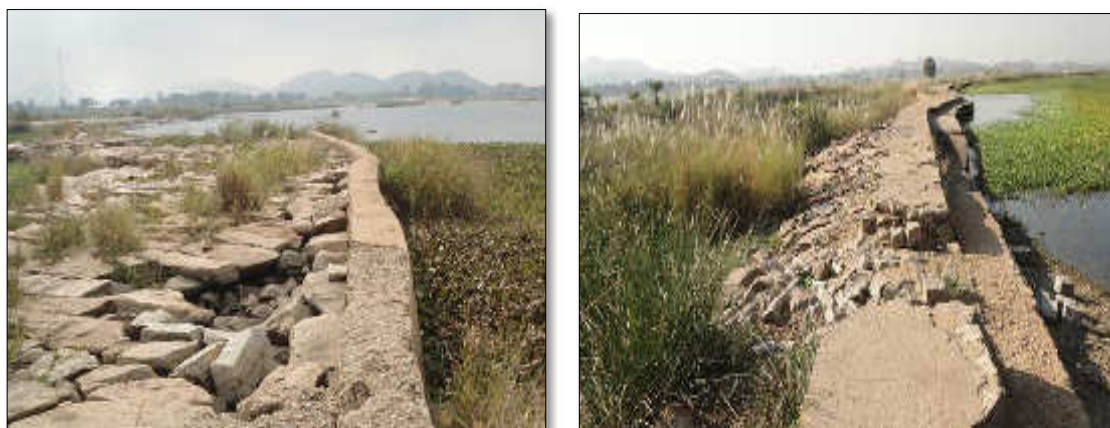
Figure 20: Typical Work within the OCR Area: Need for Realigning and Strengthening of Anicuts to prevent seepage

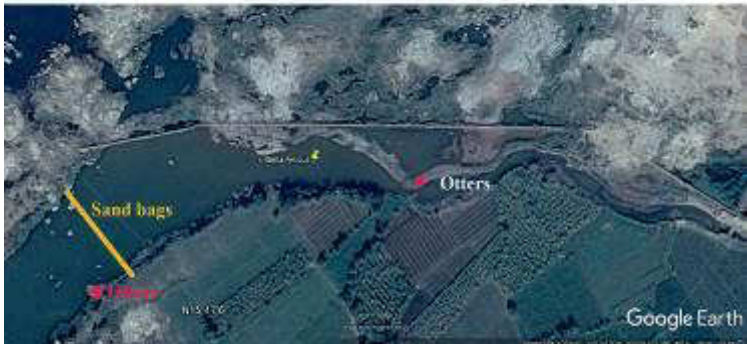
<p>This satellite image shows the Hosuru/Bella Anicut. Yellow arrows point to 'Sand bags' placed along the riverbank. A red dot marks the location of 'Otters'. The 'Bella Anicut' is labeled in the upper right. The Google Earth logo is in the bottom right corner.</p>	<p>Bella anicut:</p> <ol style="list-style-type: none"> 3. Otters and crocodiles are active in this anicut. 4. An appropriate secondary ring bund shall be built across the river in the upstream of the anicut.
2	<p>Fig-21 Interventions- Turtha anicut</p>

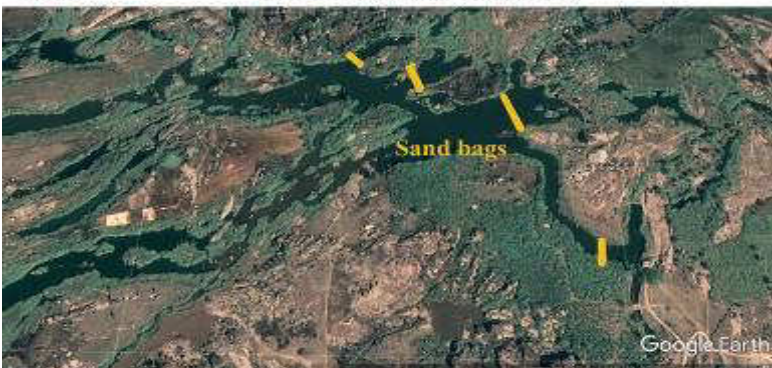
<p>This satellite image shows the Turtha anicut. Yellow arrows point to 'Sand bags' placed along the riverbank. The Google Earth logo is in the bottom right corner.</p>	<p>Turtha Anicut:</p> <ol style="list-style-type: none"> 4. Complex of 5 and more anicuts. 5. Excessive weed grown and choked with excessive sedimentation. 6. Suitable secondary ring bund to be built based on condition of the anicut

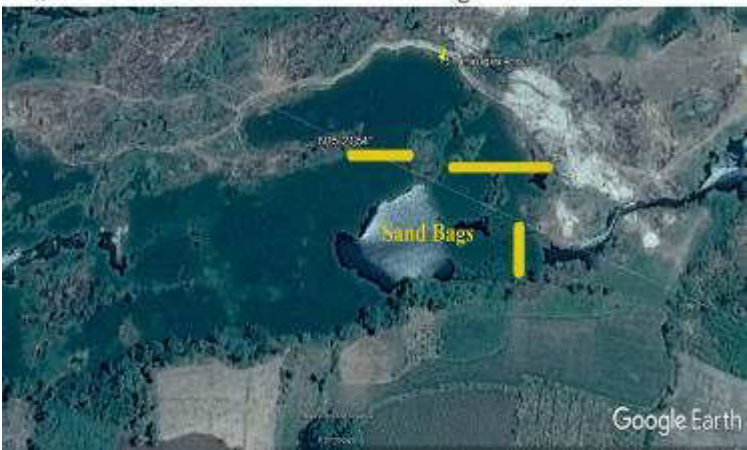
<p>This satellite image shows the Ramasagara Anicut. Yellow arrows point to 'Sand Bags' placed along the riverbank. The Google Earth logo is in the bottom right corner.</p>	<p>Ramasagara Anicut</p> <ol style="list-style-type: none"> 5. It is a very long anicut. 6. Otters and crocodiles are in good numbers in this anicut area. 7. The existing islands shall not be destroyed. 8. Secondary Ring bunds shall be planned meticulously based on the condition and water level in the anicut area.
4	<p>Fig -23 Interventions - Kampli anicut</p>

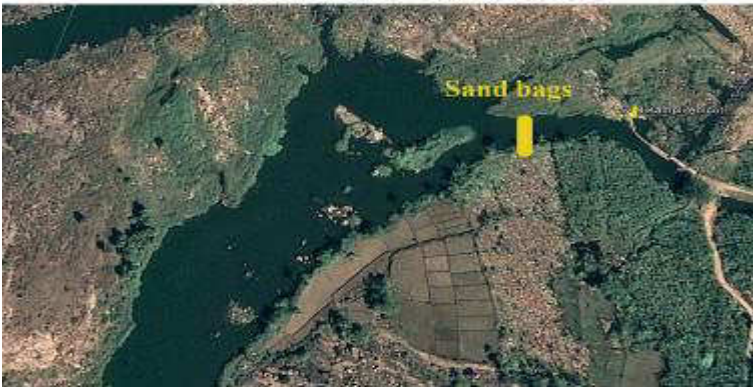
<p>This satellite image shows the Kampli anicut. Yellow arrows point to 'Sand bags' placed along the riverbank. The Google Earth logo is in the bottom right corner.</p>	<p>Kampli Anicut</p> <ol style="list-style-type: none"> 3. Otters are in good number in the anicut area. 4. A suitable secondary ring bund shall be built based on the condition of the site and season.

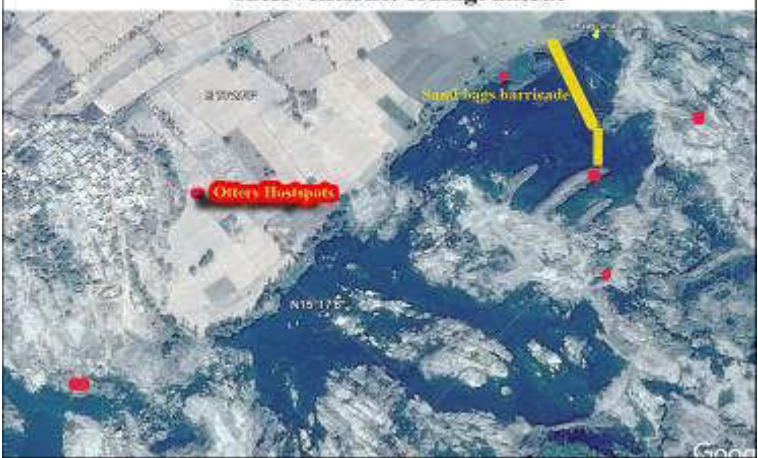
<p>The image shows a satellite view of the Hulagi anicut. A yellow line indicates a 'Sand bags barricade' across the river. Red dots mark 'Otter Habitats' on the riverbanks. The river is labeled 'N151175'.</p>	<p>Hulagi Anicut</p> <ol style="list-style-type: none"> 6. It is a very broad anicut. 7. Otters and crocodiles are in good number in this anicut. 8. The Otter use the long "finger shaped" islands for resting and mass defecation. 9. They also breed in side of the rocky island around anicut. 10. Construction of secondary ring bund shall be planned meticulously based on the condition of the anicut and season.
6	<p>Fig-16 Interventions - Shivapura anicut</p>

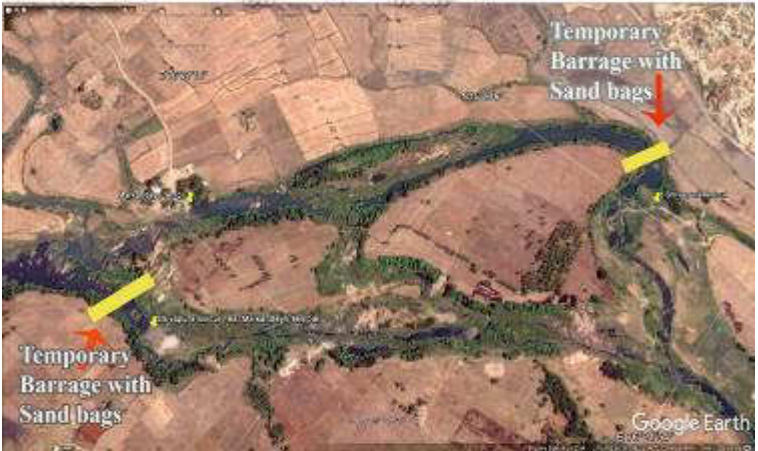
<p>The image shows a satellite view of the Shivapura anicut. Two yellow lines indicate 'Temporary Barrage with Sand bags' on either side of the river. The river is labeled 'Shivapura'.</p>	<p>Shivapura Anicut</p> <ol style="list-style-type: none"> 3. Otters and crocodiles are in good number in the upstream of the anicut. 4. Construction of Secondary ring bund shall be planned based on the condition.

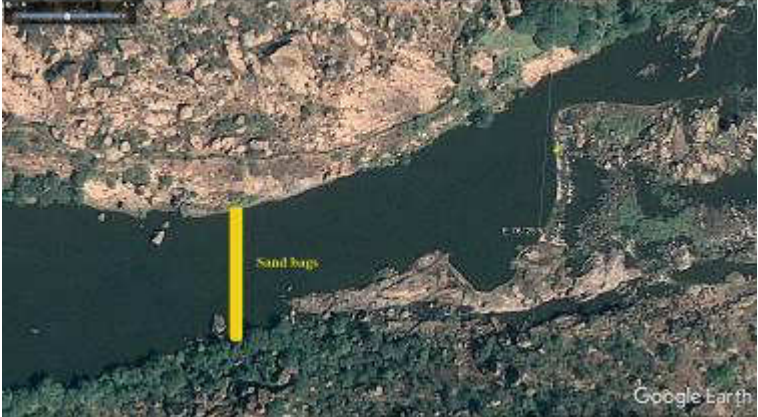
<p>The image shows a satellite view of the Sanapura /Anegundi anicut. A yellow line indicates a 'Sand bags' barrier across the river. The river is labeled 'Sanapura'.</p>	<p>Sanapura Anicut</p> <ol style="list-style-type: none"> 3. Otters use the anicut as corridor. 4. The Secondary ring bund shall be built across the narrow part of the river.

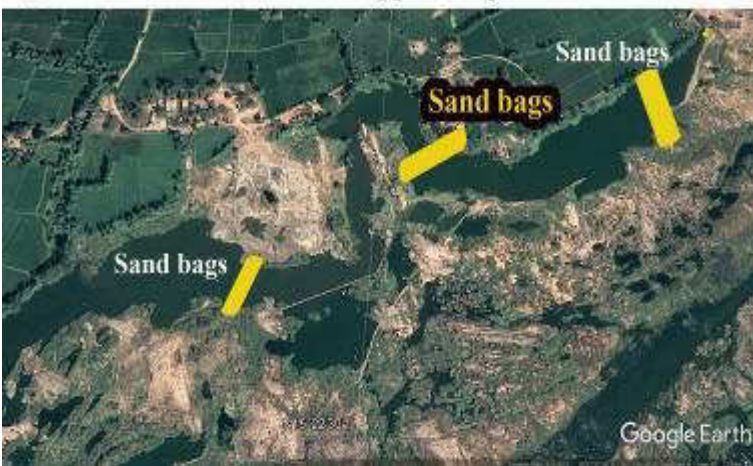
<p>Upper Gangavathi Anicut</p> <ol style="list-style-type: none"> It is a very long anicut. Most of the portion of the anicut area is over silted. The secondary ring bund shall be built based on the condition of the location.
9	<p>Fig-19 Interventions - Lower Gangavathi anicut</p>

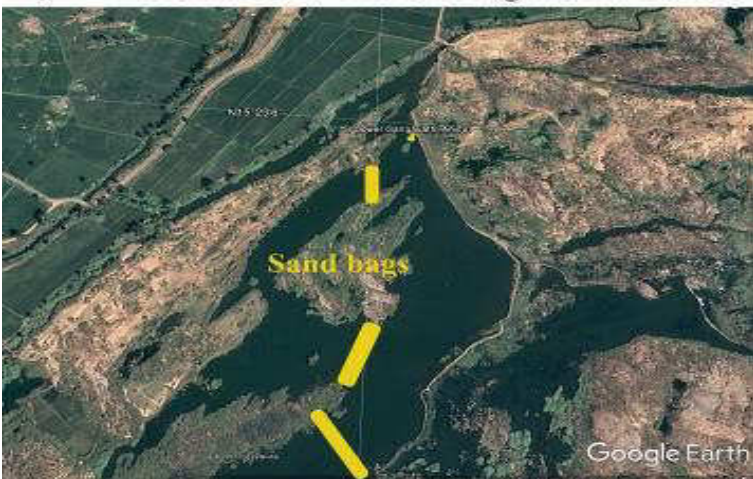
<p>Lower Gangavathi Anicut</p> <ol style="list-style-type: none"> It is a very long anicut. Secondary Ring bunds shall be constructed based on the condition of the anicut.

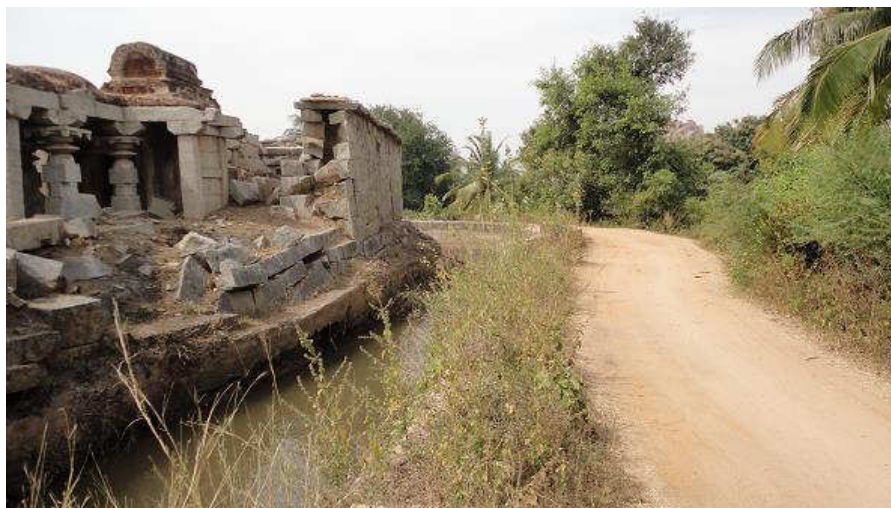
Figure 21: Part of Turtha Canal within Hampi WHA where canal rehabilitation designs should maintain integrity of the heritage landscape
