**MHI RISK ASSESSMENT ON THE NATURAL GAS FACILITY AT
TETRA4 NEAR VIRGINIA IN THE FREE STATE**

June 2022

Facility Name: CNG and LNG Processing Plant

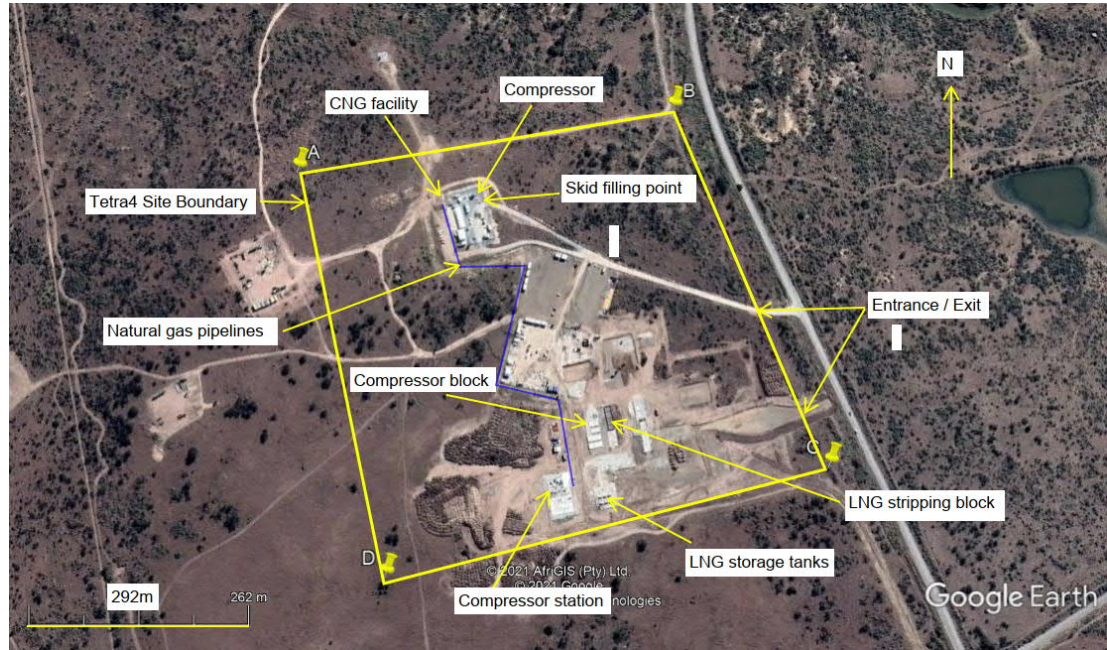
Site layout Phase I

The site layout is shown in the figure below.

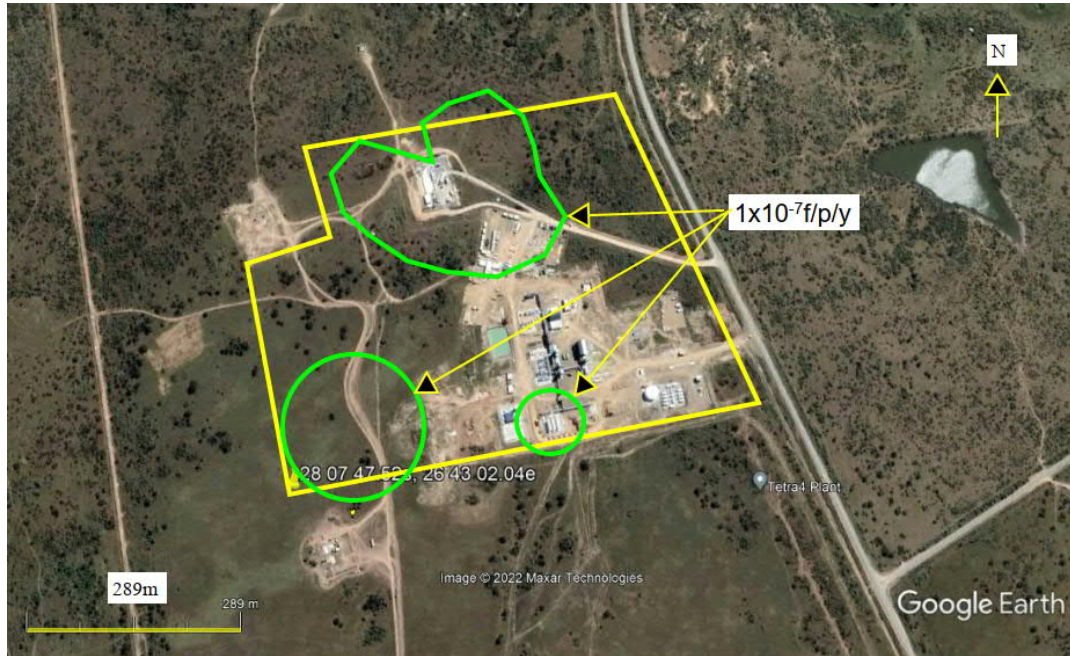
Risk zones

The individual risk calculations were done for the 16 main wind directions. The risk zones are shown in the figure below.

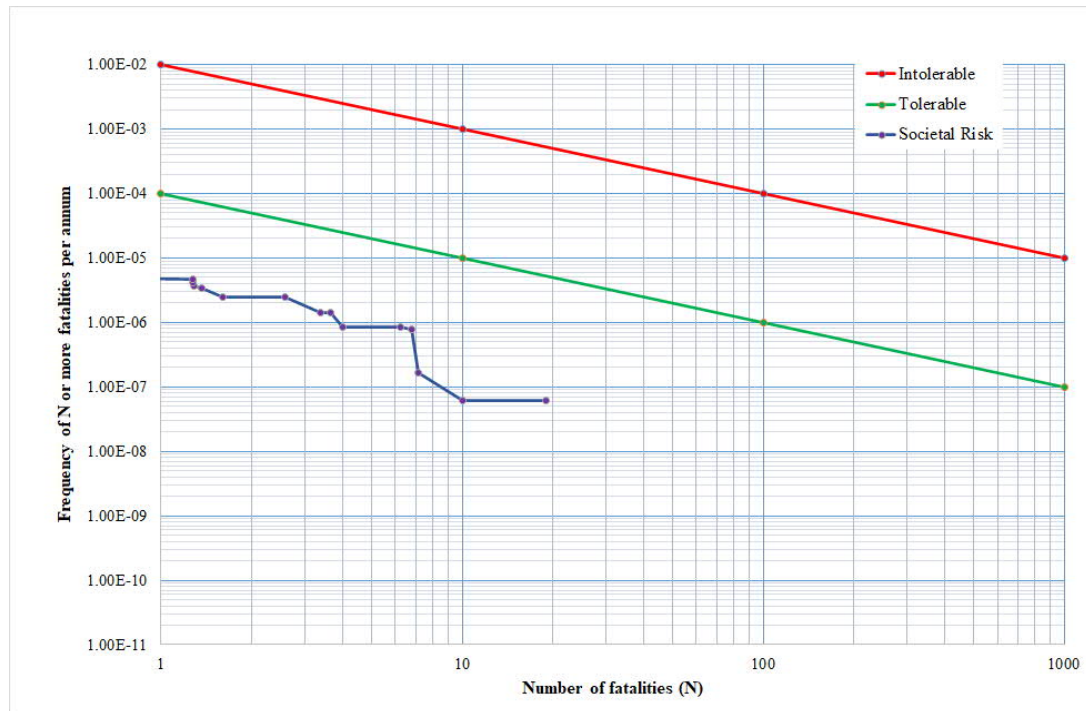
Societal Risk

The societal risk is normally presented by the so-called FN-curves. Where F is the cumulative frequency of events that may cause fatalities to the public and N represents the number of fatalities.

The societal risk, as shown in the figure below, was calculated for the eight main wind directions.

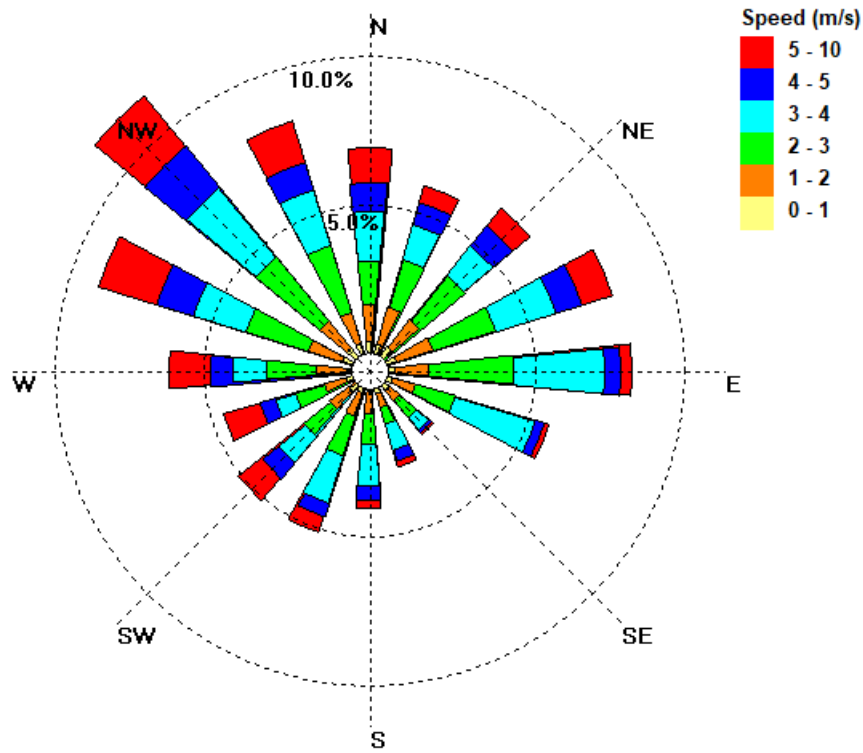
Figure 2.2a Wind rose generated from the meteorological data for Tetra4 for a complete year

From analysis of the day and night wind characteristics it was found that the following atmospheric conditions could be present during a period of one year.

- 3B – unstable with a wind speed of 3m/s, which will occur mostly in the afternoon on a hot sunny day prevailing at 10.35% of the time
- 5D – neutral with a wind speed of 5m/s, which will occur mostly during day time, with some cloud cover and a strong wind blowing prevailing at 43.21% of the time
- 5E- stable with a wind speed of 5m/s which will occur mostly during night time prevailing at 21.11% of the time
- 1.5F – very stable with a wind speed of 1.5m/s, which will occur mostly during night time with cloud cover and a moderate wind speed, prevailing at 25.31% of the time

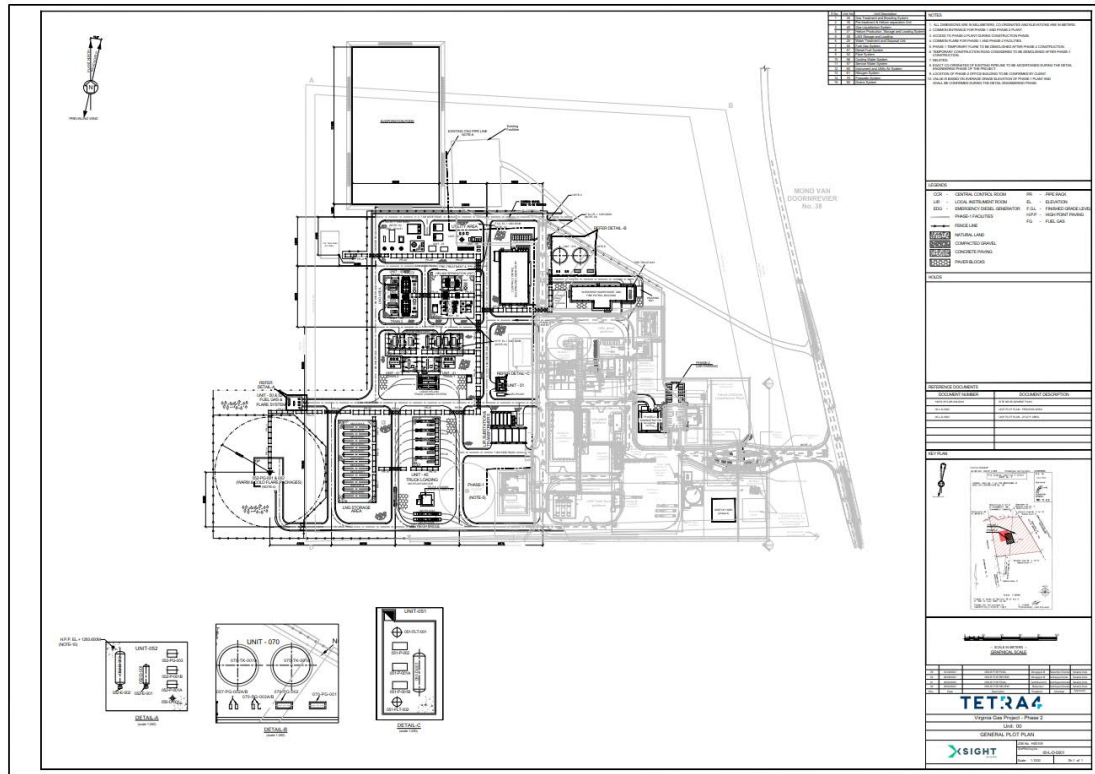
Figure 3.1a Site layout

The plant layout is shown in Figure 3.1.

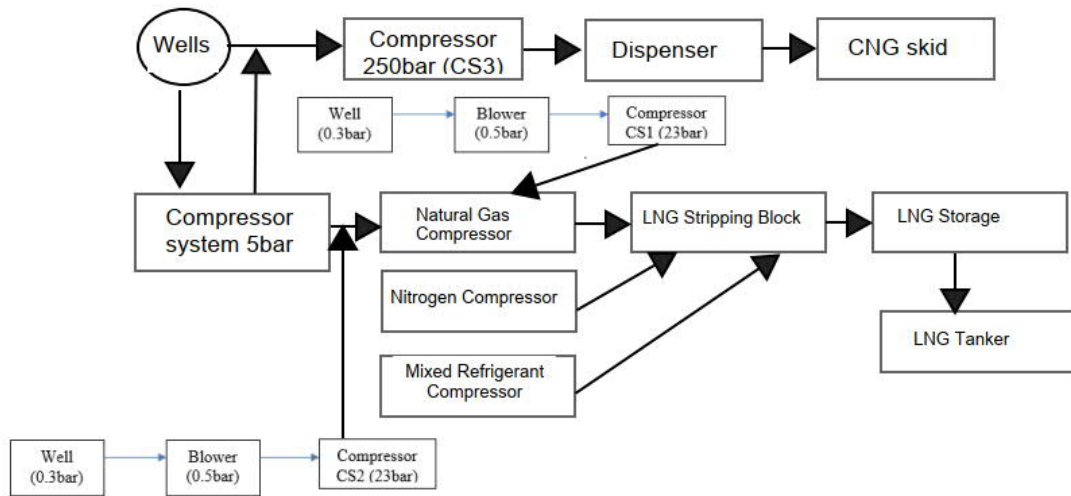
Figure 3.1b CNG LNG facility block diagram

Natural gas is withdrawn from a well at a pressure of approximately 19kPa. The gas is then compressed to 250barg and supplied via a dispenser to a 9 tube CNG skid.

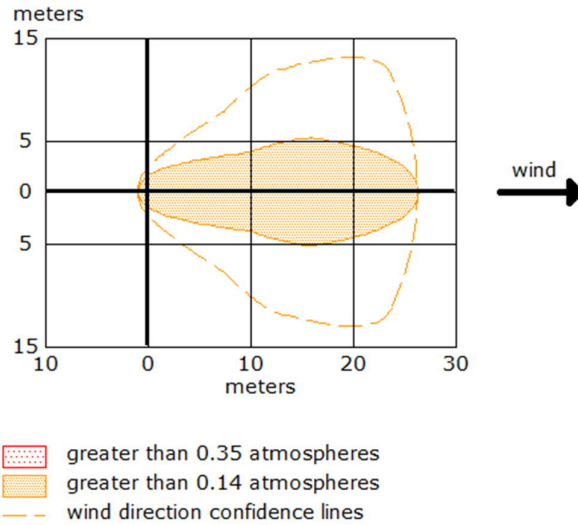
Figure 3.2 VCE under atmospheric stability 3B

It follows from Figure 3.2 that the following explosion overpressures will be present due to VCE:

- An over pressure of 0.14 bar occurs at a distance of 26.0m from the point of release. At this overpressure, minor damage to process equipment and less than 1% fatalities may occur.

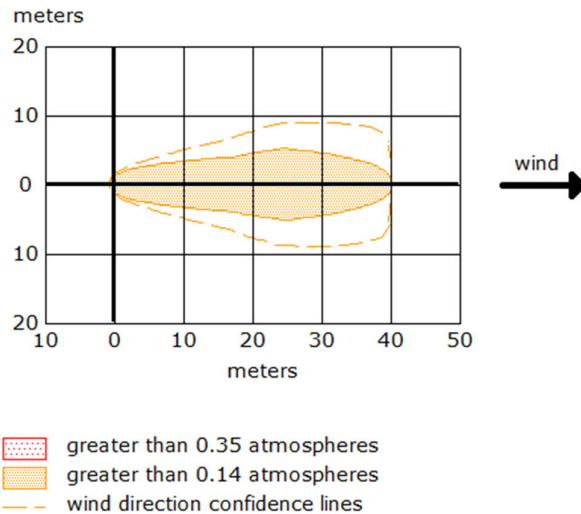
Figure 3.3 VCE under atmospheric stability 5D

It follows from Figure 3.3 that the following explosion overpressures will be present due to VCE:

- An over pressure of 0.14 bar occurs at a distance of 40.0m from the point of release. At this overpressure, minor damage to process equipment and less than 1% fatalities may occur.

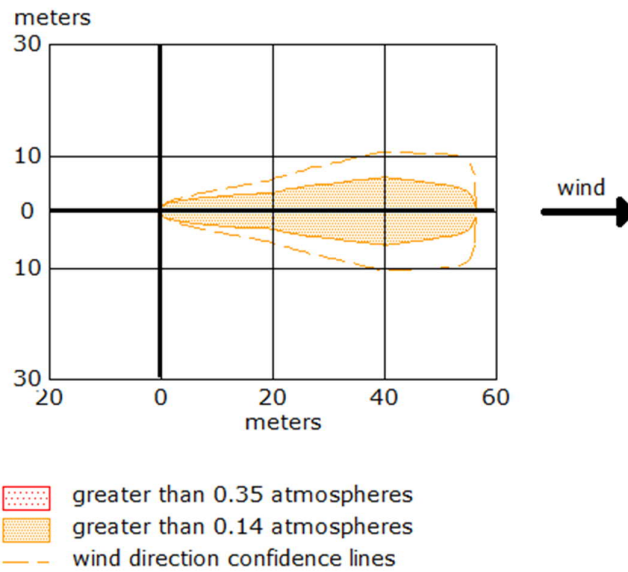
Figure 3.4 VCE under atmospheric stability 5E

It follows from Figure 3.4 that the following explosion overpressures will be present due to VCE:

- An over pressure of 0.14 bar occurs at a distance of 57.0m from the point of release. At this overpressure, minor damage to process equipment and less than 1% fatalities may occur.

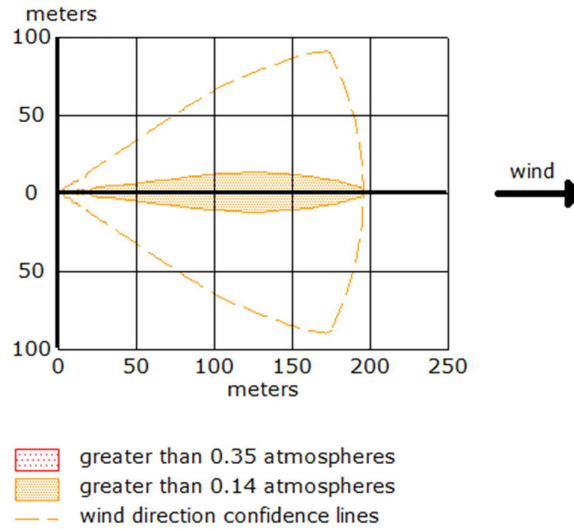
Figure 3.5 VCE under atmospheric stability 1.5F

- An over pressure of 0.14 bar occurs at a distance of 196.0m from the point of release. At this overpressure, minor damage to process equipment and less than 1% fatalities may occur.

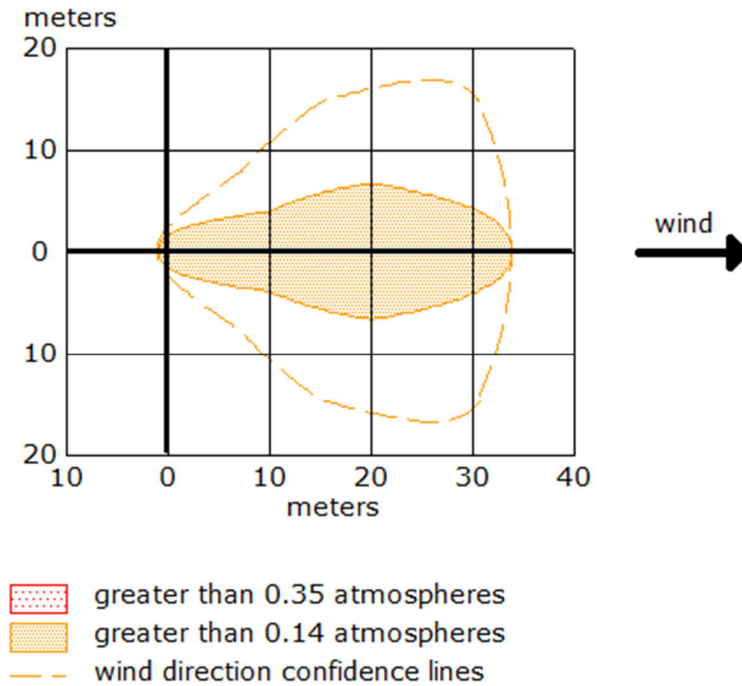
Figure 3.7 VCE under atmospheric stability 3B

- An over pressure of 0.14 bar occurs at a distance of 34.0m from the point of release. At this overpressure, minor damage to process equipment and less than 1% fatalities may occur.

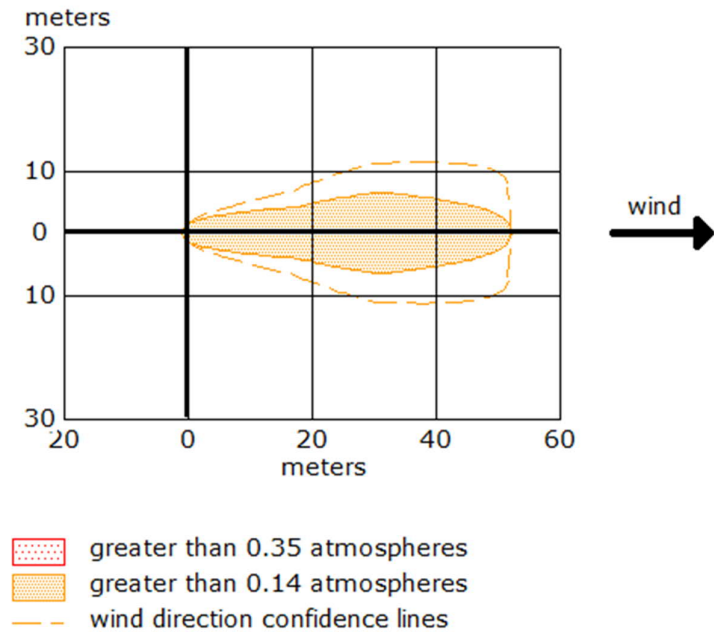
Figure 3.8 VCE under atmospheric stability 5D

- An over pressure of 0.14 bar occurs at a distance of 52.0m from the point of release. At this overpressure, minor damage to process equipment and less than 1% fatalities may occur.

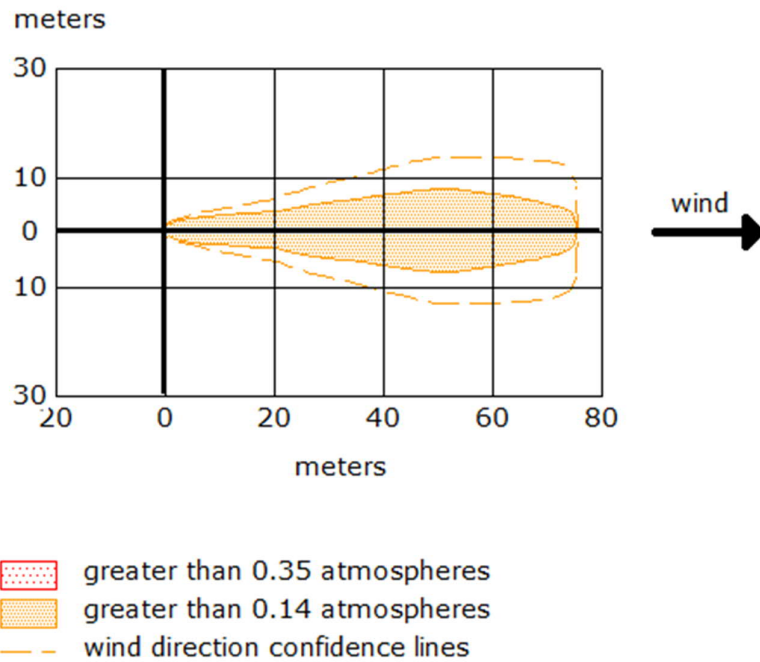
Figure 3.9 VCE under atmospheric stability 5E

- An over pressure of 0.14 bar occurs at a distance of 76.0m from the point of release. At this overpressure, minor damage to process equipment and less than 1% fatalities may occur.

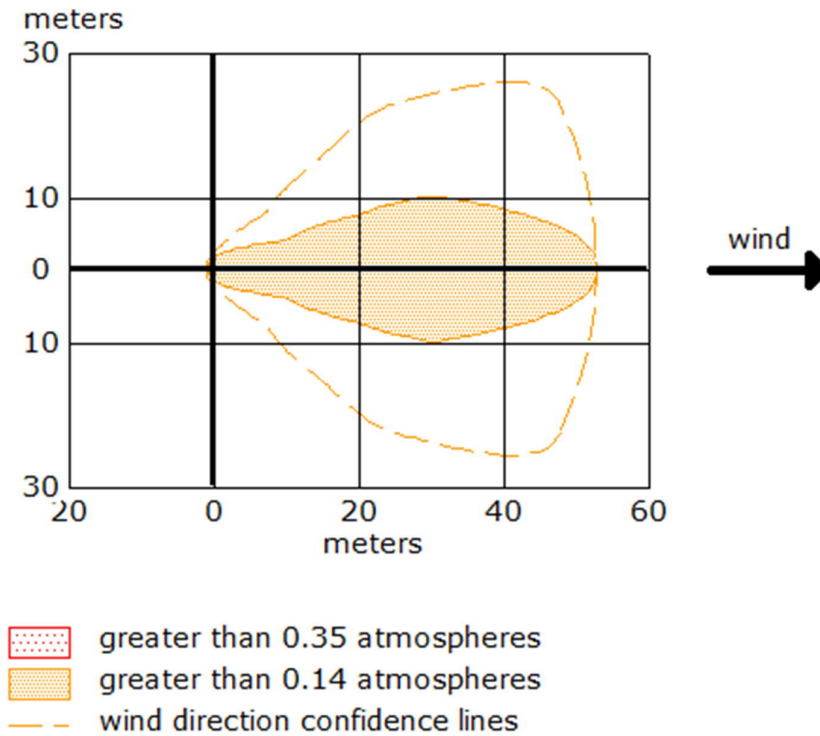
Figure 3.12 VCE under atmospheric stability 3B

- An over pressure of 0.14 bar occurs at a distance of 53.0m from the point of release. At this overpressure, minor damage to process equipment and less than 1% fatalities may occur.

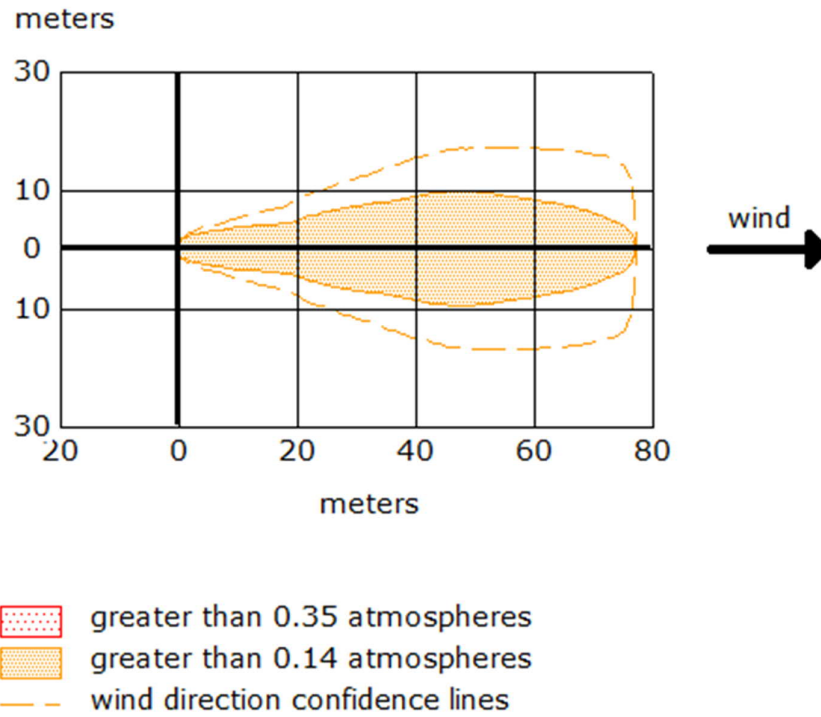
Figure 3.13 VCE under atmospheric stability 5D

- An over pressure of 0.14 bar occurs at a distance of 78.0m from the point of release. At this overpressure, minor damage to process equipment and less than 1% fatalities may occur.

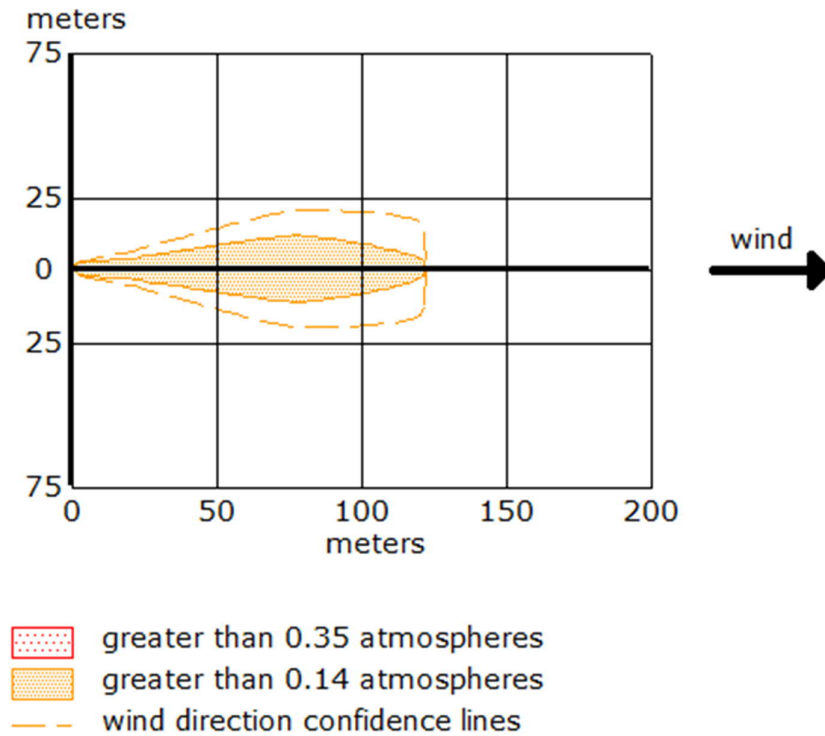
Figure 3.14 Isopleths for the explosive part of the CH₄-plume for atmospheric stability 5E

- An over pressure of 0.14 bar occurs at a distance of 123.0m from the point of release. At this overpressure, minor damage to process equipment and less than 1% fatalities may occur.

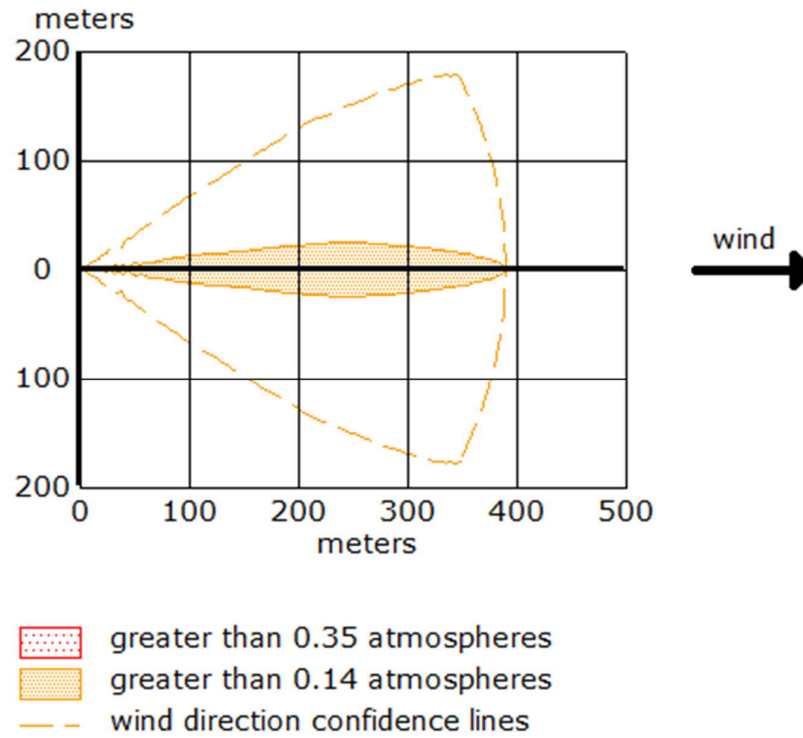
Figure 3.15 VCE under atmospheric stability 1.5F

- An over pressure of 0.14 bar occurs at a distance of 392.0m from the point of release. At this overpressure, minor damage to process equipment and less than 1% fatalities may occur.

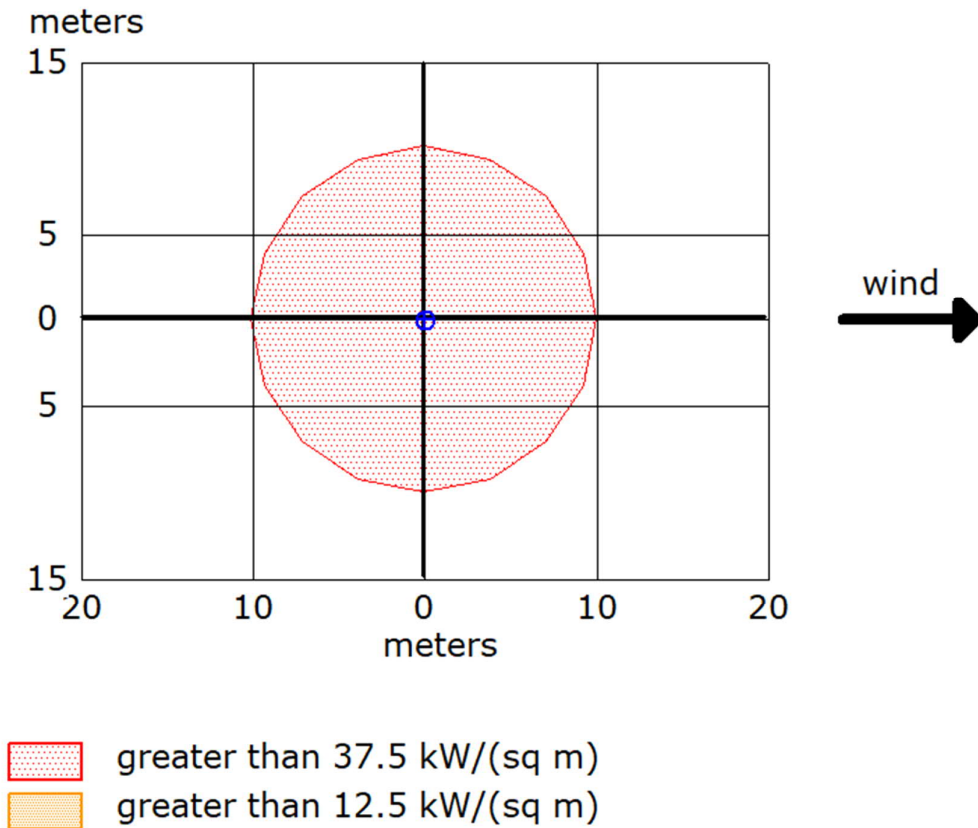
Figure 3.17 Heat radiation from jet flame

The heat radiation from such a jet flame is shown in Figure 3.17.

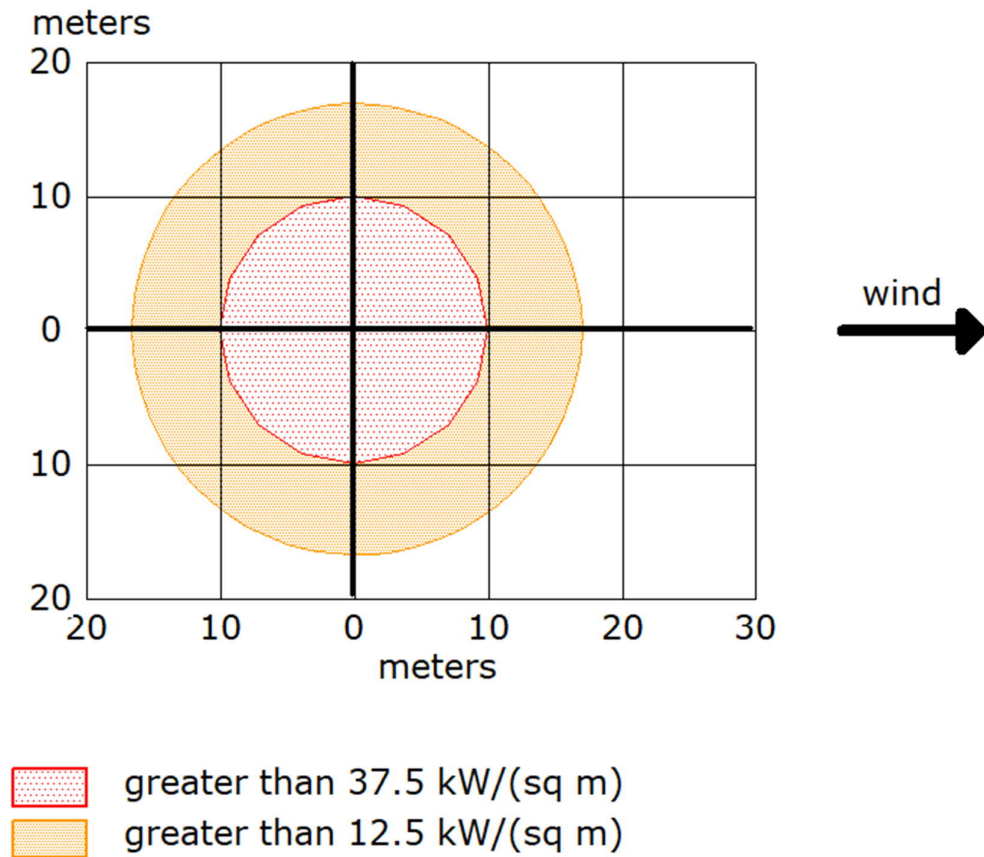
Figure 3.18 Heat radiation from jet flame

The heat radiation from such a jet flame is shown in Figure 3.18.

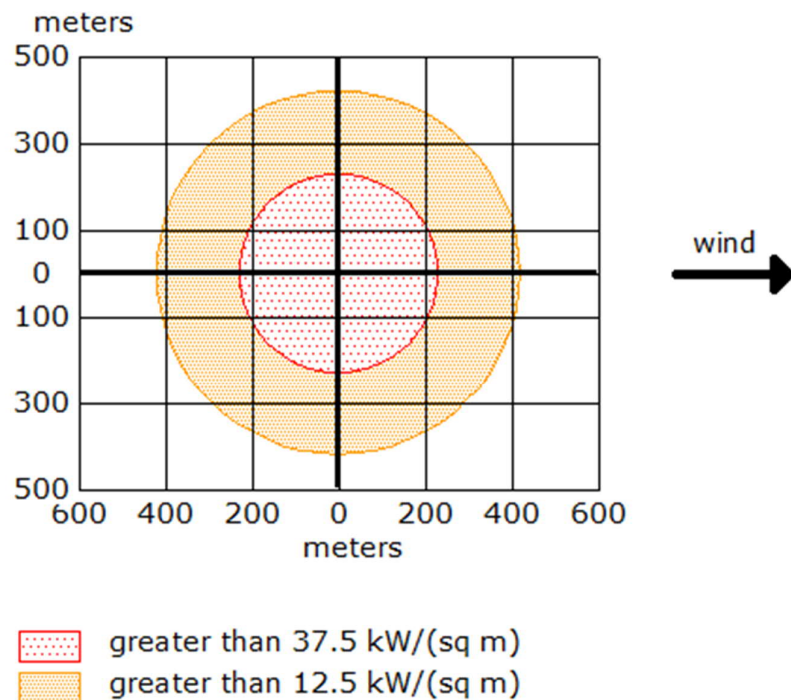
Figure 3.19. Heat load as a function of the distance from the centre of the fireball

The radius of the fireball was calculated to be 101.5m and the duration of such a fire ball will be 13.0s. Figure 3.19 presents the heat load as a function of the distance from the centre of the explosion due to a BLEVE.

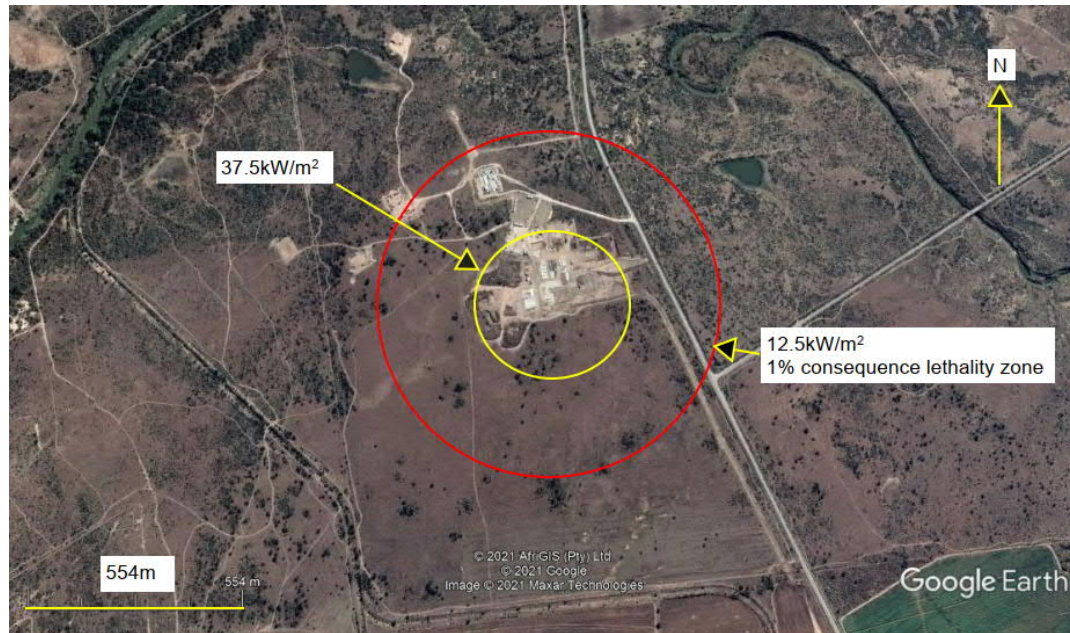
Figure 3.20: Heat radiation levels due to a BLEVE from a 100m^3 container

Figure 3.20 shows the radii of the thermal radiation and overpressure due to a BLEVE from a 100m^3 cryogenic container.

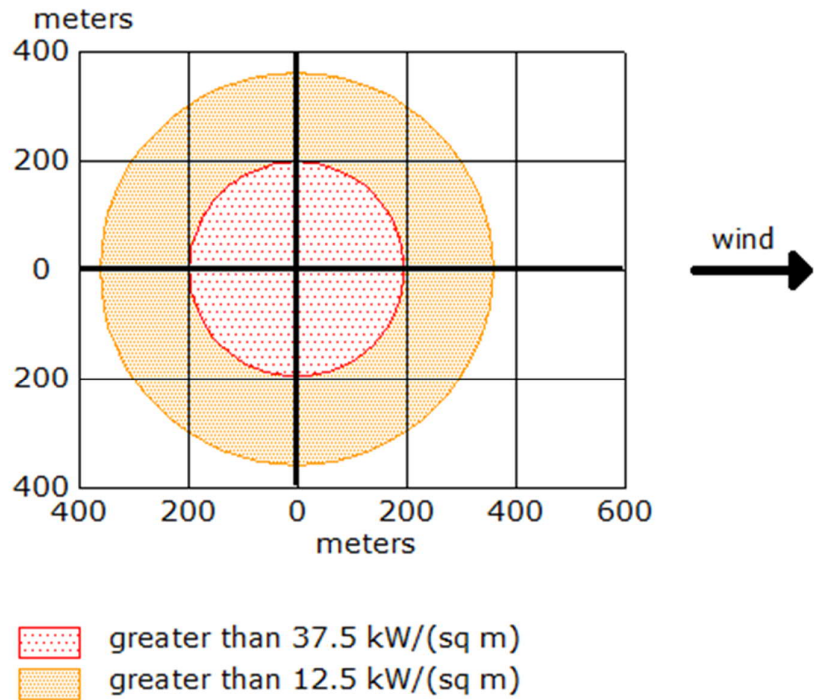
Figure 3.21 Heat load as a function of the distance from the centre of the fireball

The radius of the fireball was calculated to be 86.0m and the duration of such a fire ball will be 11.0s. Figure 3.21 presents the heat load as a function of the distance from the centre of the fireball.

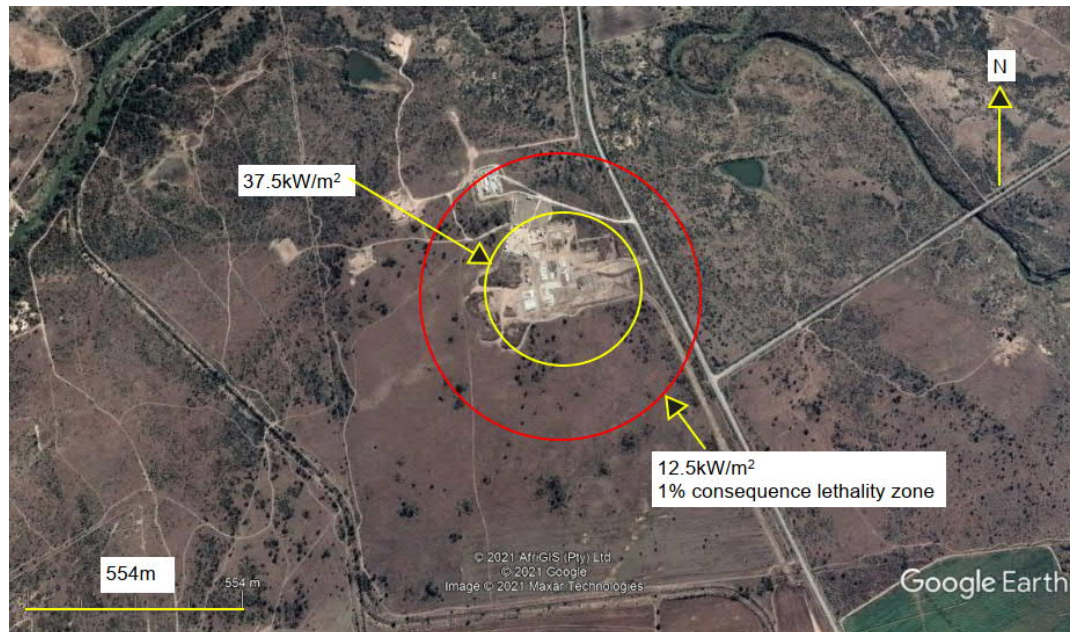
Figure 3.22: Heat radiation due to a BLEVE from a 61.5m³ cryogenic tanker

Figure 3.22 shows the radii of the thermal radiation and the overpressure due to a BLEVE from a 61.5m³ cryogenic tanker

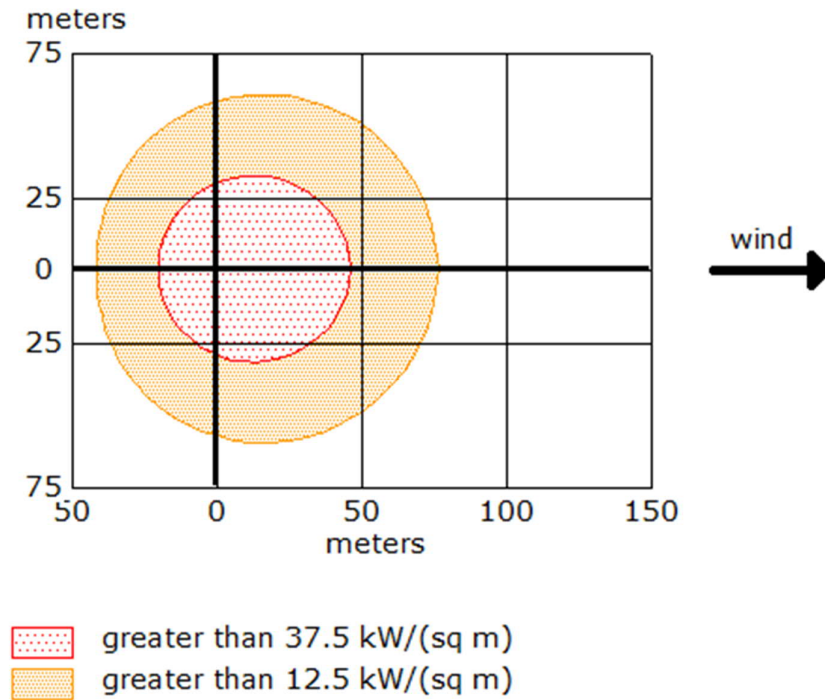
Figure 3.23 Thermal radiation levels from the pool fire under atmospheric stability 5D

In the event of a catastrophic failure of a 100m³ cryogenic container into the bunded area a fire may result in the presence of an ignition source. Figure 3.23 shows the radiation levels of such a fire.

- Heat radiation of 37.5kW/m^2 at a distance of 47m from the centre of the fireball. This heat intensity is sufficient to damage process equipment and result in 100 % fatalities within one minute. A fuel tank of a vehicle exposed to such a radiation level can explode.
- Heat radiation of 12.5kW/m^2 up to a distance 77m from the centre of the fireball. This heat intensity is sufficient to ignite wood or melt plastic and may result in 1 % fatalities within one minute.

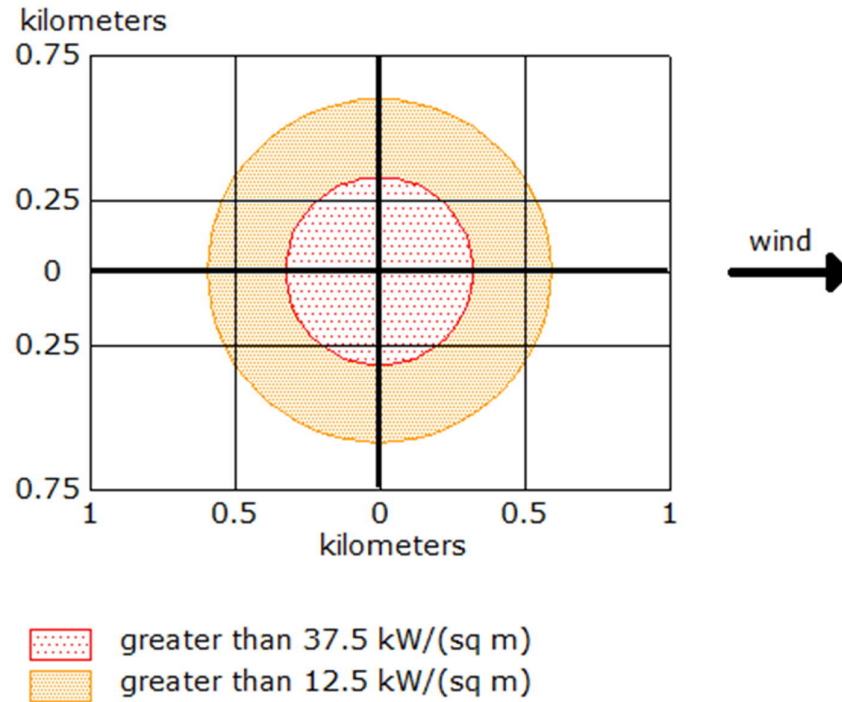
Figure 3.19. Heat load as a function of the distance from the centre of the fireball

The radius of the fireball was calculated to be 101.5m and the duration of such a fire ball will be 13.0s. Figure 3.23 presents the heat load as a function of the distance from the centre of the explosion due to a BLEVE.

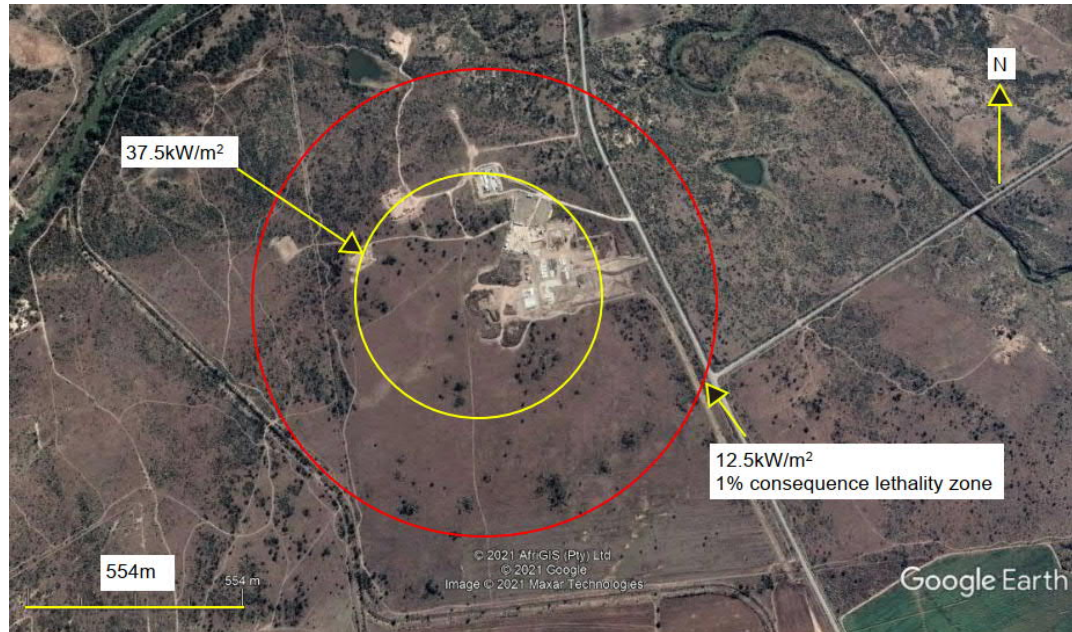
Figure 3.24: Heat radiation levels due to a BLEVE from a 300m³ container

Figure 3.24 shows the radii of the thermal radiation levels due to a BLEVE from a 300m³ cryogenic container.

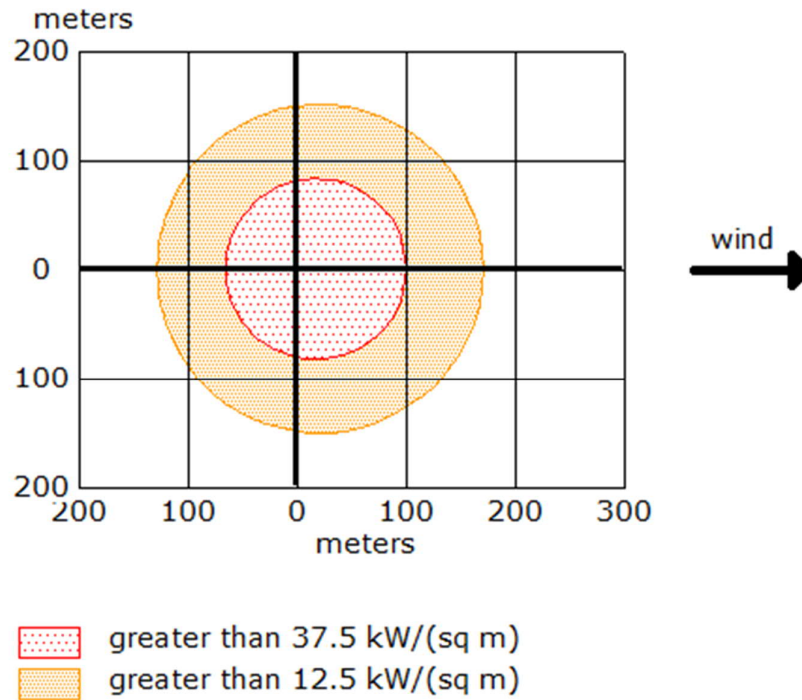
Figure 3.25 Thermal radiation levels from the pool fire under atmospheric stability 5D

In the event of a catastrophic failure of a 100m³ cryogenic container into the bunded area a fire may result in the presence of an ignition source. Figure 3.25 shows the radiation levels of such a fire.

- Heat radiation of 37.5kW/m^2 at a distance of 101m from the centre of the fireball. This heat intensity is sufficient to damage process equipment and result in 100 % fatalities within one minute. A fuel tank of a vehicle exposed to such a radiation level can explode.
- Heat radiation of 12.5kW/m^2 up to a distance 171m from the centre of the fireball. This heat intensity is sufficient to ignite wood or melt plastic and may result in 1 % fatalities within one minute.

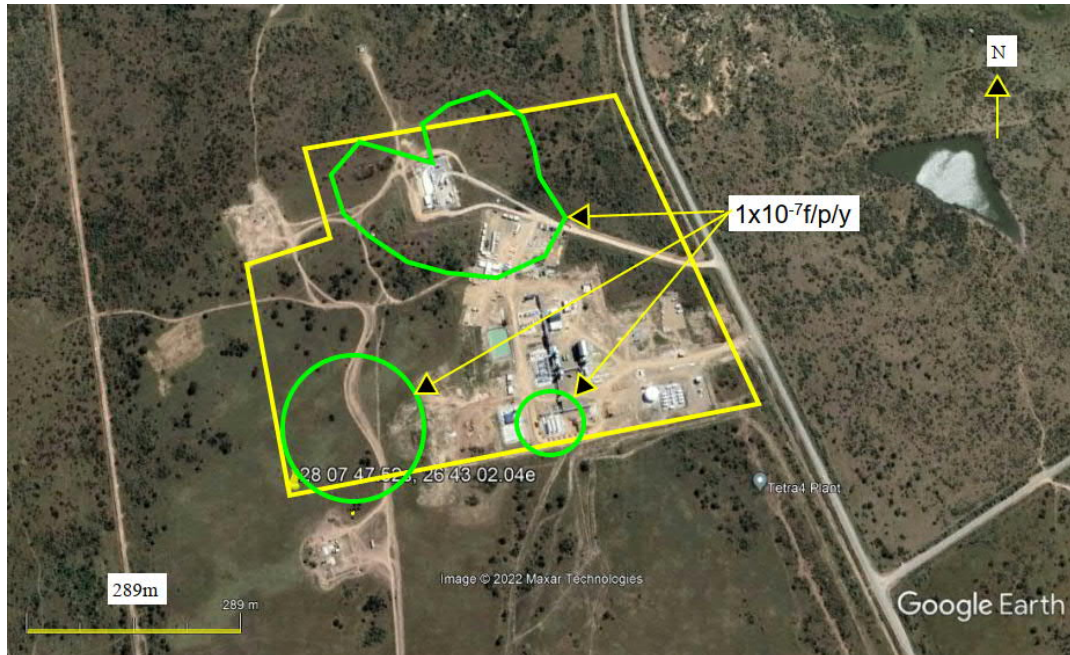
Figure 3.39: Risk Zones

These calculations were done for the 16 main wind directions. The risk zones are shown in Figure 3.39.

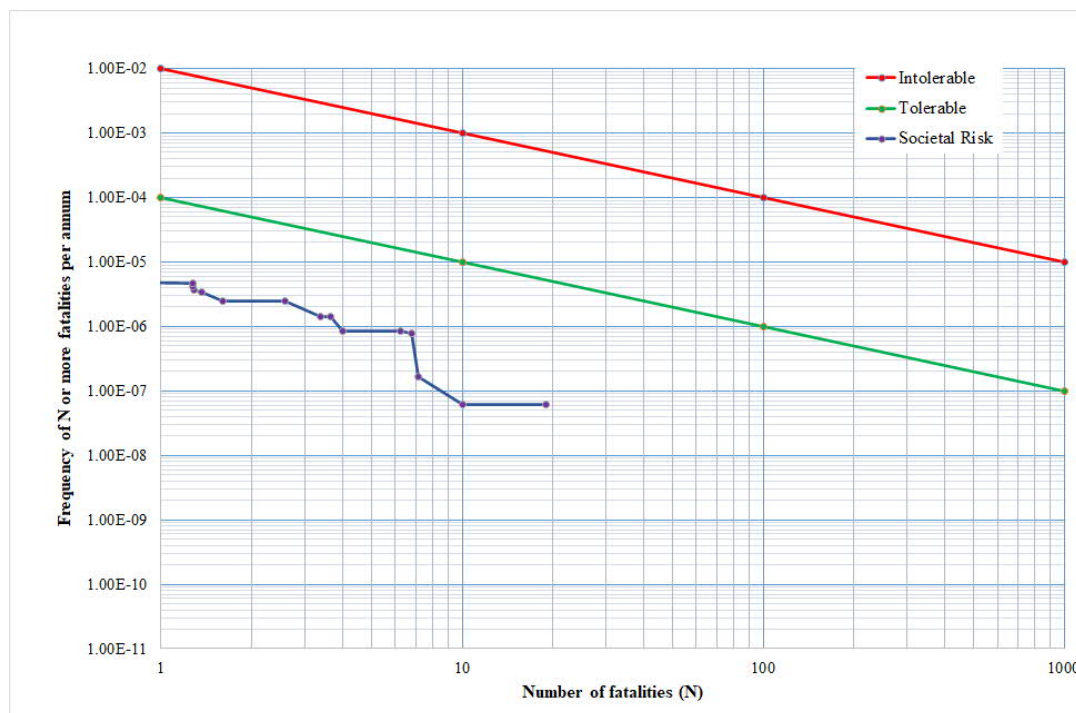
Figure 3.41 Societal risk as posed by the CNG and LNG facilities

The societal risk, as shown in Figure 3.41, was calculated for the eight main wind directions.

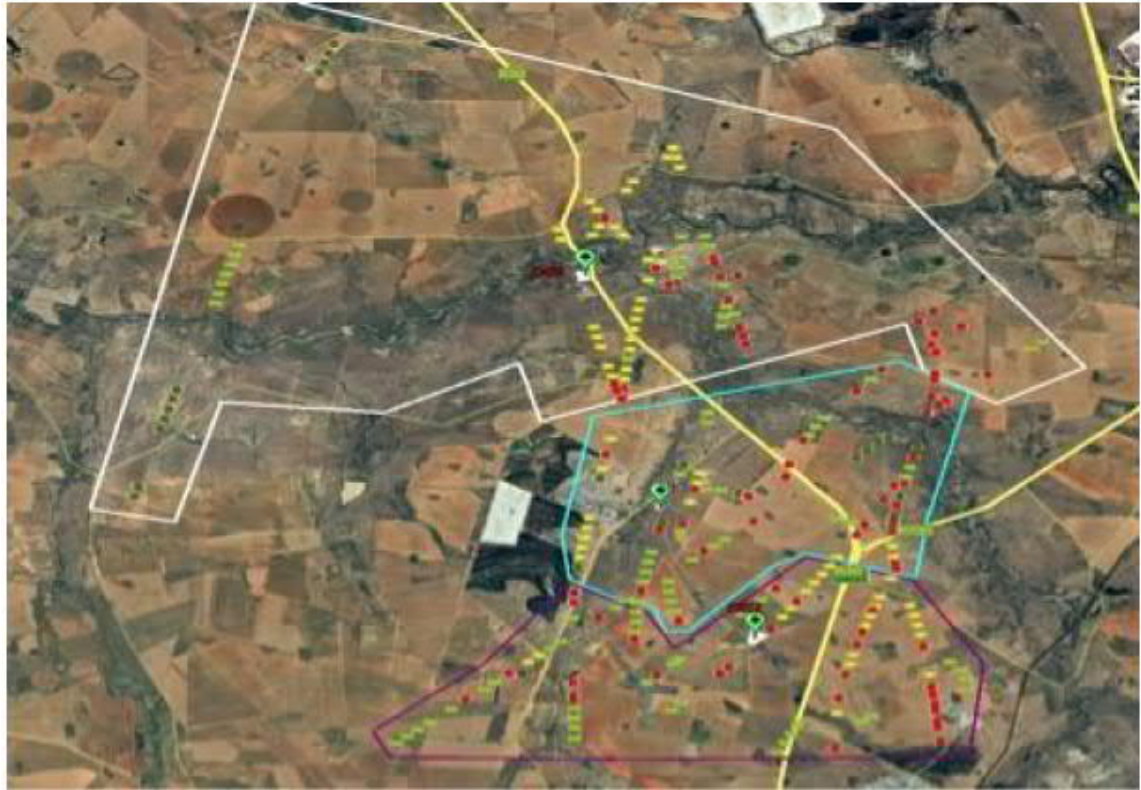
Figure 2.1 Well locations

Natural gas is obtained from wells at a pressure of approximately 0.3bar and routed to the LNG facility at Tetra4. There are approximately 300 wells. From the wells the natural gas is fed via below surface lines to blowers and from the blowers it is fed to compressor stations at a pressure of 50kPa. From the compressor stations the natural gas is fed via an underground line to the LNG facility at a pressure of 23bar (design 30bar) through a 10inch line.

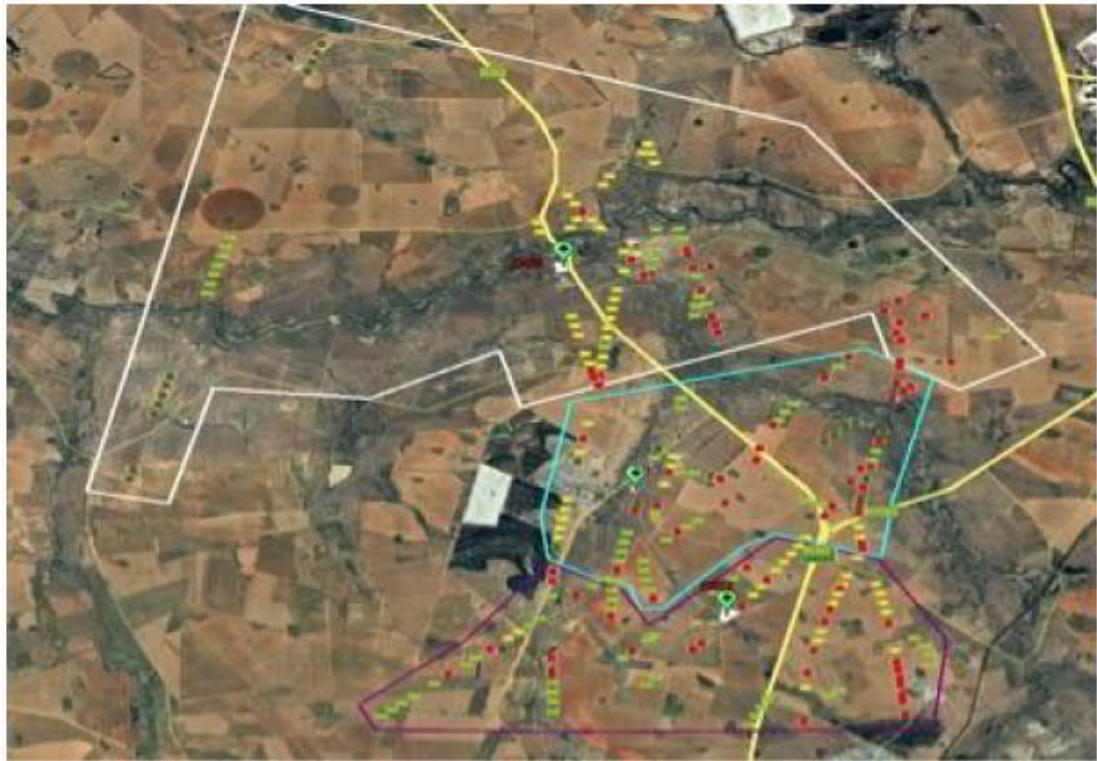
Figure 3.1a Site layout (wells)

The site layout is shown in Figure 3.1.
