# Environmental and Social Monitoring Report

Annual Report  
Project Number: 47929-001  
February 2015 to December 2015

## PAK: Gulpur Hydropower Project

**Pre-Construction Progress Report**

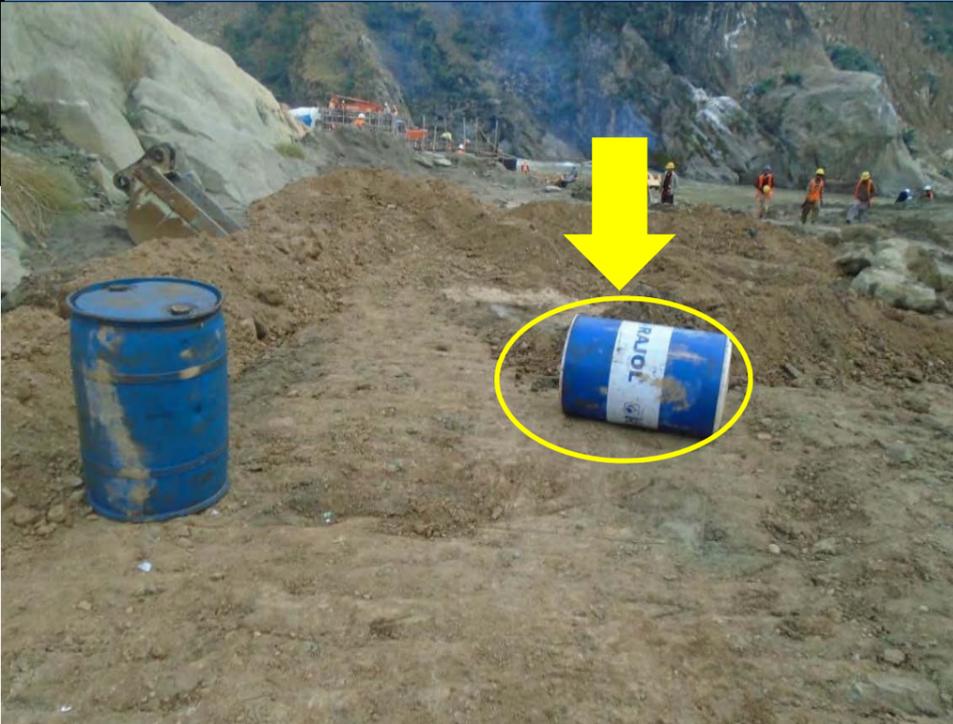
Encircled: Drum containing diesel fuel. (Capacity 200 L)

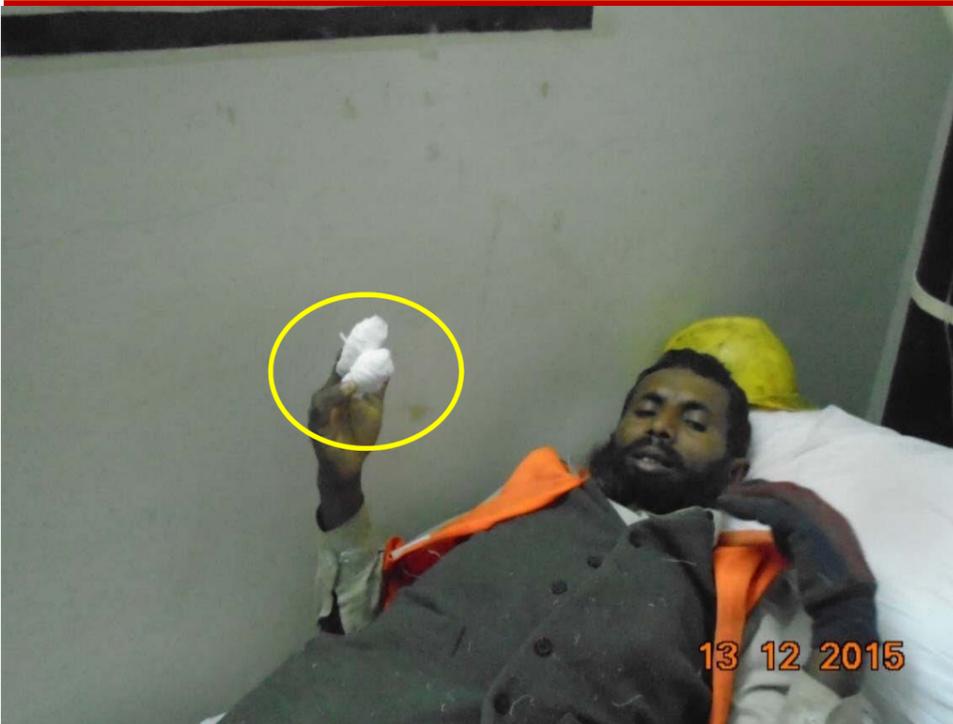
Encircled: Fingers of Injured laborer

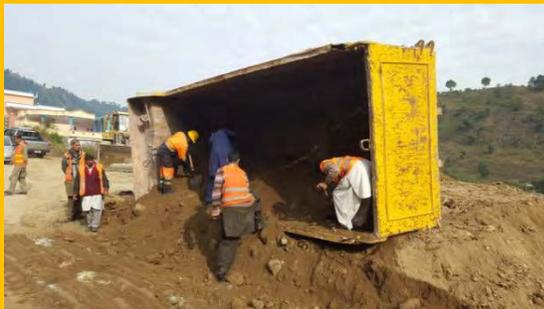
## Dumpers Tip Over During Unloading Activity

On 1<sup>st</sup> and 12<sup>th</sup> November 2015 Sub-Contractor Dumper truck tip over during unloading activities at two separate places due to disposal on loose ground as well as on uneven surface.

**INVESTIGATION** The investigation found that disposal does not meet the standards and requirements of safety while dumping.

- Untrained drivers: Driver driving dumpers were unaware of the loose soil hazard and vehicle tip over on similar surfaces.
- Helper: Dumpers were missing helpers to assist drivers in safe and proper reversing of vehicle and spotting of loose surface/uneven surfaces.
- Improper and lack of supervision at site by site supervisors.
- Not maintaining safe distance from loose un-compacted soil surfaces.

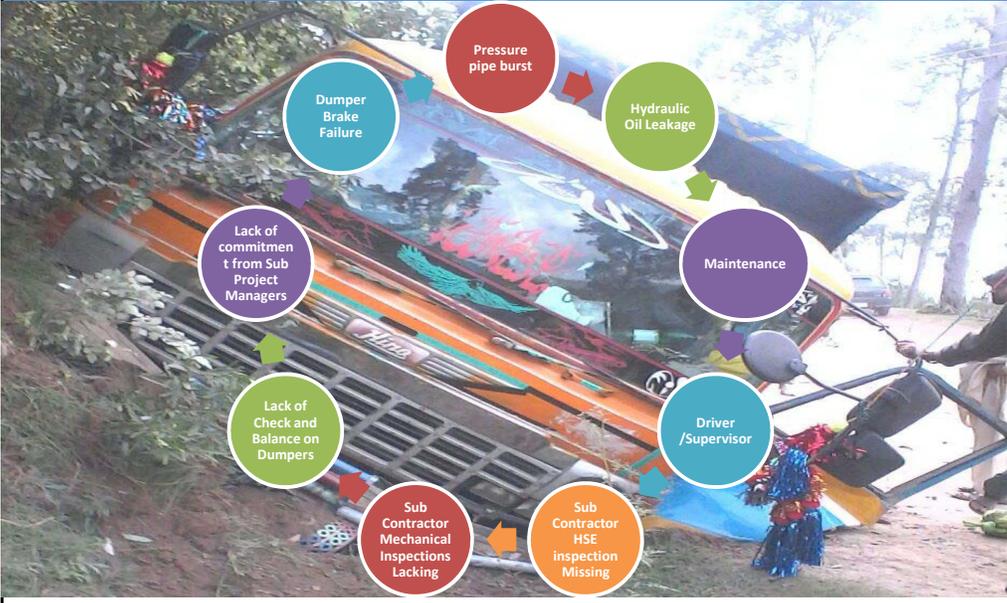
Cause Analysis of Dumper Hydraulic Pipe Failure

Brakes Failure- Caused the dumper hydraulic pipe to release pressure and thus fluid

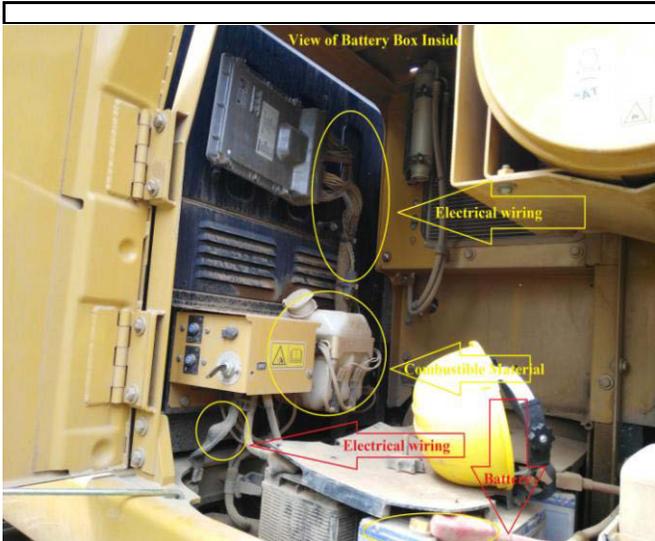
1. Absence of Excavator Helper
- 2: Absence of Signalman
- 3: Absence of Fire fighting equipment inside excavator
4. Presence of combustible materials inside Battery Box

**View of Excavator Battery Box**

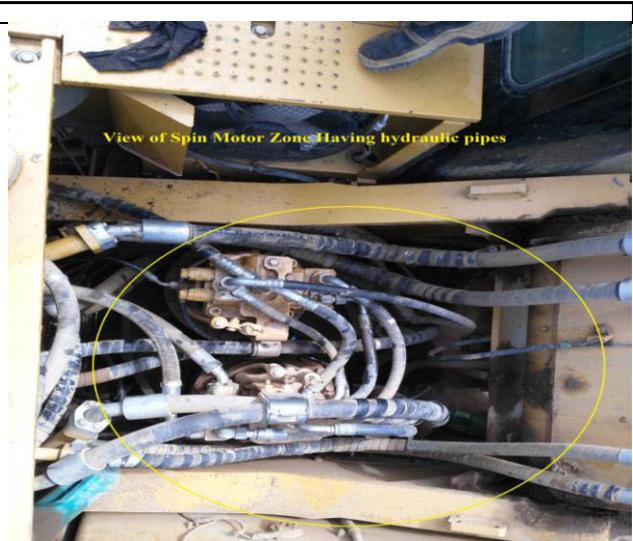
**View of Spin Motor Zone which lies near to Battery Zone**

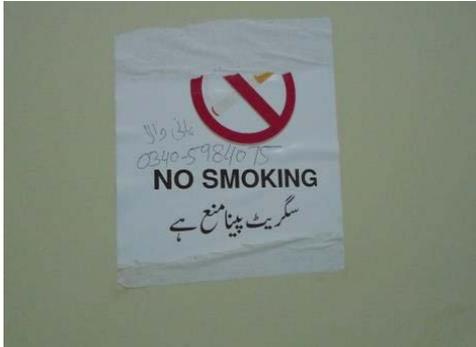
*No Smoking signage tampered with*

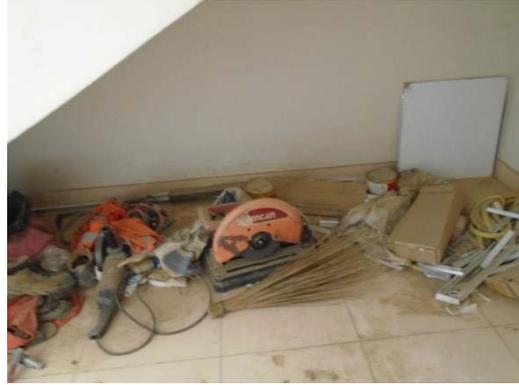
*Scattered Tools in M Block building of TTC*
