Government of Zambia

# Environmental and Social Audit Report and Remedial Action Plan for Ten Dams in Zambia

Additional Financing Irrigation Support Development Project (P102459 & AF-P172140)

April 16, 2020

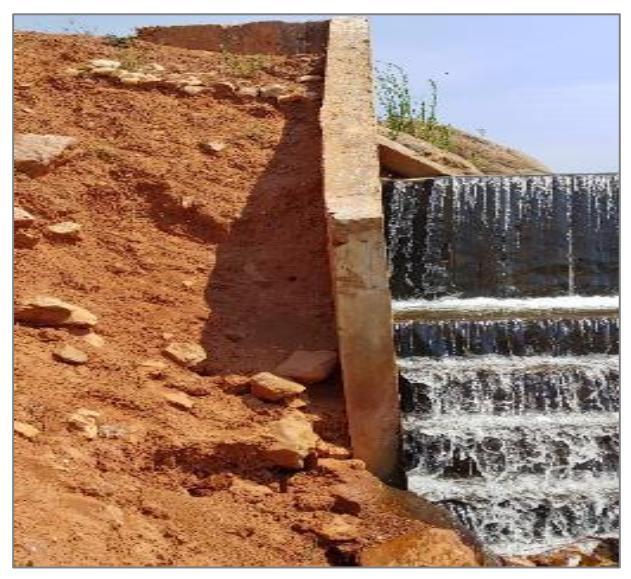
Lack of proper compaction and grass cover on side wall abutments resulting in erosion loss which will eventually undercut the steps (November 2019).

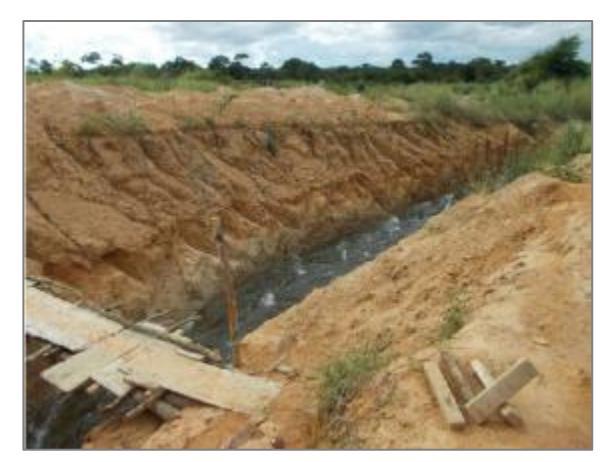
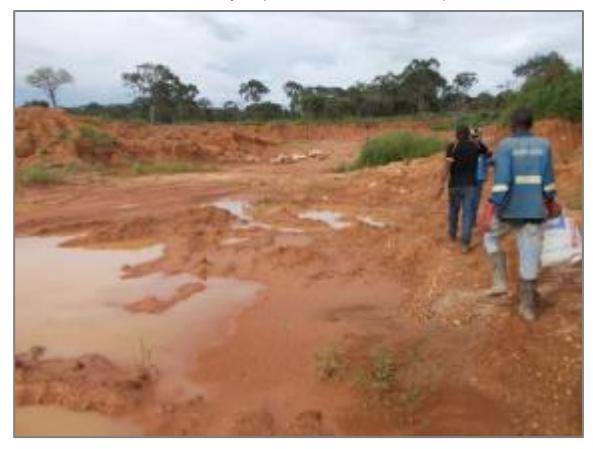
Figure 8-5. Issues relating to rehabilitation of the site (Katembula).

River diversion during construction. Note highly Borrow pit on the right bank (March 2018). eroded embankments (March 2018).

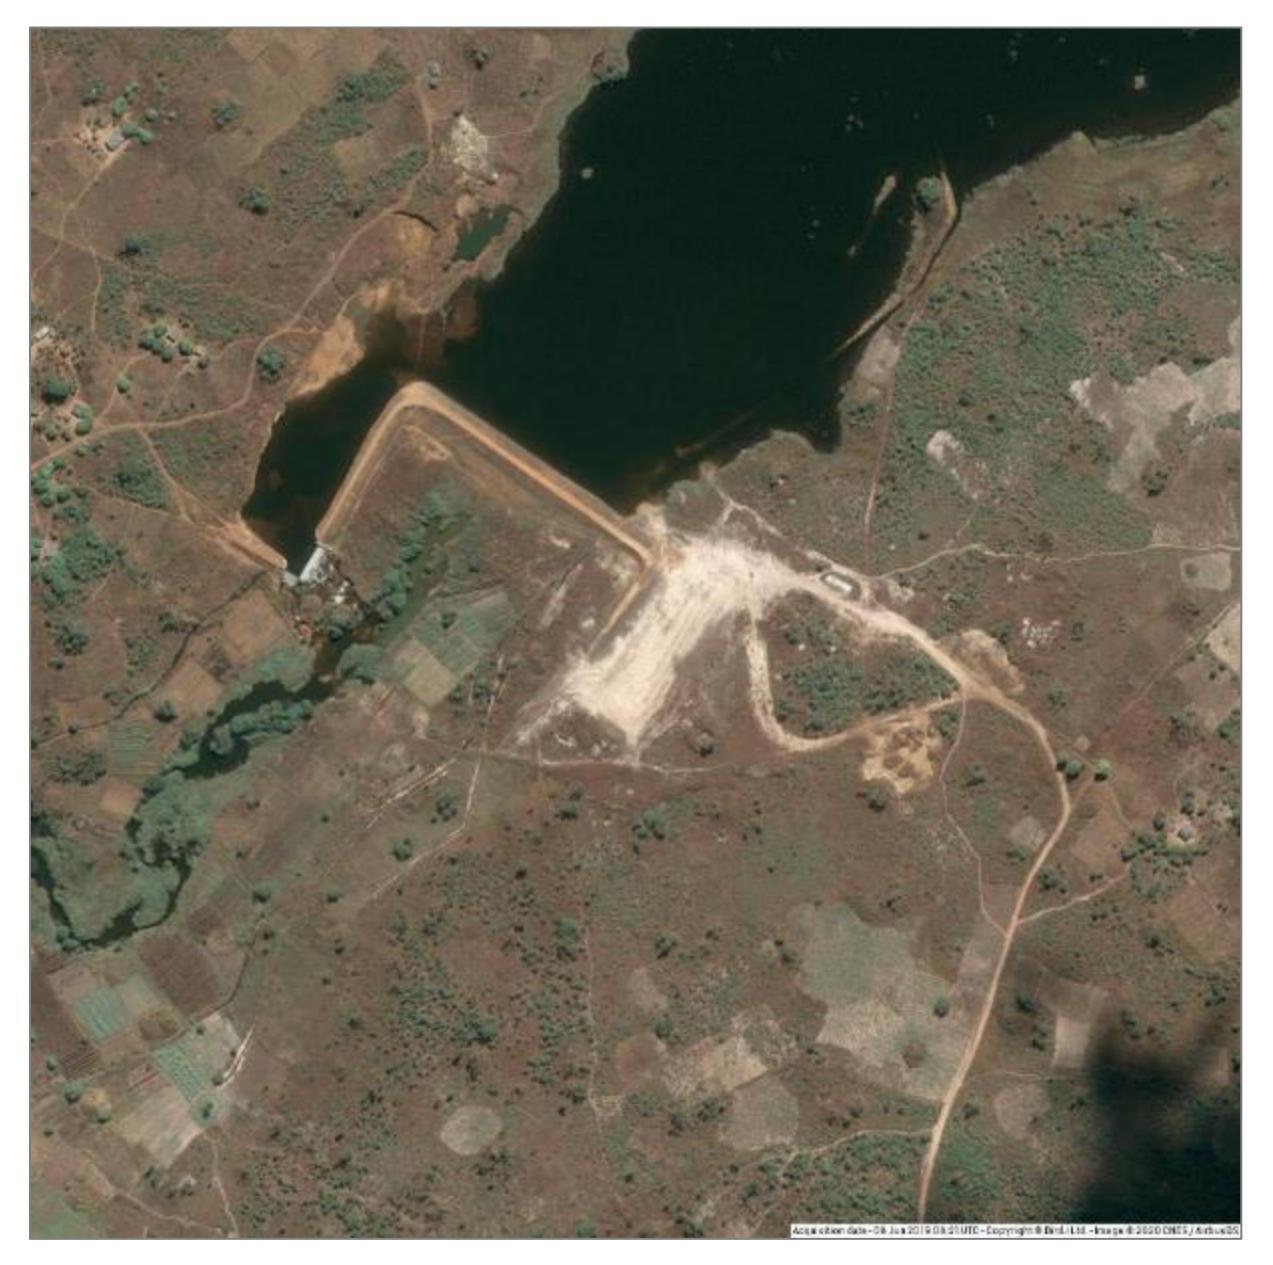
Figure 8-7. Chibalashi Dam – detail of the wall (imagery date June 2019).

Code	Aspect	Safeguard requirement (ESMP/ARAP)	Risk	Compliance status
Construc	tion Remediation	Phase		
ENB-1	Demobilisation and Restoration	Prepare demobilisation and restoration plan.	Plan ensures structured management to minimise environmental risk of dam construction impacts.	No plan prepared or implemented.
ENB-2	Rehabilitation of work areas	Rehabilitate disturbed work areas and restore as close as possible to original contours. Restore topsoil from stockpiles. Replant with native plant seed mixes, where natural revegetation likely to be unsuccessful.	Erosion and sedimentation. Alien plant infestation. Loss of use of land.	Appears that grassing of the embankment was done and is in reasonable condition. Contour furrows for reseeding or erosion control on the embankments still evident. Adequacy of topsoil restoration uncertain. High levels of construction disturbance (borrow?) on the left bank (Figure 8-7).

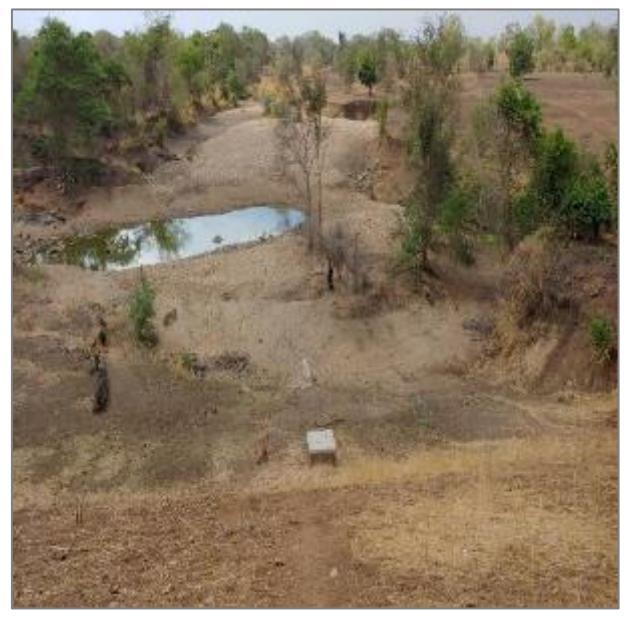
Downstream slope of main embankment with (blocked) outlet chamber (November 2019).

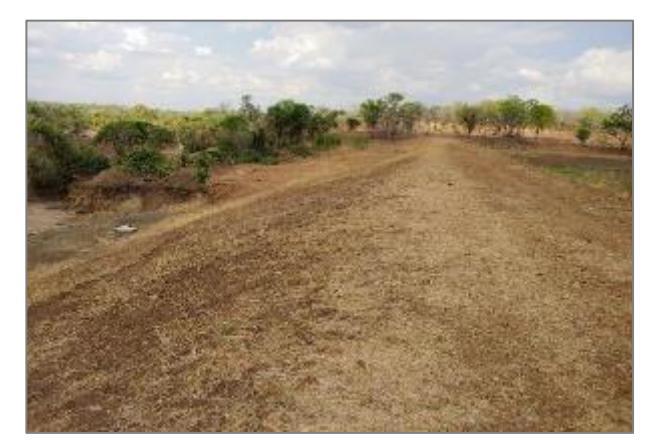
Figure 8-14. Natural reinstatement of grass cover at Chikowa Dam.

Topsoil on main wall appears to have been placed but cover remains poor. Soils may be dispersive.

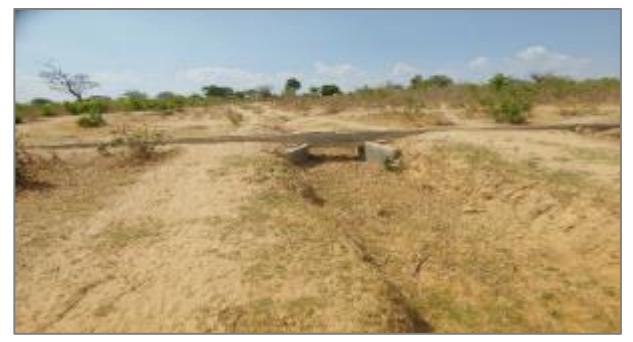
Existing first drop structure (March 2018).

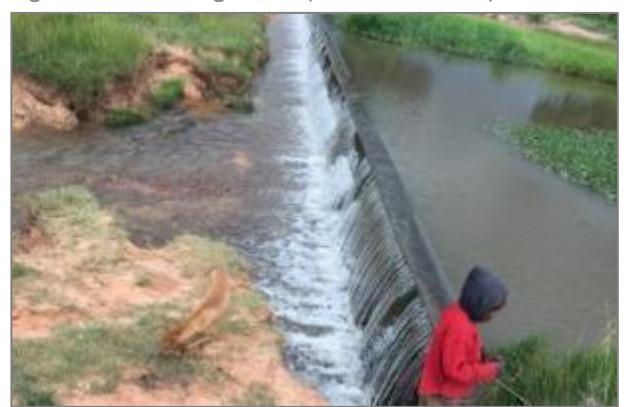
Right bank market gardens (November 2019).

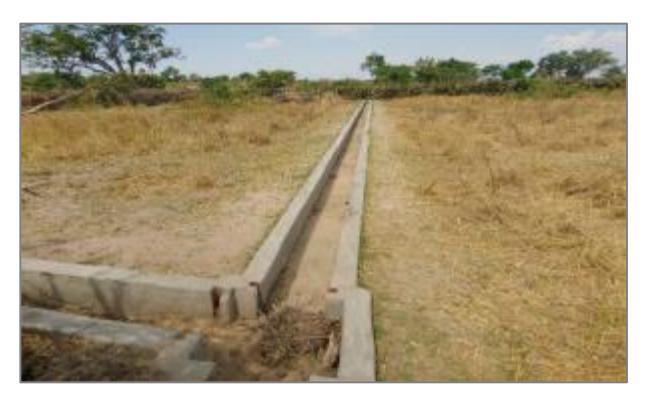
Canal termination (November 2019).

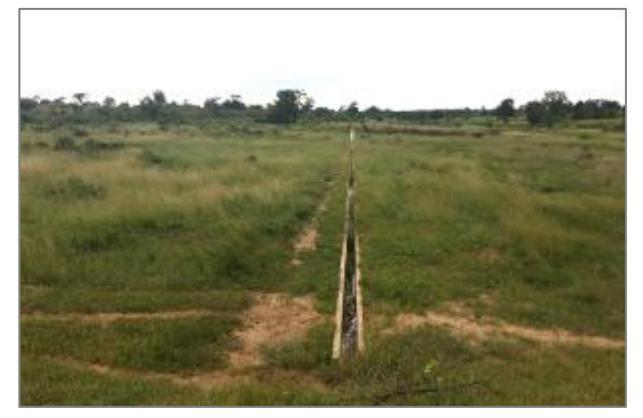
One of the new irrigation canals downstream of dam (March 2018).

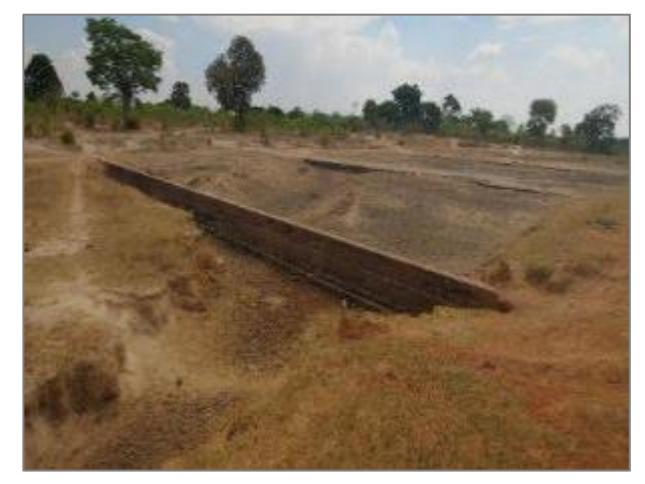
Second check weir (November 2019).

*Figure 8-22. Downstream erosion of the channel at the second check weir below the Makaba Dam spillway.*

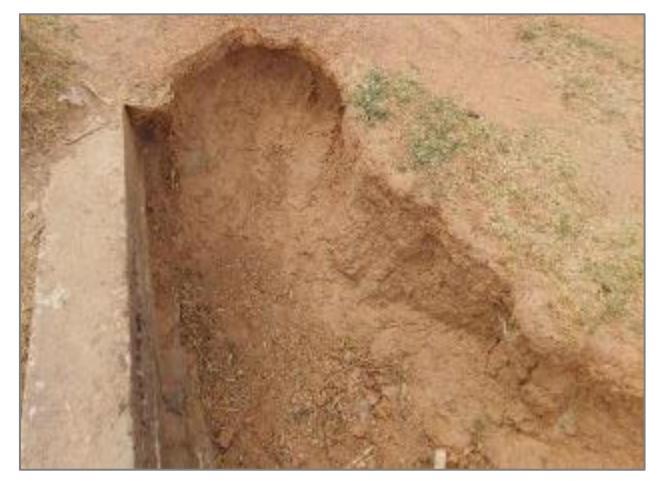
Second check weir left abutment erosion (November 2019).

Code Aspect Risk Action required SFE-1 Structural Overtopping of the Confirm the design flood. ٠ safety embankment. SFE-2 Structural Regularly monitor seepage (install V-notch weirs to Seepage and embankment ٠ safety failure. measure flows on the right bank. Install toe drain filter. • • Monitor/remove termites. SFE-3 Failure of dam embankment due Structural Repair the drop weirs and spillway. ٠ to headward erosion and safety undermining of the spillway.

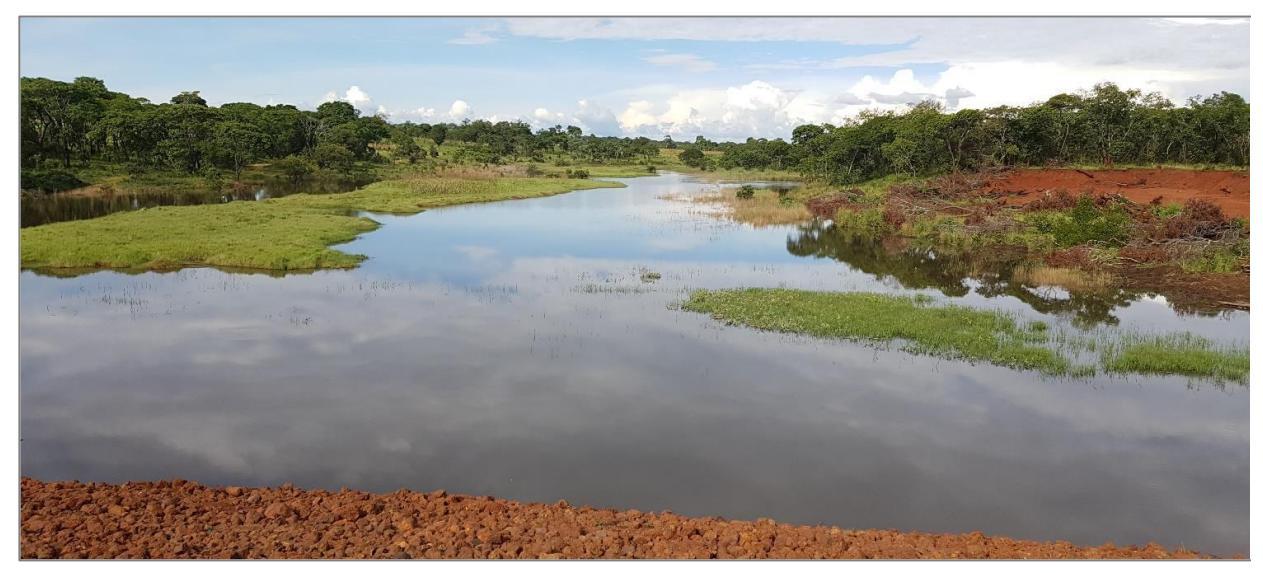
View of the Nabowa Dam from the crest (March 2018).

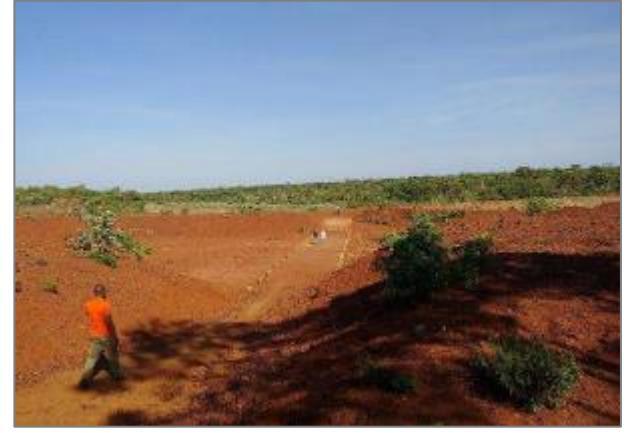
Main spillway and causeway (March 2018).

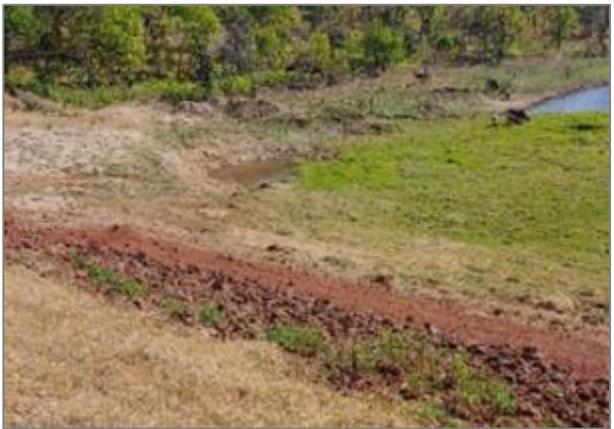
Downstream face partially stone pitched (March 2018).

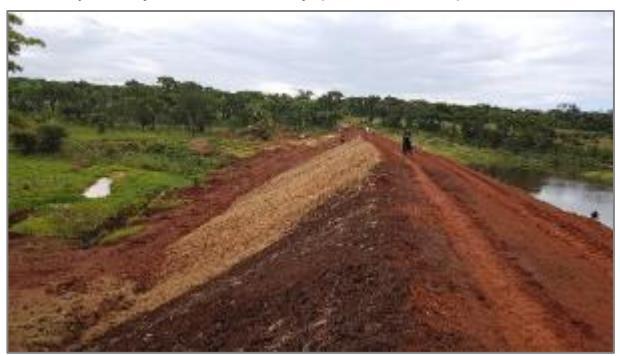
Embankment construction looking towards right flank. Note water impoundment (March 2018).

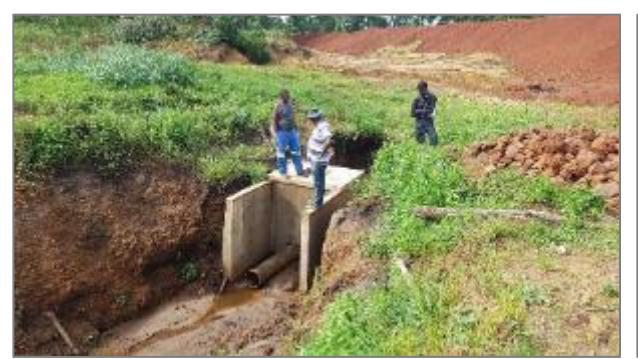
Downstream view of low flow pipe feeding water into the irrigation channel (March 2018).

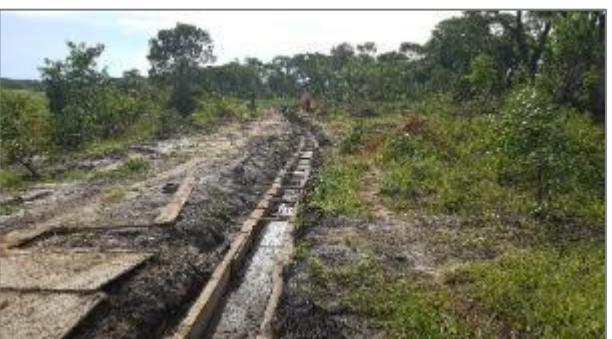
Irrigation canal on the right abutment of the dam (March 2018).

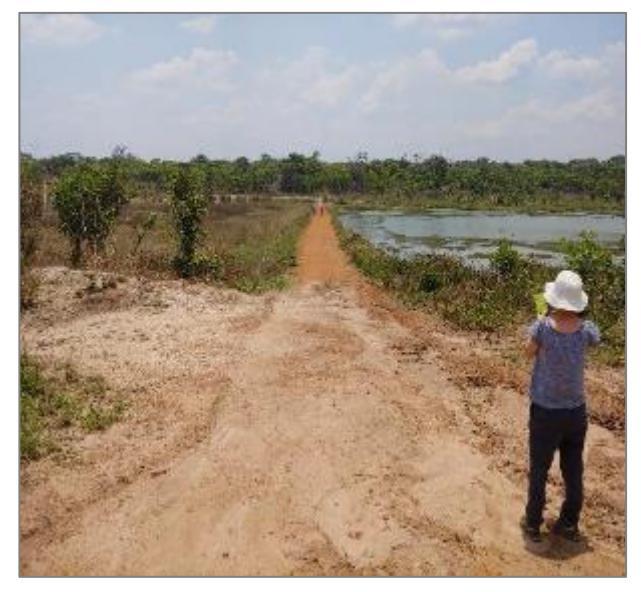
Dam crest remains unchanged from the old dam (November 2019).

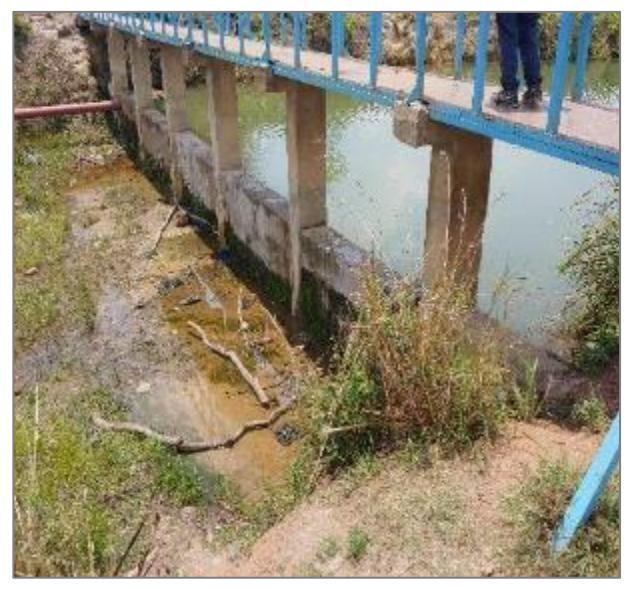
Dam crest remains unchanged from the old dam Raised spillway with pedestrian bridge (November 2019).

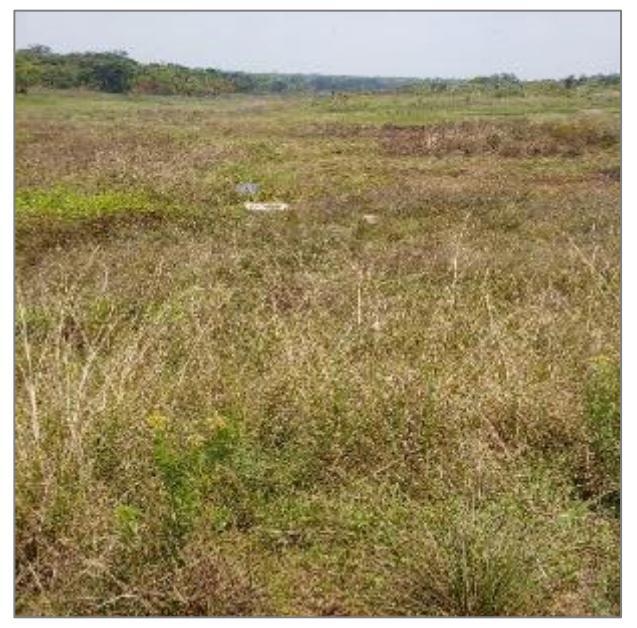
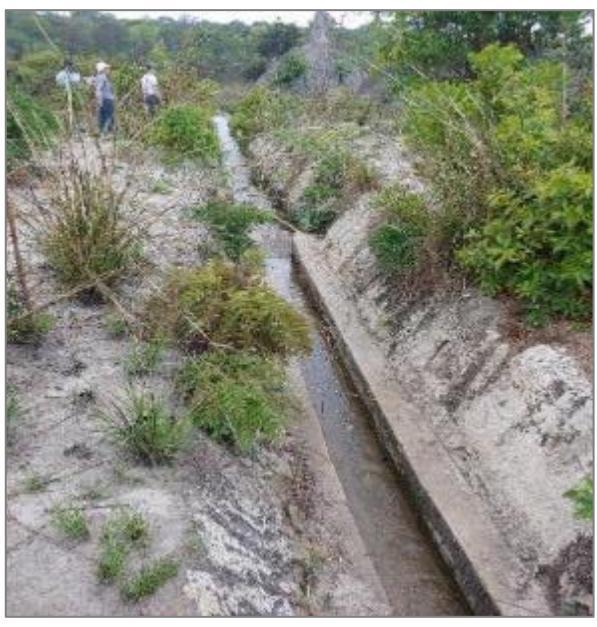
Valve chamber located in downstream wetland Irrigation channel (November 2019). (November 2019).

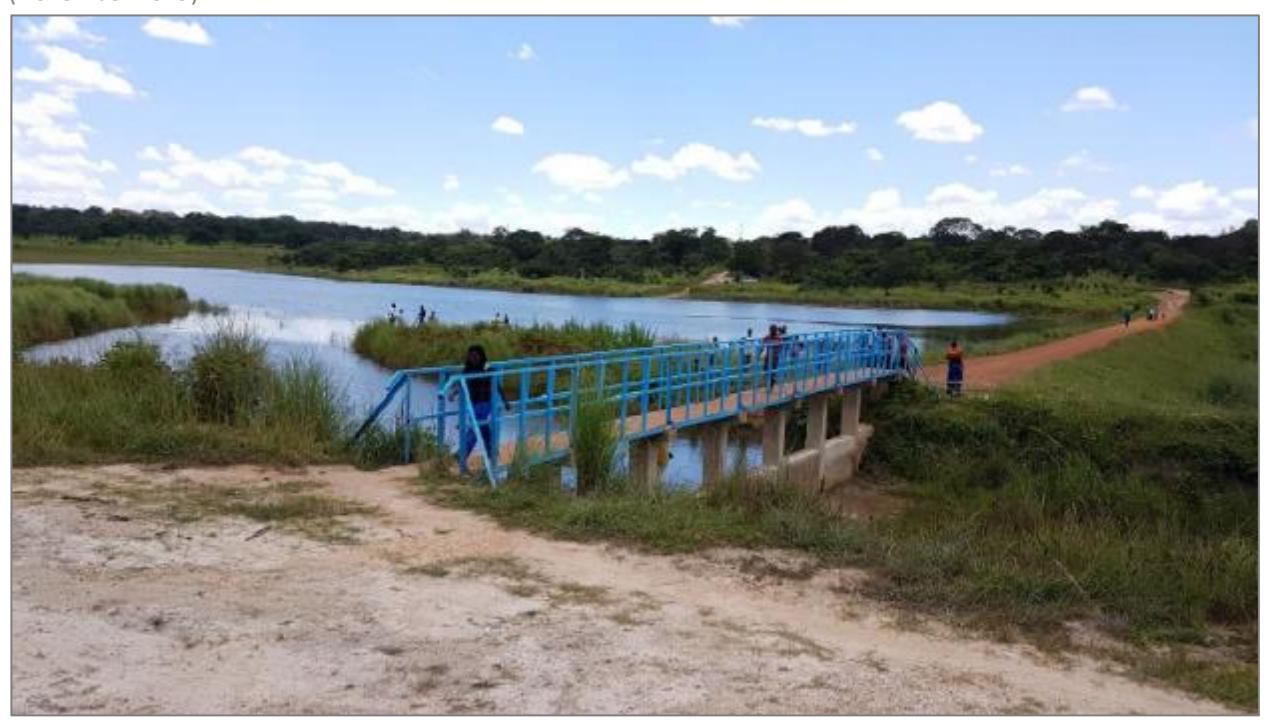
Completed raised spillway and pedestrian bridge (April 2018). Figure 8-31. Kawiko Dam after construction.

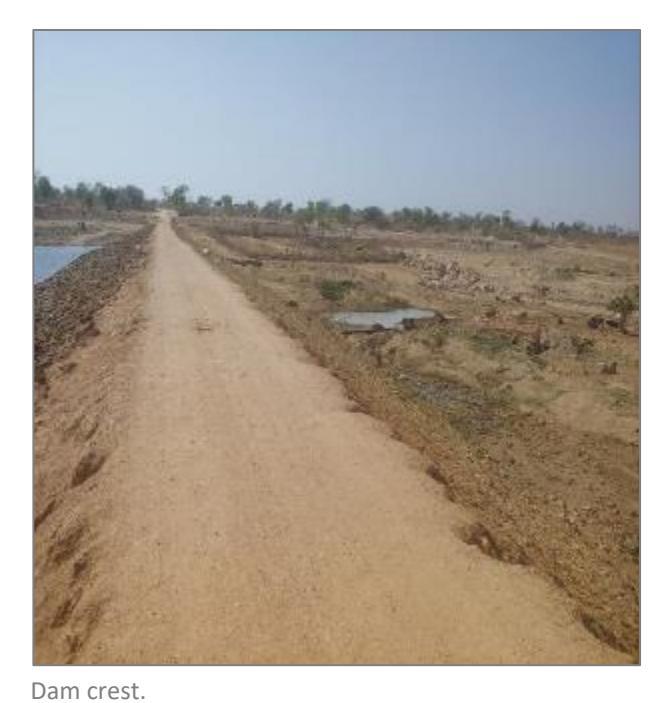
Code	Aspect	Concern/non-compliance	Risk
		badly without appropriate drop weirs, possibly threatening the causeway	
SFI-3	Structural safety	Secondary spillway has caused incised gullying near the embankment	Causeway damage and loss of integrity. Downstream community safety
SFI-4	Structural safety	Crest heavily used as a local thoroughfare for people and livestock and requires remedial work	Erosion and loss of integrity of the embankment

Erosion of the cam embankment partly cause by livestock.

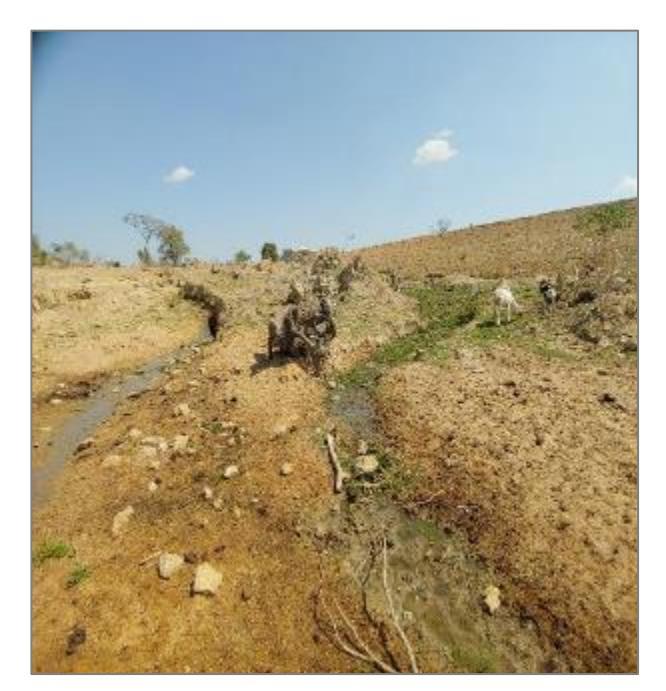
Gullying in the return channel.

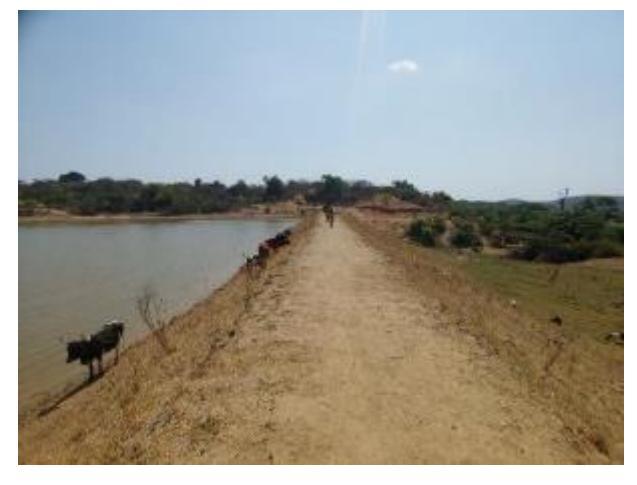
Dam crest in the dry season (November 2019).

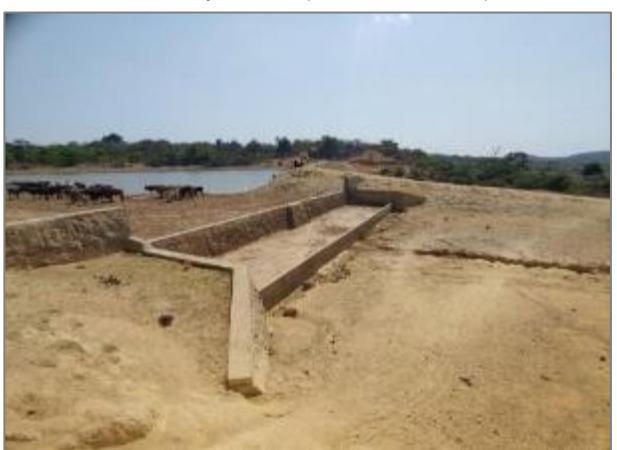
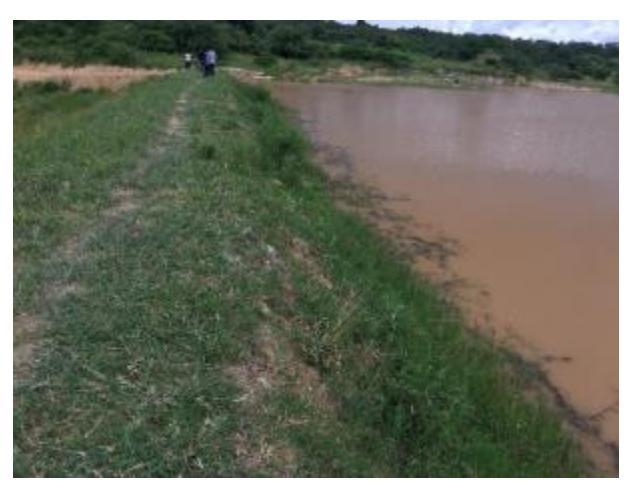
Dam crest in the wet season (March 2018).

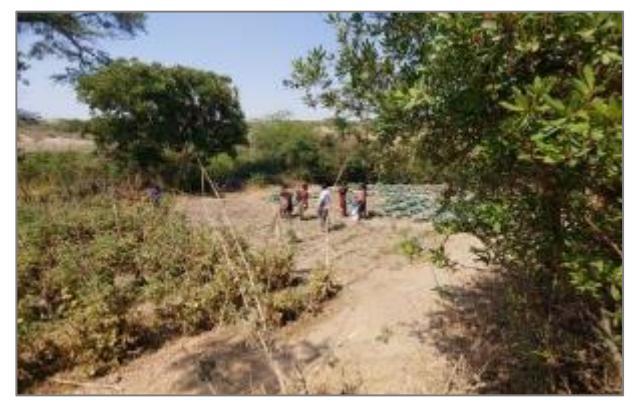
Existing gardens downstream of the dam benefitting from the dambo (November 2019).

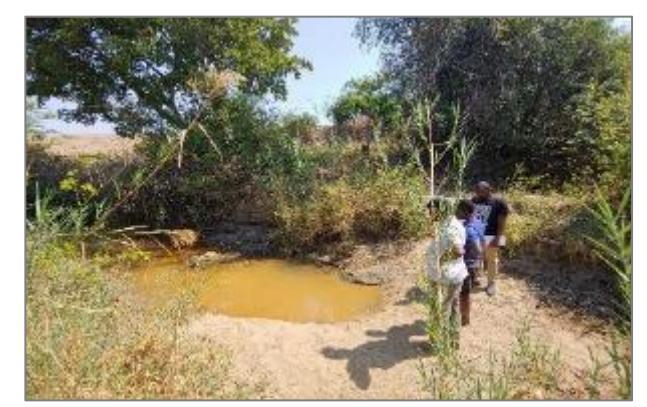
Bucketing water for gardens downstream of the dam (November 2019).
